CFM56 TRF Eddy Current

Sam Tucker
NDT Process Engineering
SFOEP

2015 A4A NDT Forum
Fort Lauderdale, FL

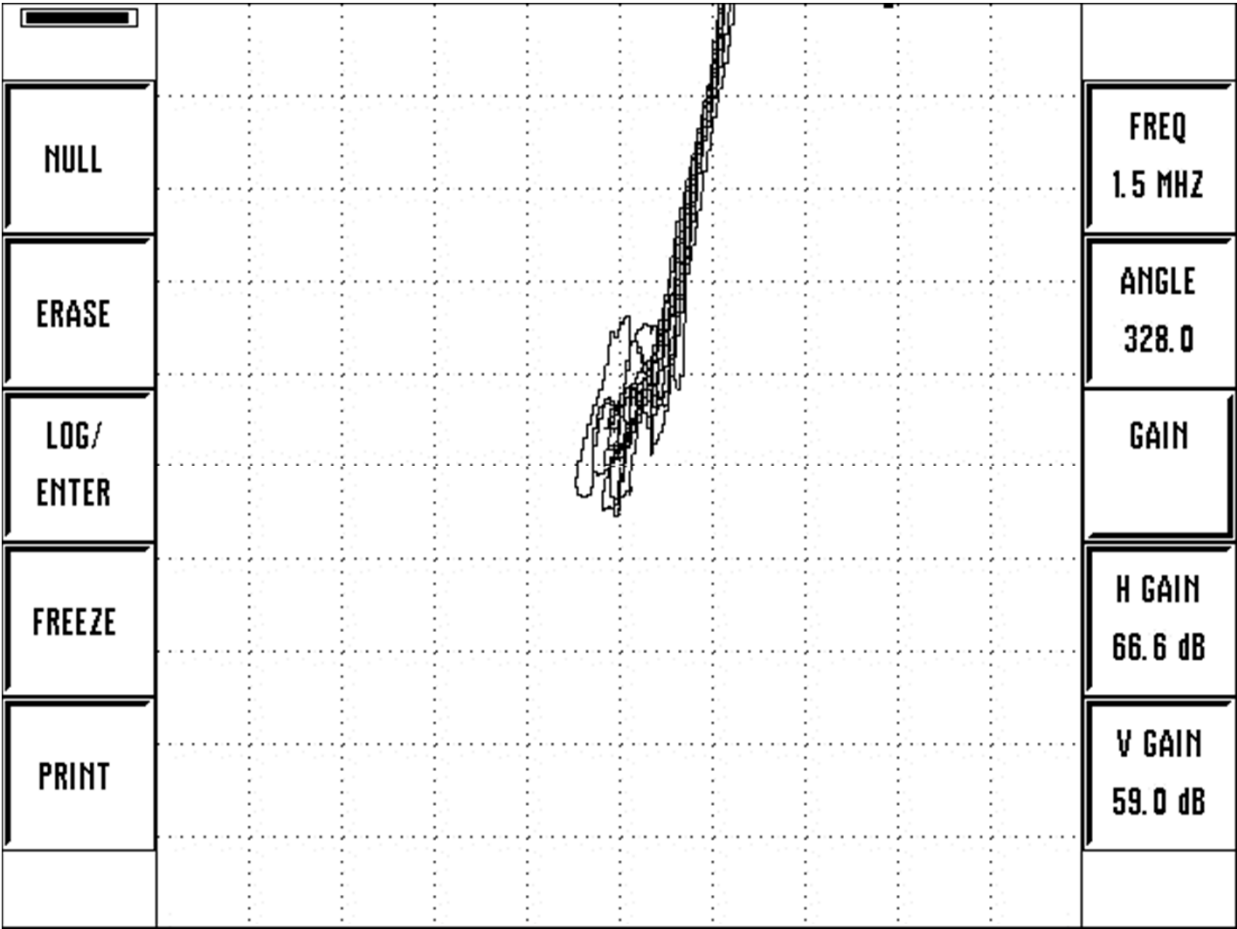
What does it look like when we scan across the weld?

Rejectable signal = 1.5 divisions. Houston, we have a problem!

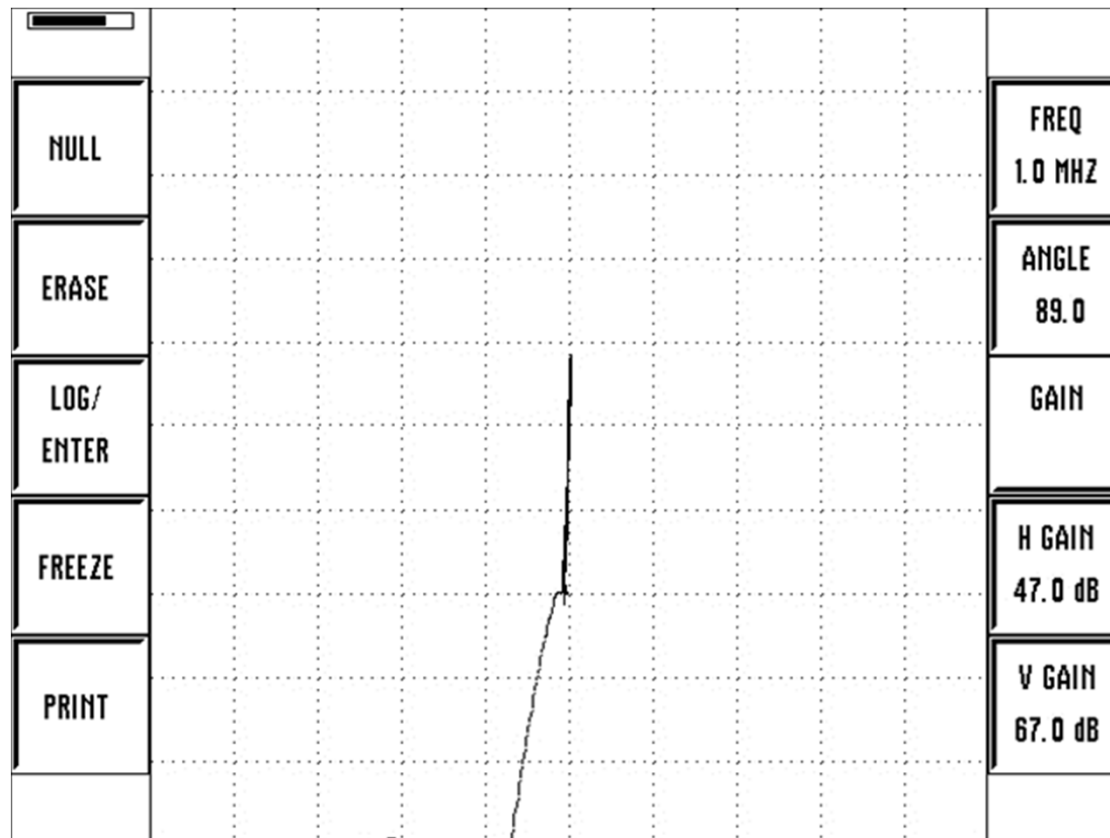
- Neither of the borrowed weld probes we tried would set up on the ref standard...
- The Uniwest US-1839 gave a nice signal on the reference standard. Instead of 10 degrees of separation, we had 180!

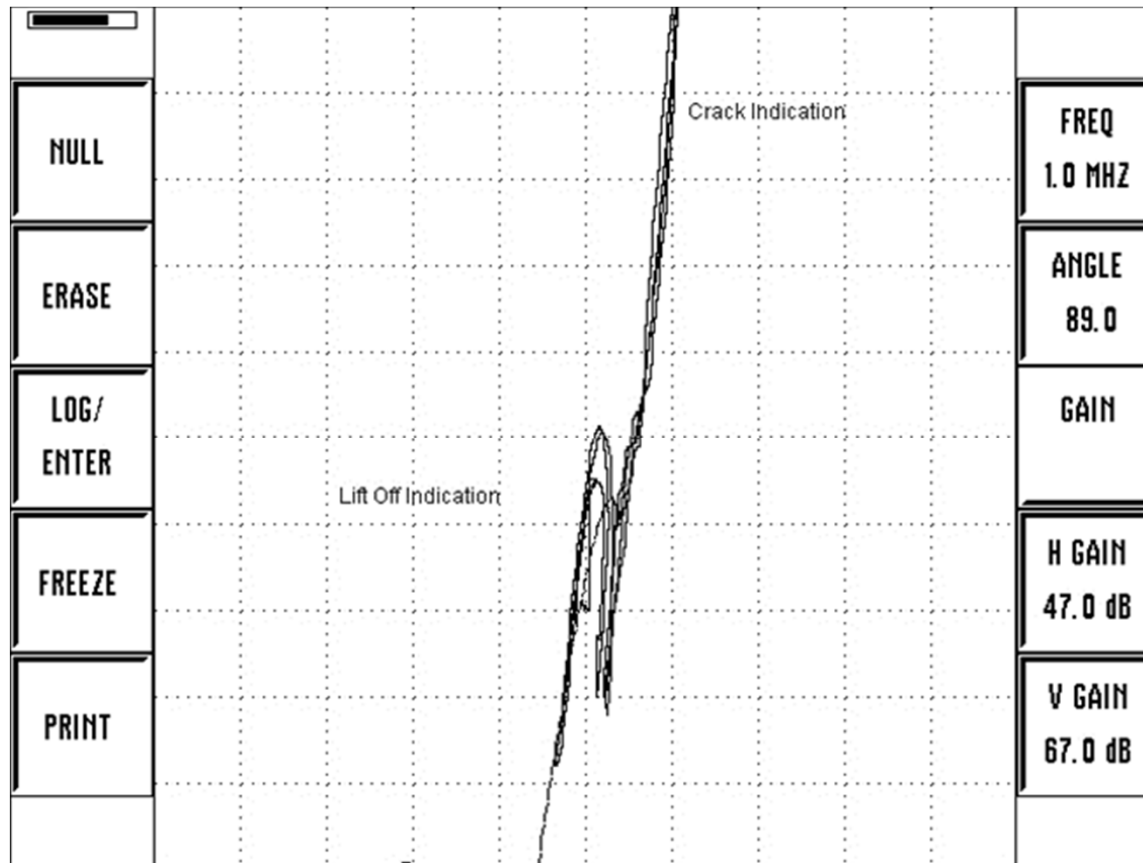
But what is this???
