Inspection and Teardown of Aged In-Service Bonded Repairs

Waruna Seneviratne, John Tomblin, and Brandon Saathoff

National Institute for Aviation Research (NIAR)
Wichita State University (WSU)

2018 Airlines for America NDT Forum
Seattle, Washington
September 18, 2018

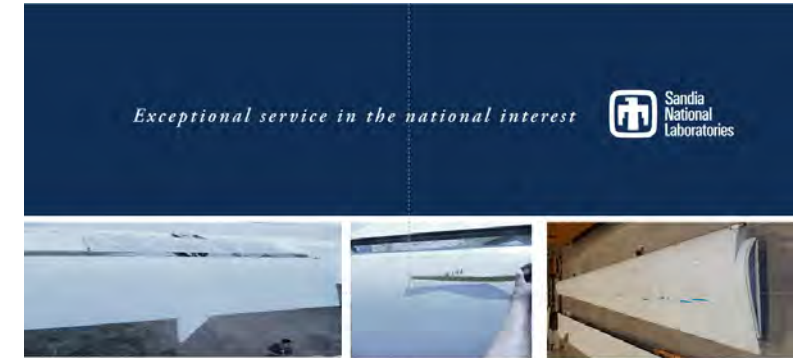
Repair 14A NDI Results

- The repair intersected a line of tape on the surface of the component.
- Core replacement and repair appear to be in good condition.
- One indication observed in the parent material (circled).

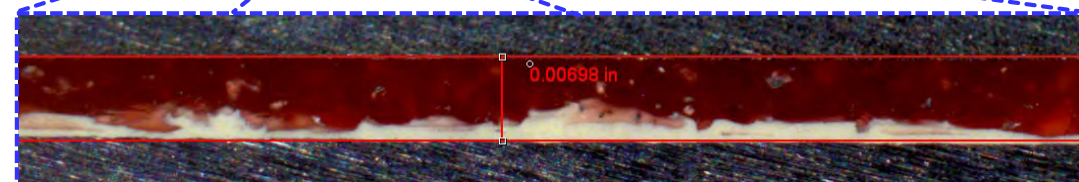
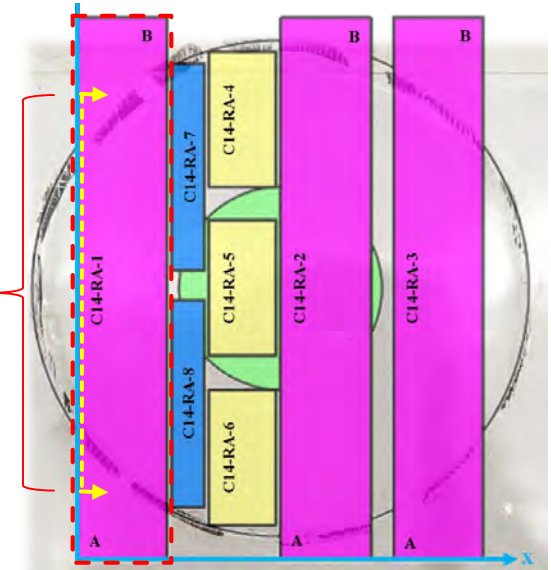
C14-RA-1 Cross-Section

← *Material of Concern*

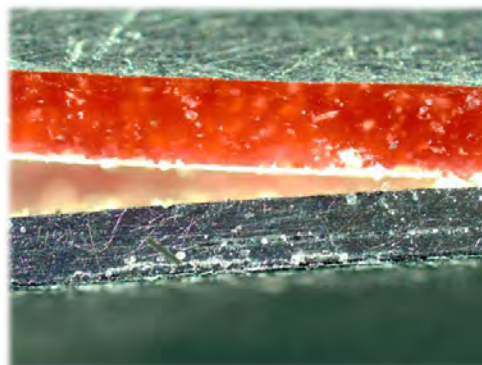
Repair Specimen Failure

- T-Peel (ASTM D1876)
 - Repair Peel Strength: $\approx 64\%$ of BL panels
 - Repair failure along interfacial anomaly
 - BL specimens: Cohesive failures

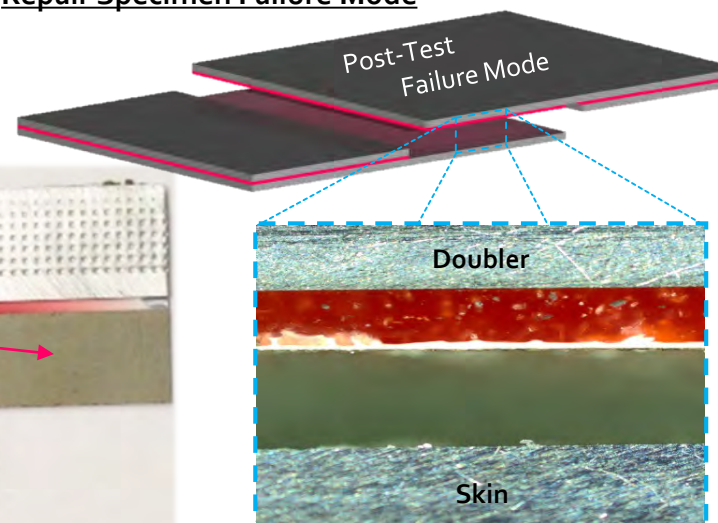
Repair Specimen Failure Mode

- Lap-Shear Testing (ASTM D3165)
 - Repair Shear Strength at failure: $\approx 50\%$ of BL panels
 - BL specimen failure controlled by adherened tensile strength
 - Repair specimens: Adhesive failure (primer)

Primer adhesion controlled failure

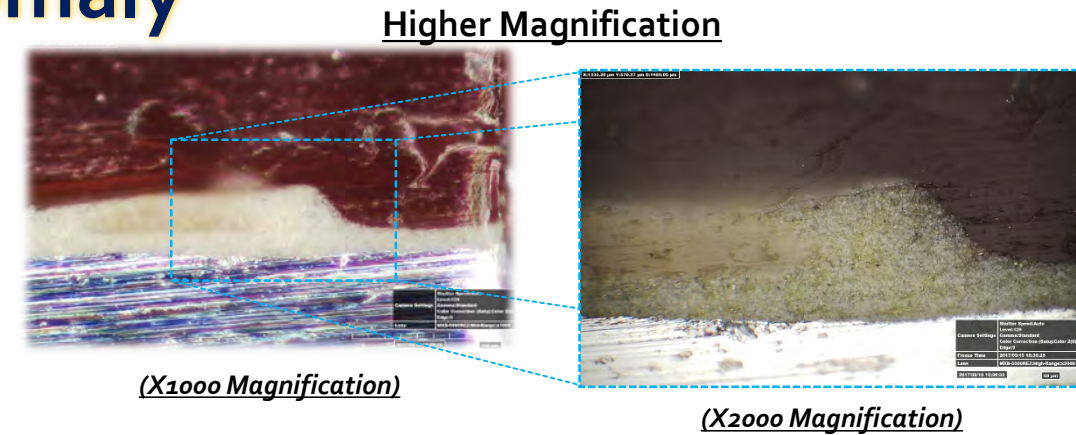
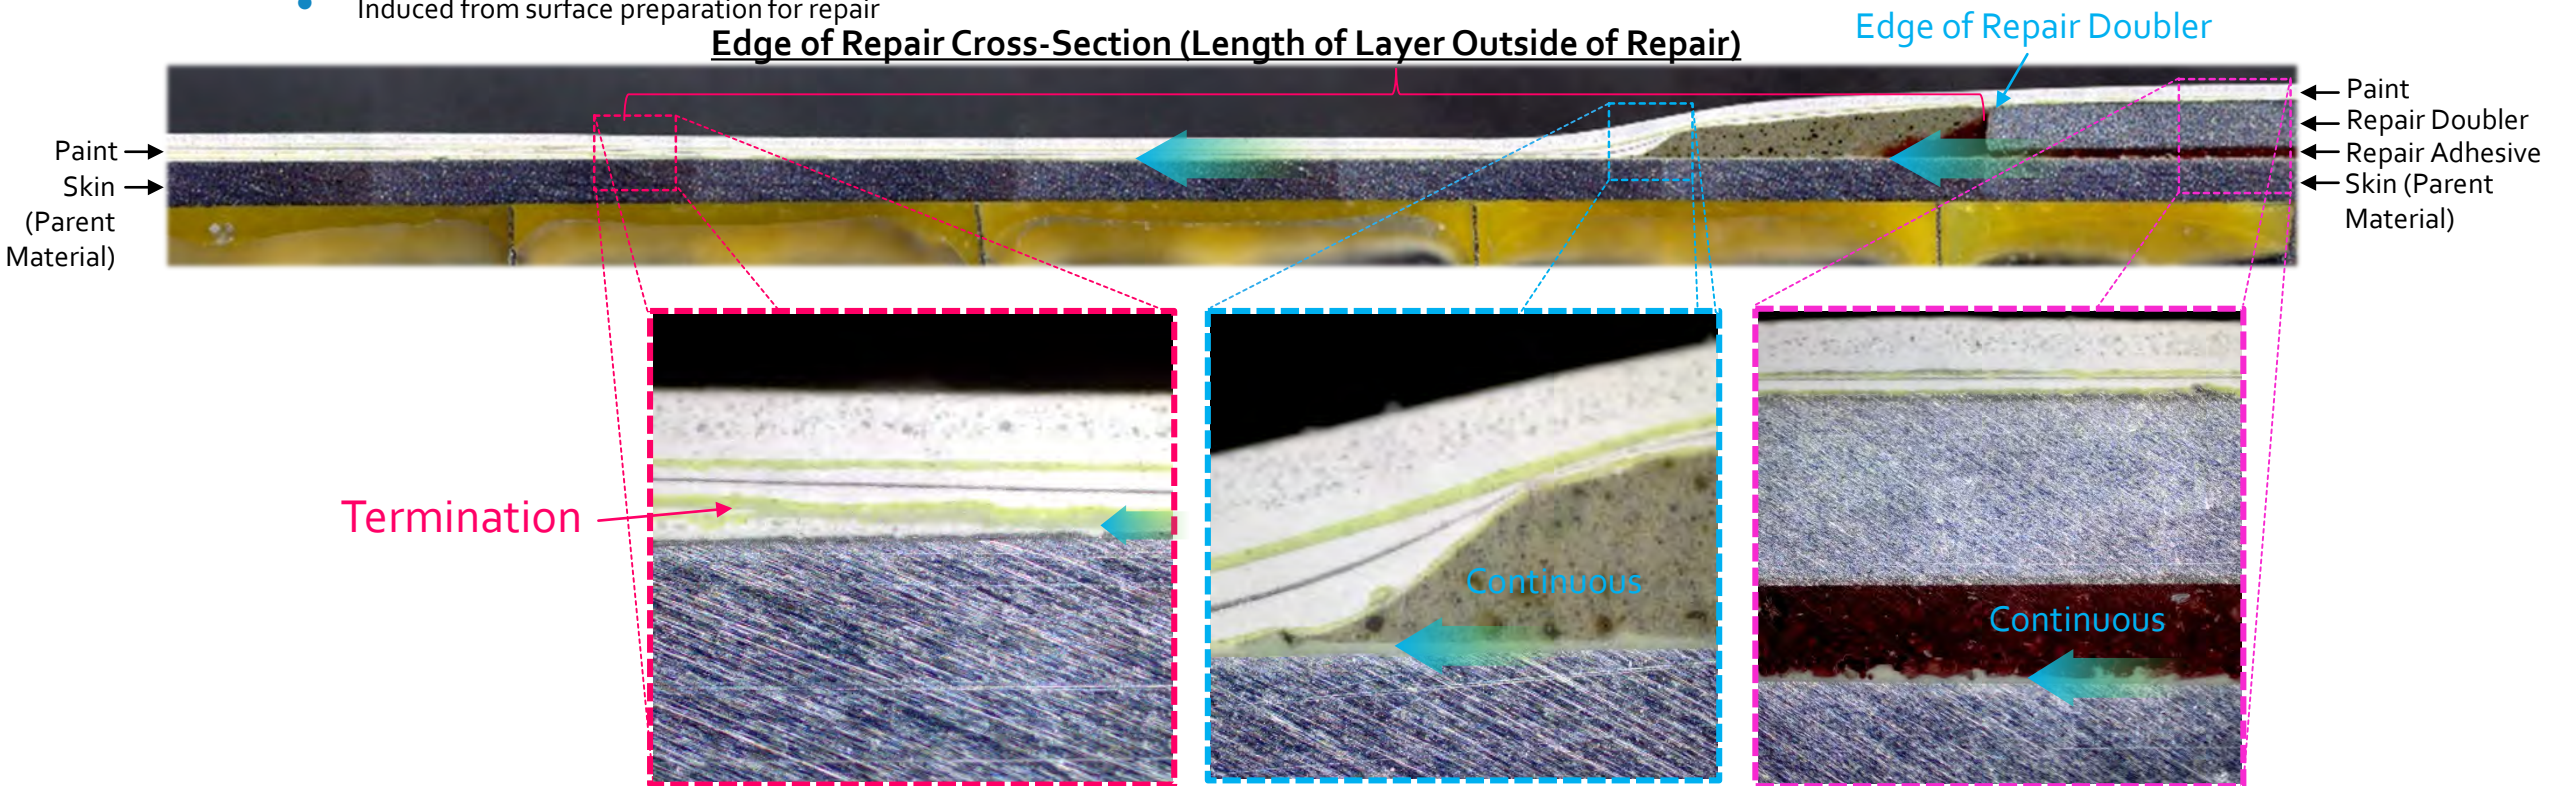
Interfacial Anomaly

- Component 13/14
 - Noticed in 8 out of 9 repairs
 - Repair on lower surface of C13 (likely different damage event – repaired separately)
 - Controlled performance of bond
 - EDS on surface of failed T-peel specimen
 - Chrome present
 - Layer terminates outside of repair region (≈ 0.5 -inches outside repair doubler)
 - Induced from surface preparation for repair

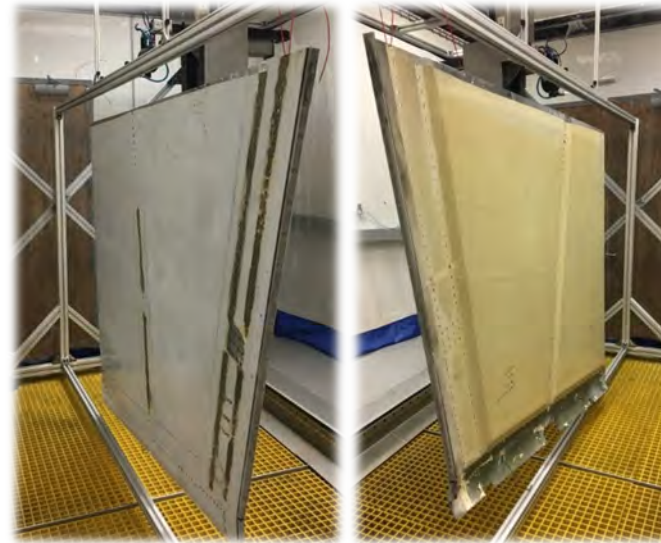
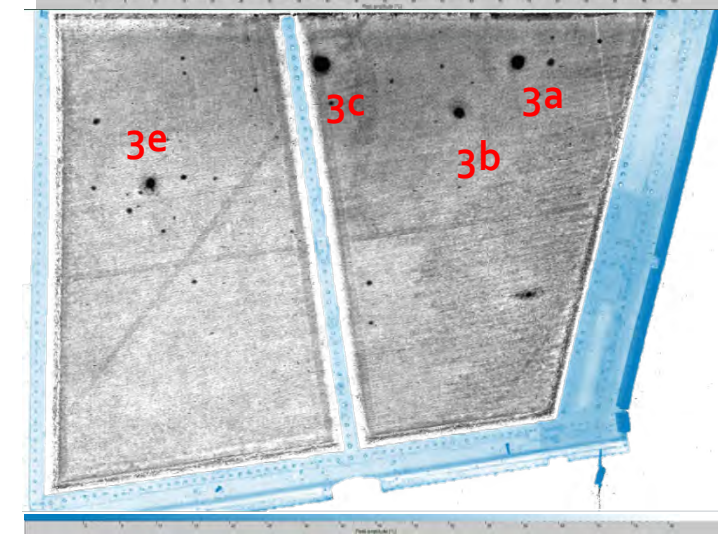
Component 3 TTU C-scan

- Inspection Findings
 - Large amount of indications outside of repair regions
 - High levels of attenuation in center of repairs
 - Not representative of a core plug (potting compound used)

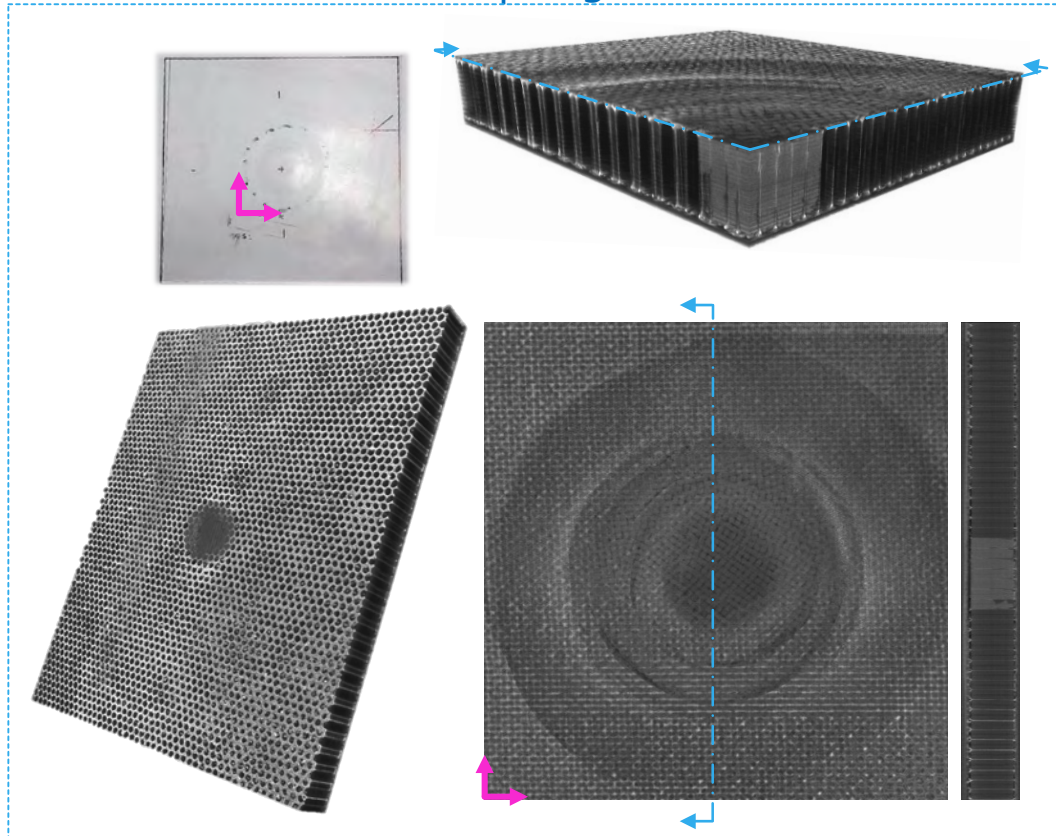
- X-ray CT Inspections
 - A clean repair and a repair with multiple indications was inspected
 - Repair 3e – No Speckling Pattern in Resonance C-Scans
 - Repair 9b – Speckling Pattern in Resonance C-Scans

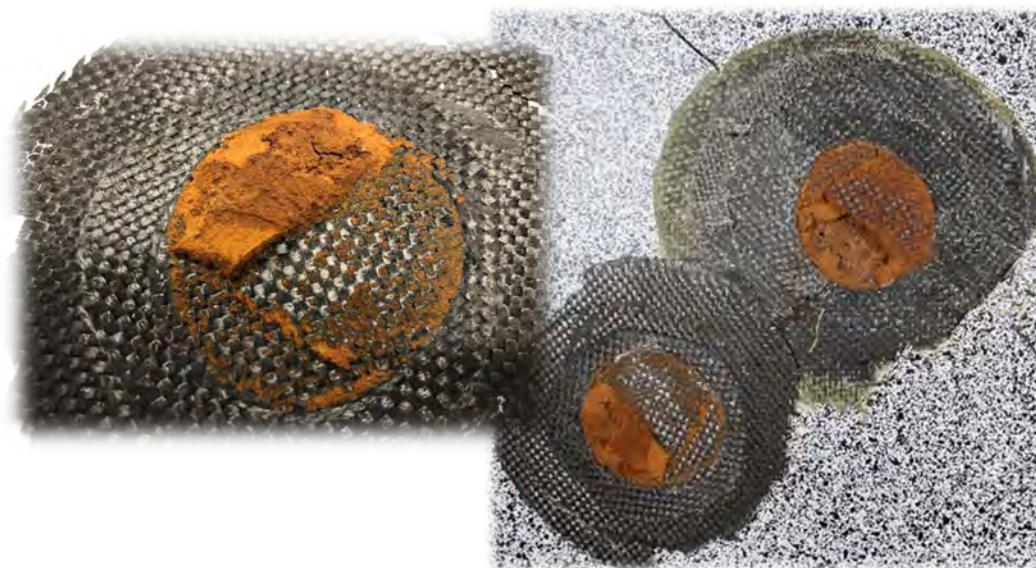
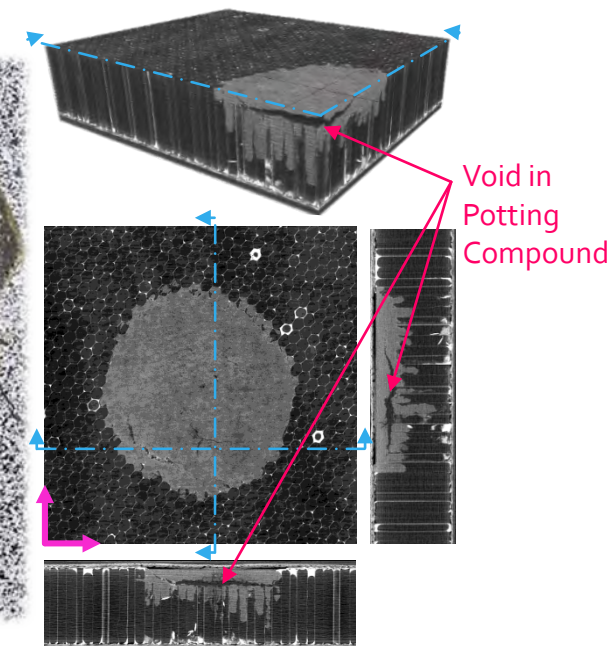
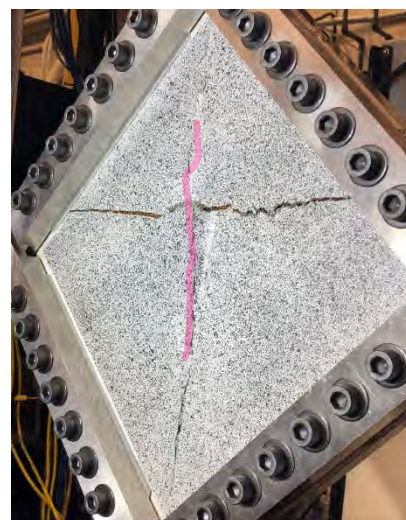
- Repair 9b

- Failure through void in potting compound allowing patch separation from core
 - Speckling further investigated following completion of testing and removal of repair patch

- Repair 3e

- Failure through repair material

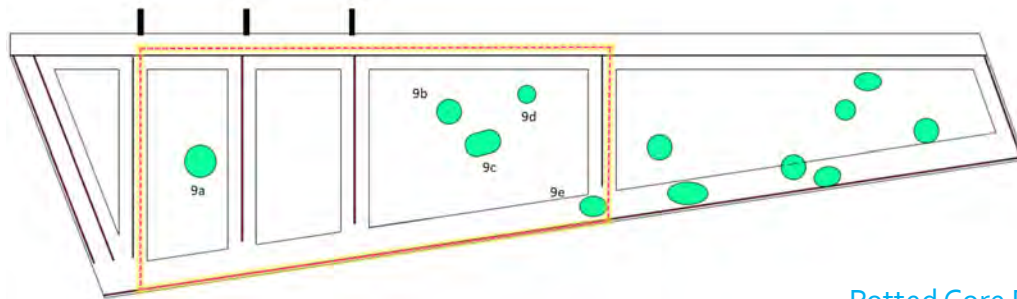
- **Post-test teardown of PFS Elements**
 - Evaluation of speckling pattern noted in NDI results on Component 4 and 9
 - Build-up of material in honeycomb cells stemming from external facesheet (top and bottom skins)
 - Green in color and small levels witnessed on internal facesheets
 - Less defined on lower skin
 - Random distribution
 - Located in specific regions on the components
