JAL Experience - 787 1st D-Check and NDI use cases

Junya Matsuda
Airframe Engineering
JAL Engineering Co., Ltd.

30OCT2022

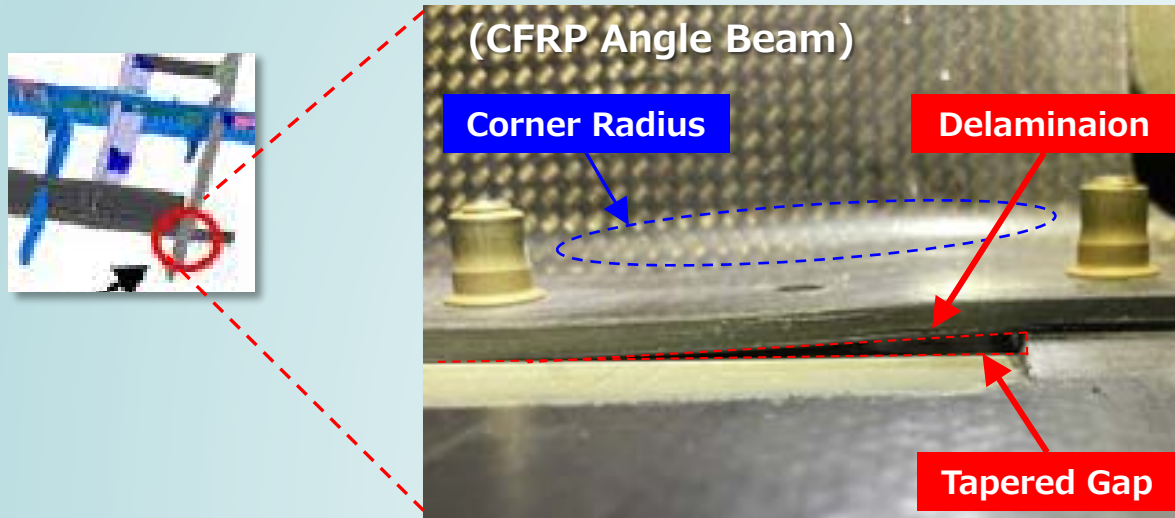
Delamination at CFRP Angle Beam Flange

Needed to determine if the delam propagated into corner radius...

- **Finding:** Delamination at flange caused by a tapered gap
- **Challenges:** Needed to determine if delam propagated to corner radius to see if intensive cut & splice repair required, or minimized repair could be applicable.
⇒ Required the following equipment.
 - ✓ A scan instruments with TCG (Time-Compensated Gain)
 - ✓ XDCR for quick swap delay line (was not available)
 - ✓ Probe shoe for corner radius (was not available)
 - ✓ Specific reference standard (was not available)
- **Solutions:**
 - ✓ XDCR : Utilized alternate size
 - ✓ Probe shoe & Ref STD : Locally fabricated
- **Result:**
Confirmed the delam not extended to corner radius
⇒ Repaired with reinforce angle
(Avoided the cut & splice repair !!!)

NDI support operator/MRO for eliminating the concern/minimizing the impact

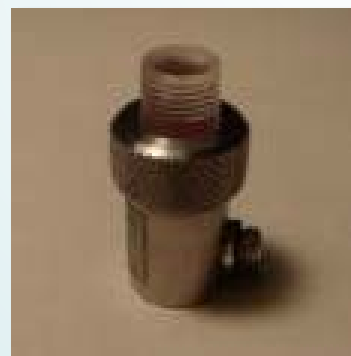
Probe Shoe and Reference Standard for corner radius

Transducer for delay lines

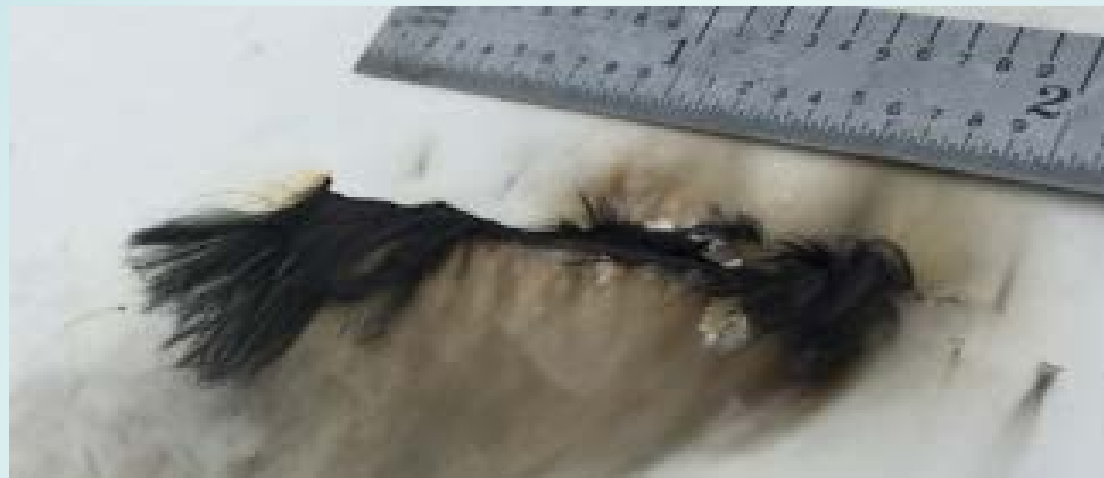
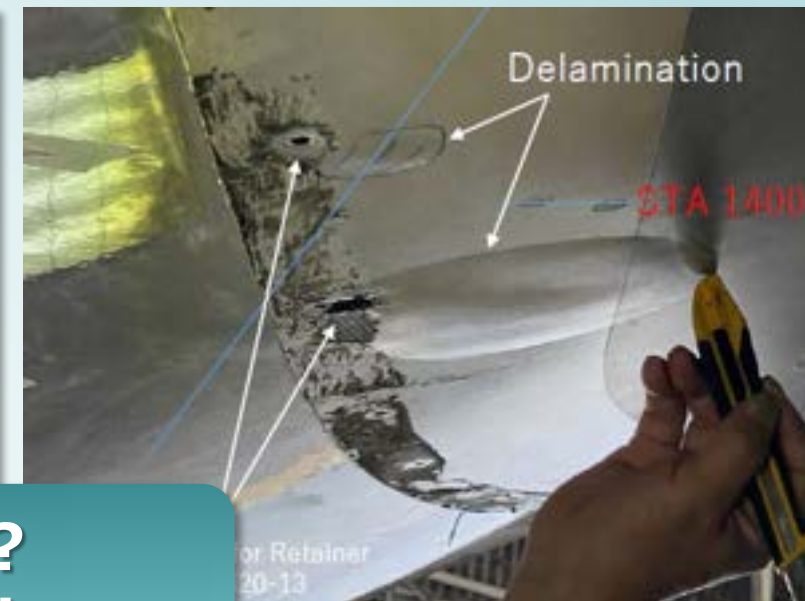
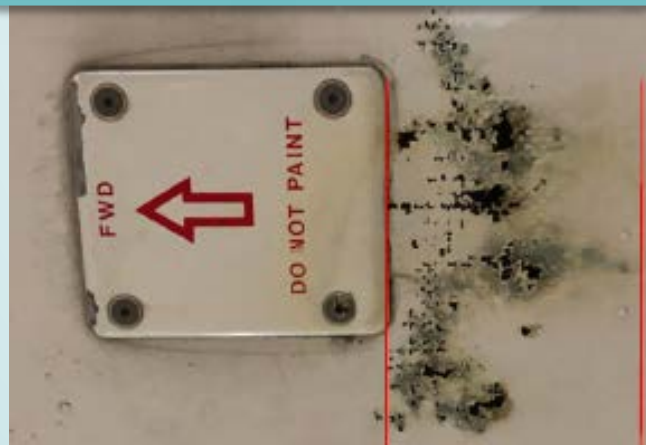
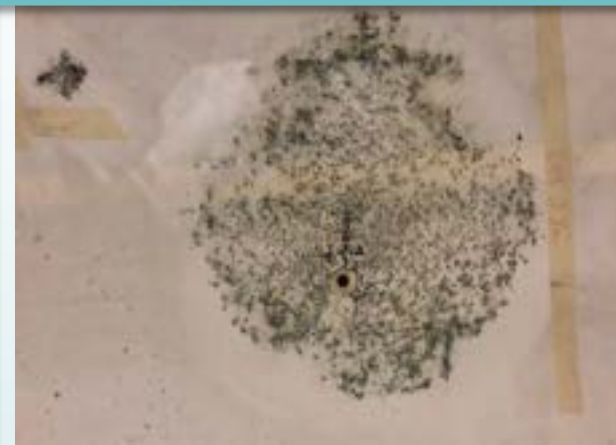
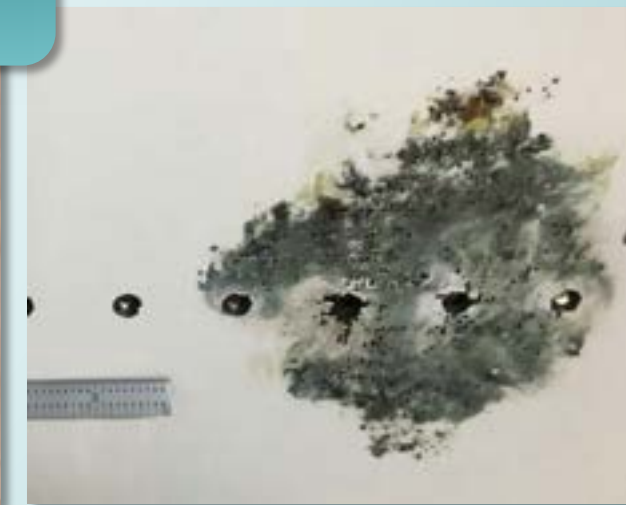
Which is serious ? Which is not ?
⇒ NDI is the key for determination...

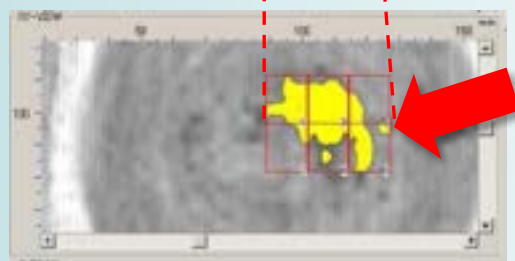
VOID,,,

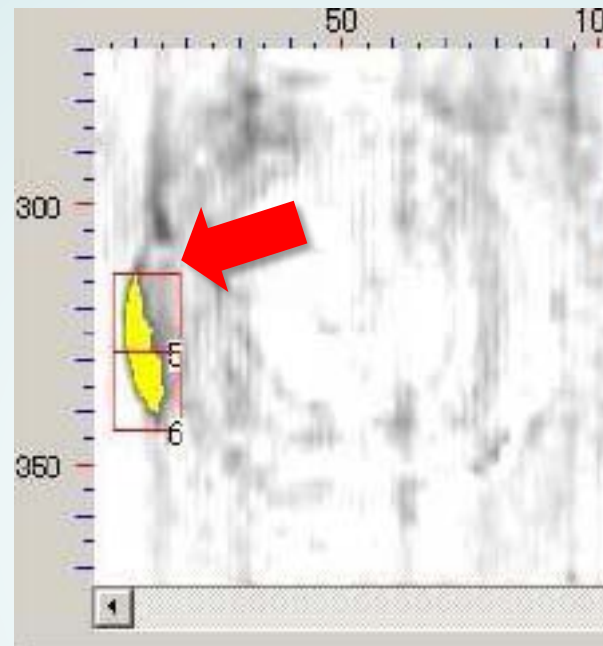
VOID,,,

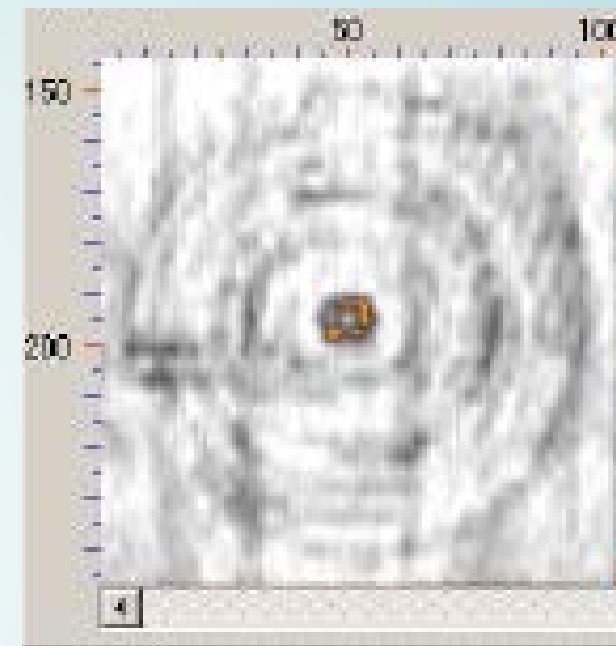
NO VOID!!
(wz acceptable porosity)

May need multiple round ⇒ Down time to be extended...
The more experienced, the more efficient and less errors

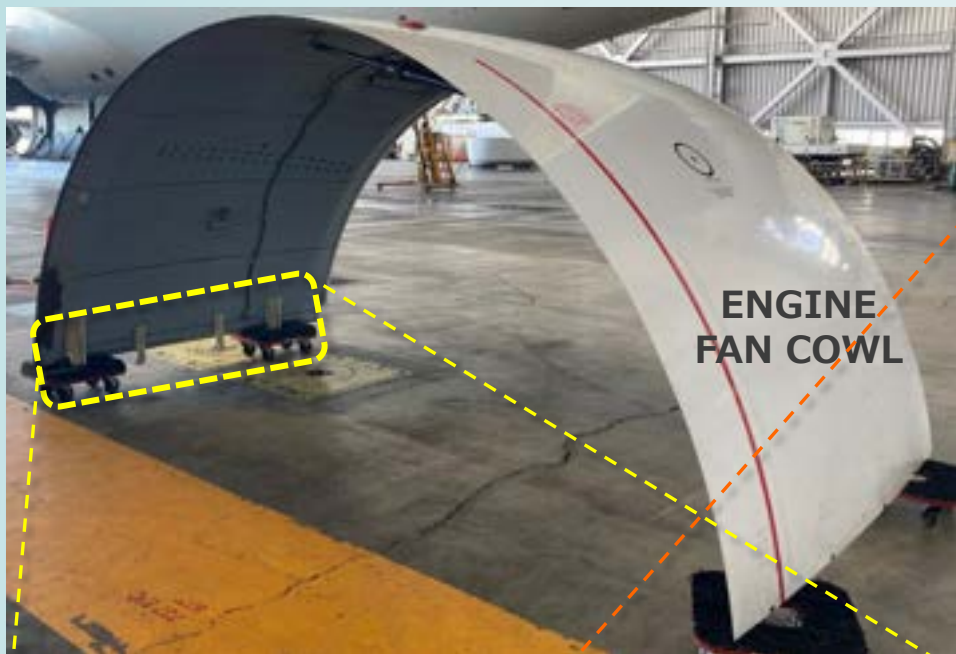
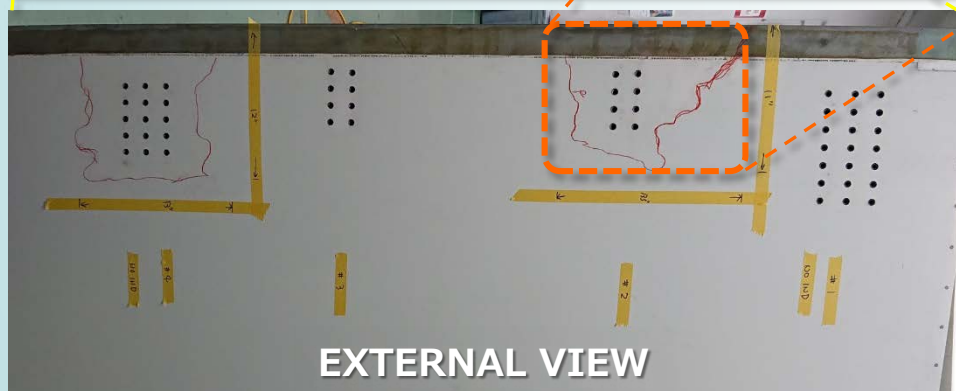
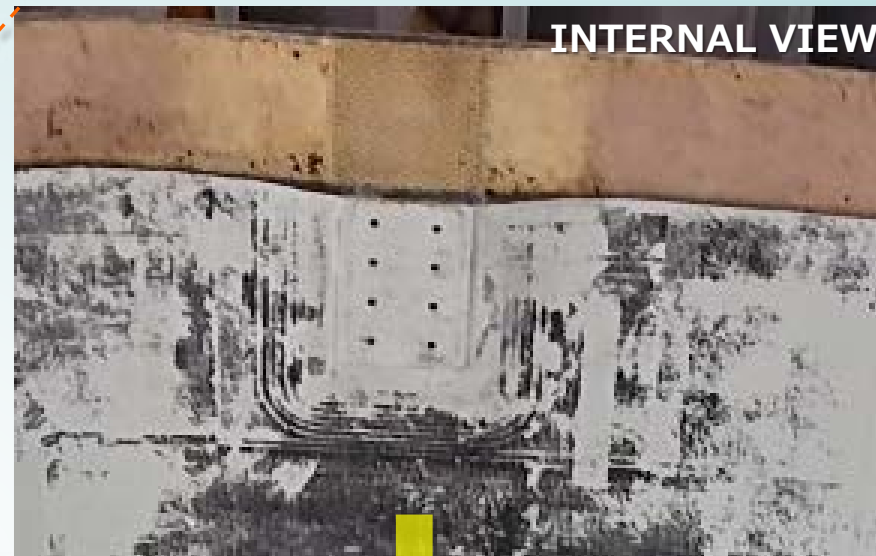
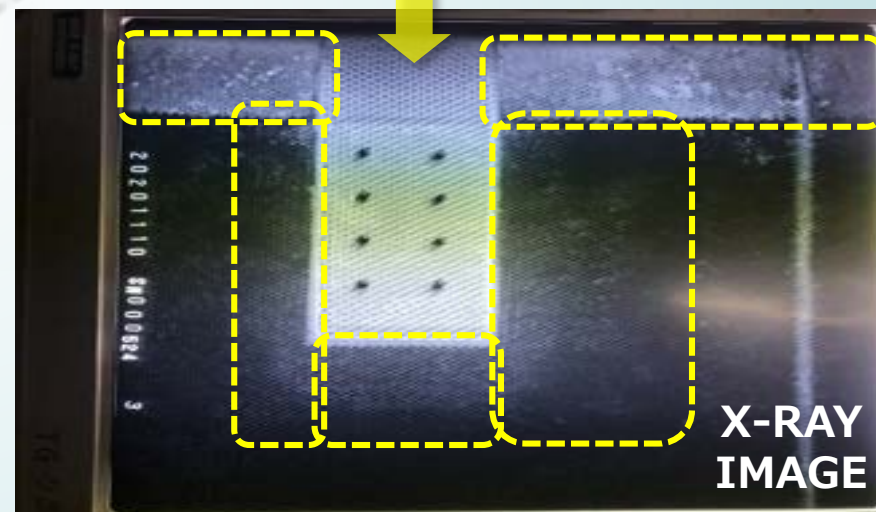
Moisture Ingress - Engine Cowling

(MOISTURE INGRESS AT MILKY WHITE AREA)

Nature of H/C structure, freeze-thaw cycle could cause core damages

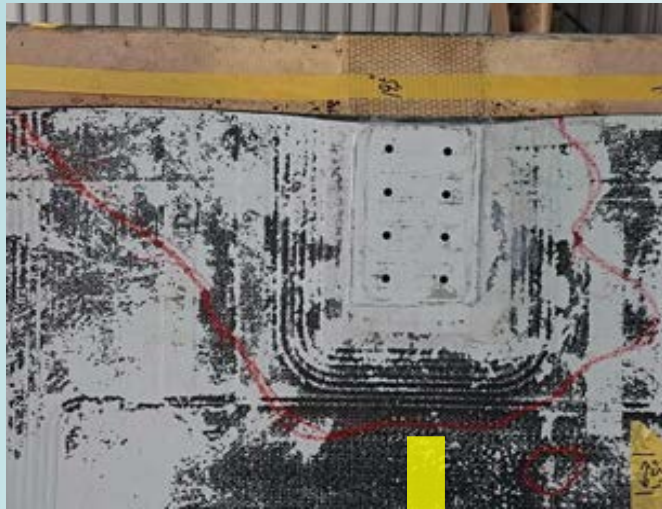
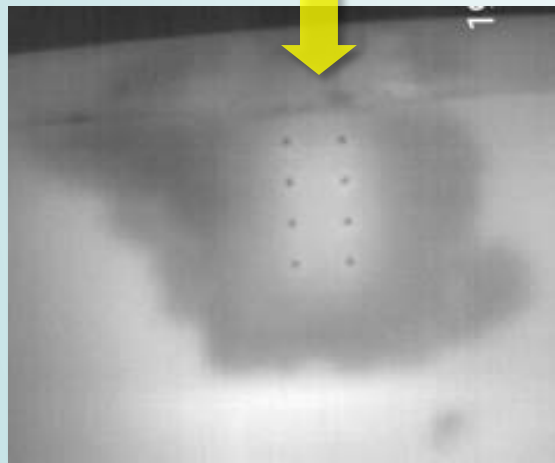
X-RAY IMAGE

NDI support the determination/judgement for repairability

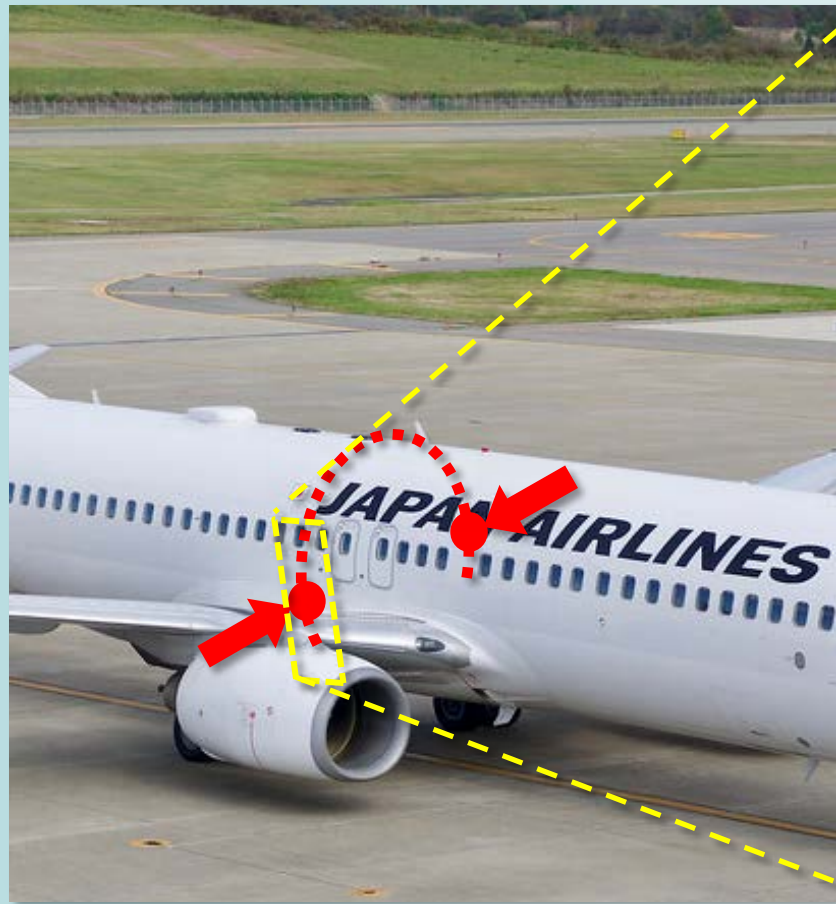
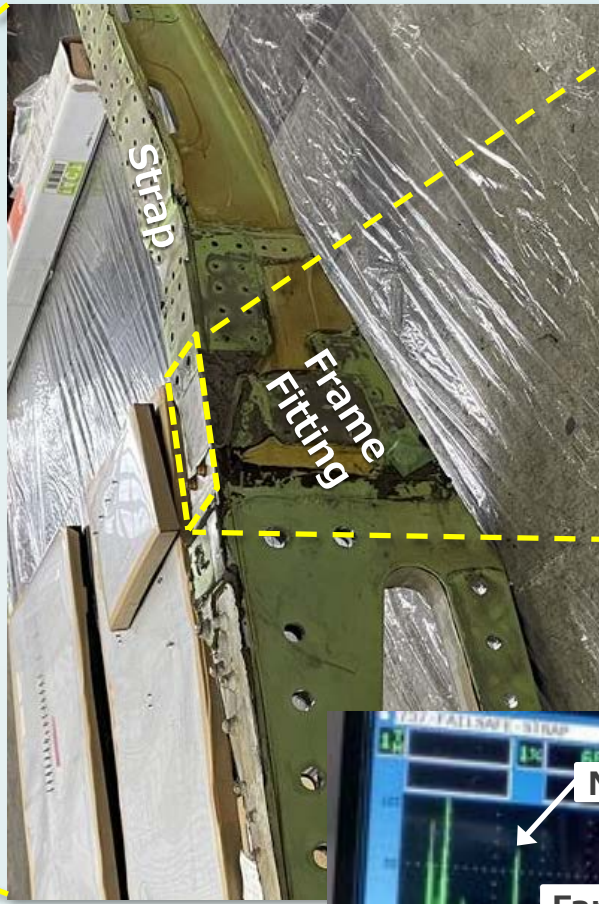
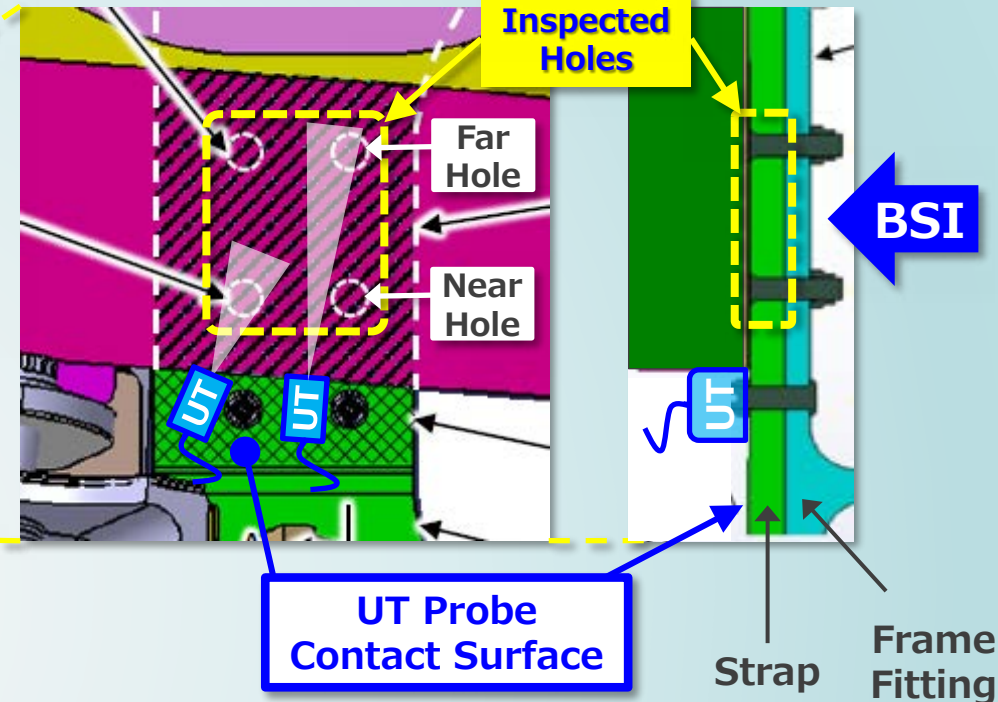
Fuselage Frame-Fitting UT Inspection

NDI enables earlier detection, and detecting the flaw at invisible area

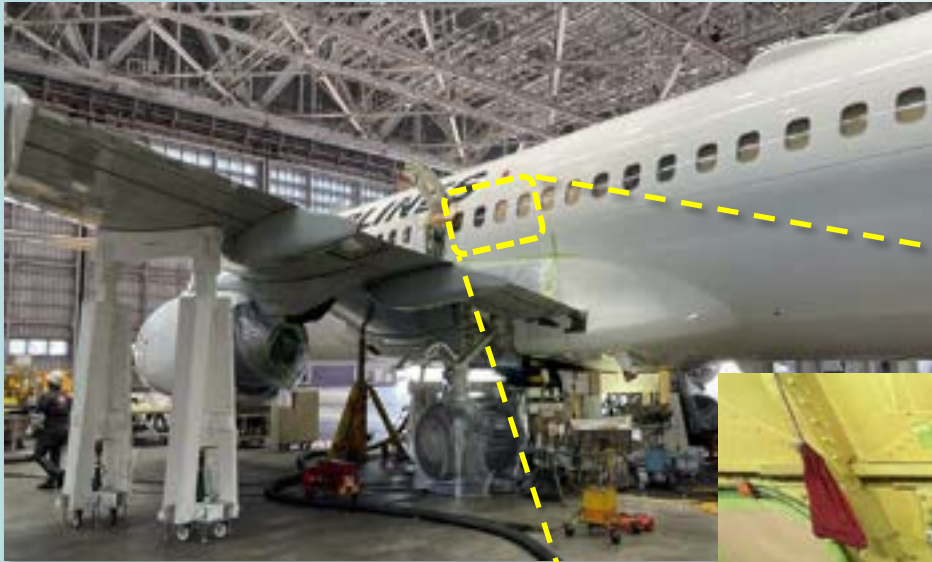
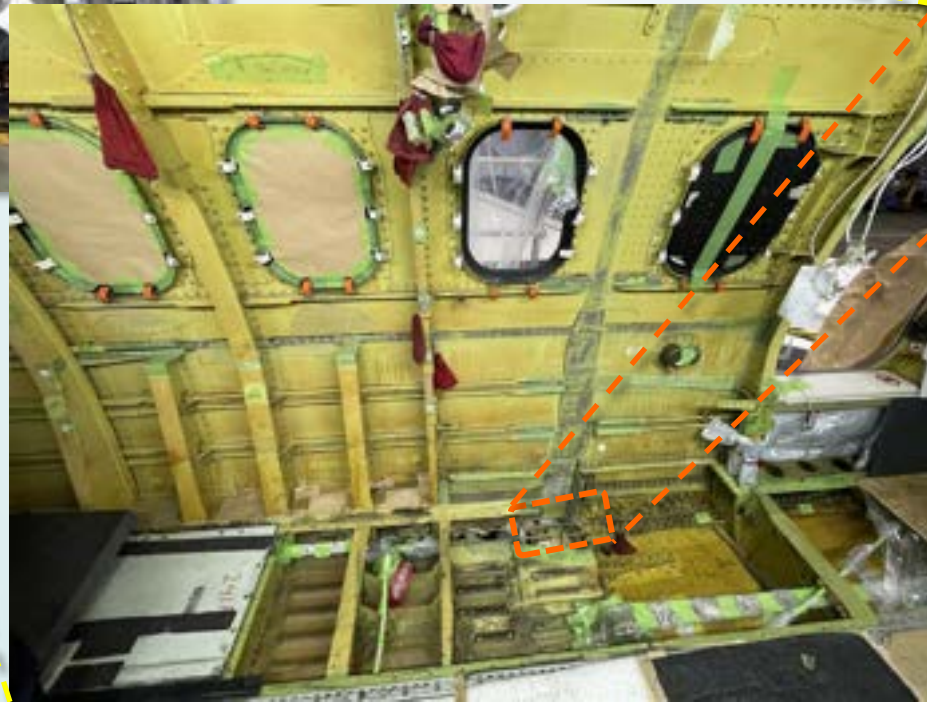
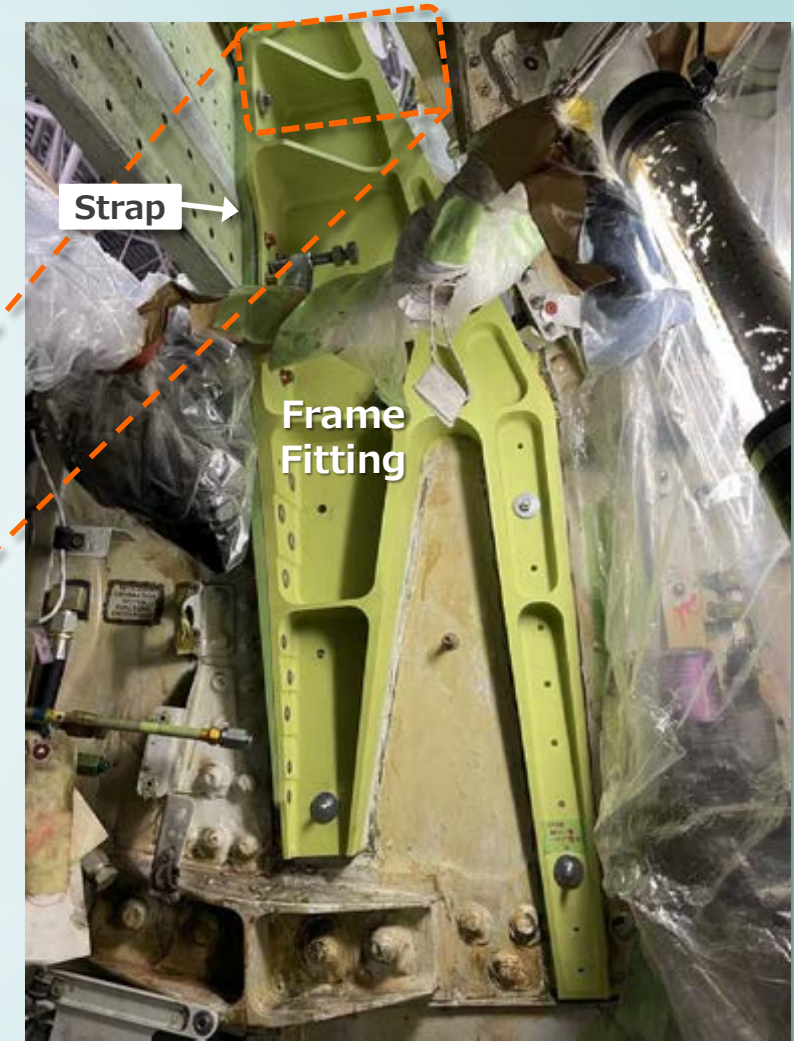
Fuselage Frame-Fitting UT Inspection

NDI prevents the significant damage and maintain satisfied level of safety
