United Airlines 787 Composite Damage and Repair- Operational Experience

Sam Tucker
NDT Process Engineering
TYSQC

2022 A4A NDT Forum
San Antonio, TX

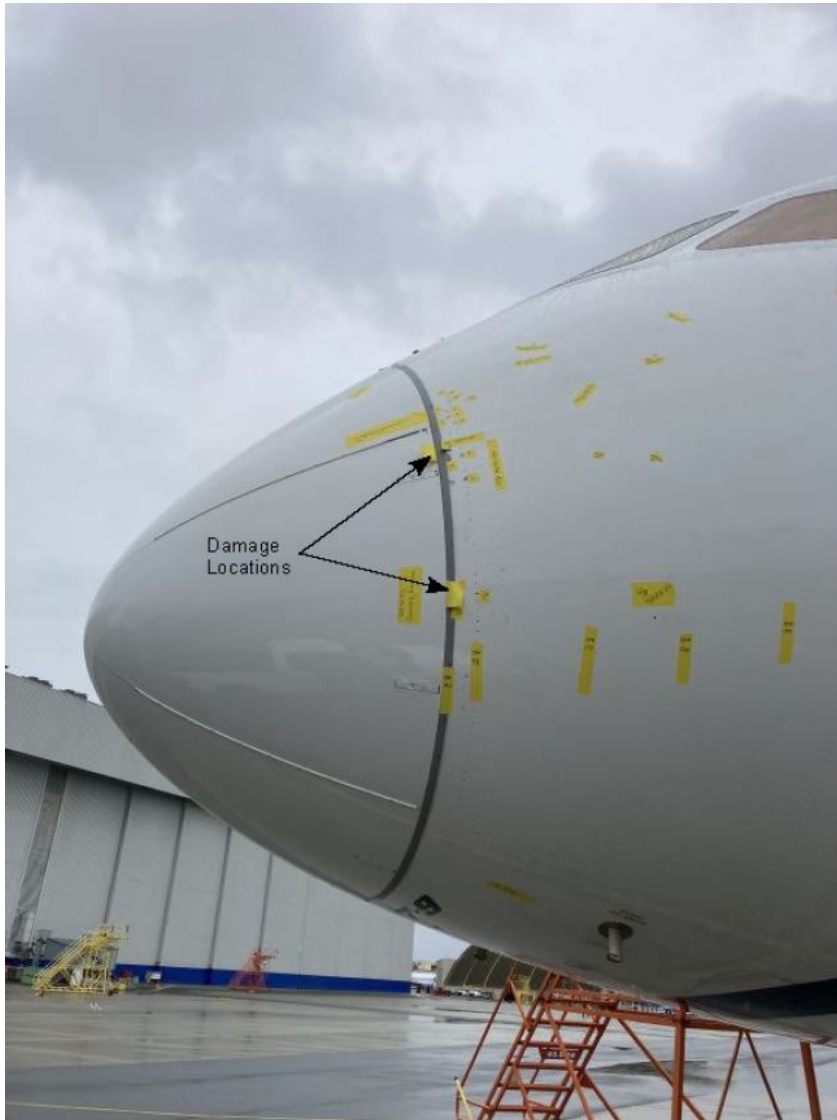
Lightning strike- AC 981

**Our Christmas gift 2021-
Found on arrival 12/25
with over 50 areas of
damage**

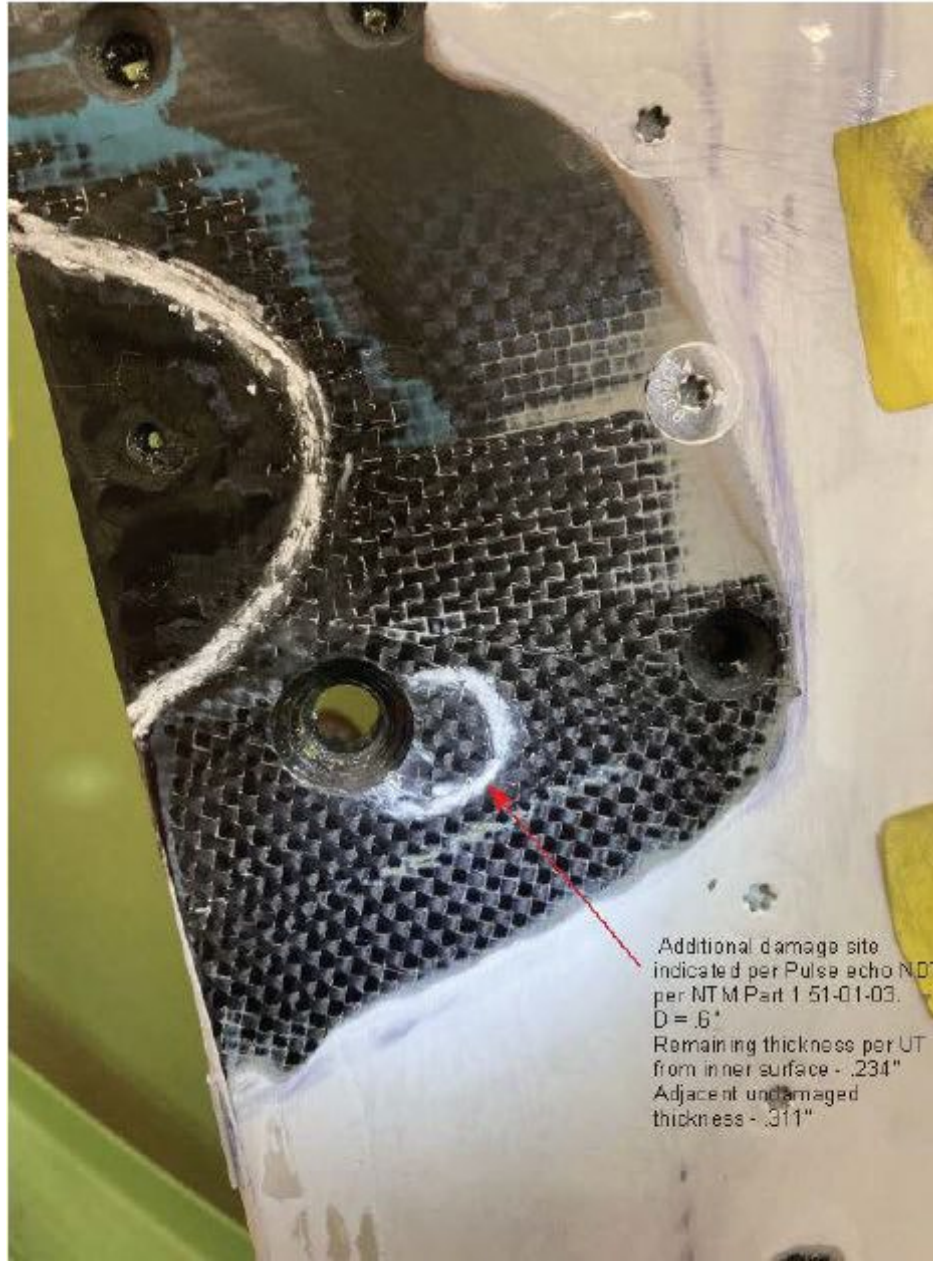
Lightning strike- AC 981

Additional damage site
indicated per Pulse echo NDT
per NTM Part 1 51-01-03.
D = .6"
Remaining thickness per UT
from inner surface - .234"
Adjacent undamaged
thickness - .311"

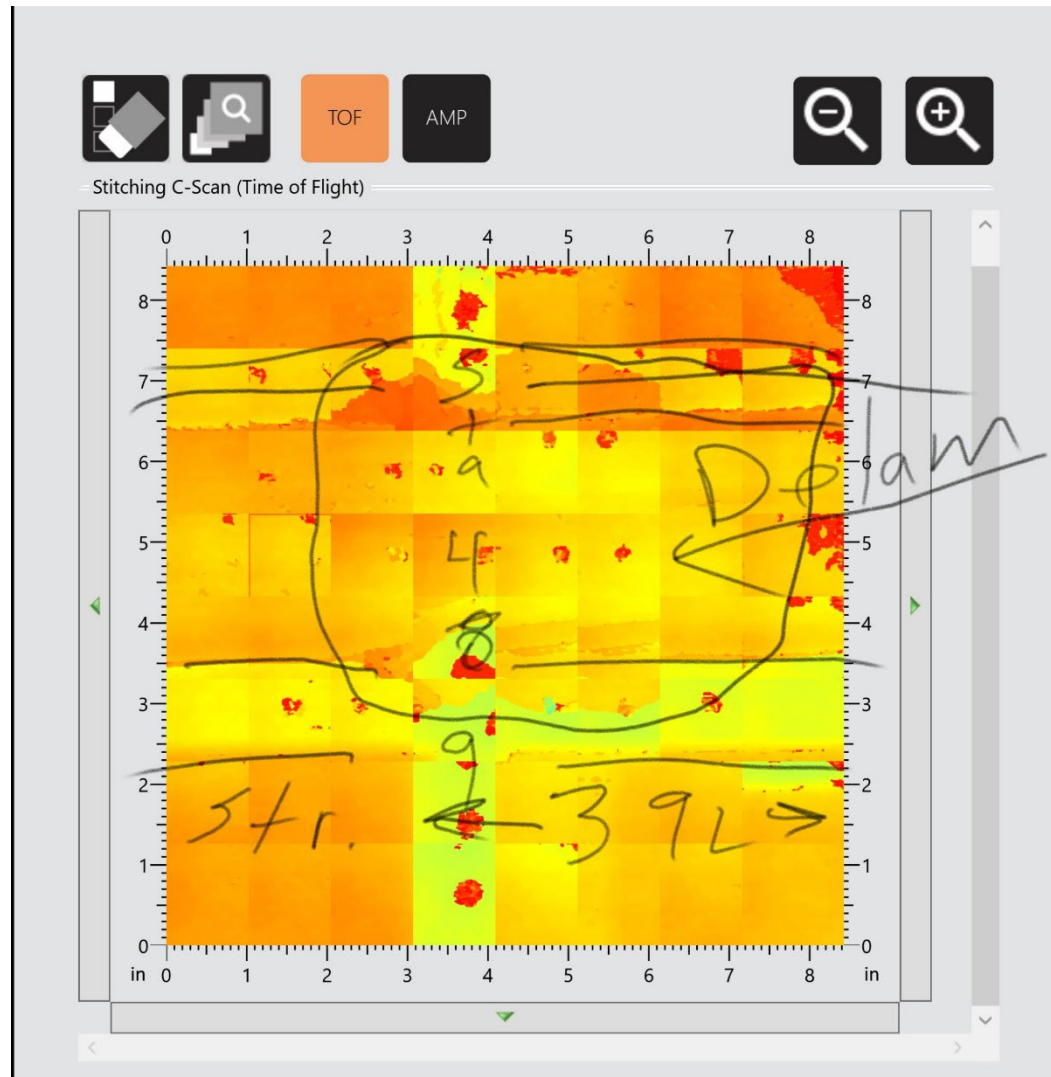
On walkaround, damage was found on the bottom of the right wing

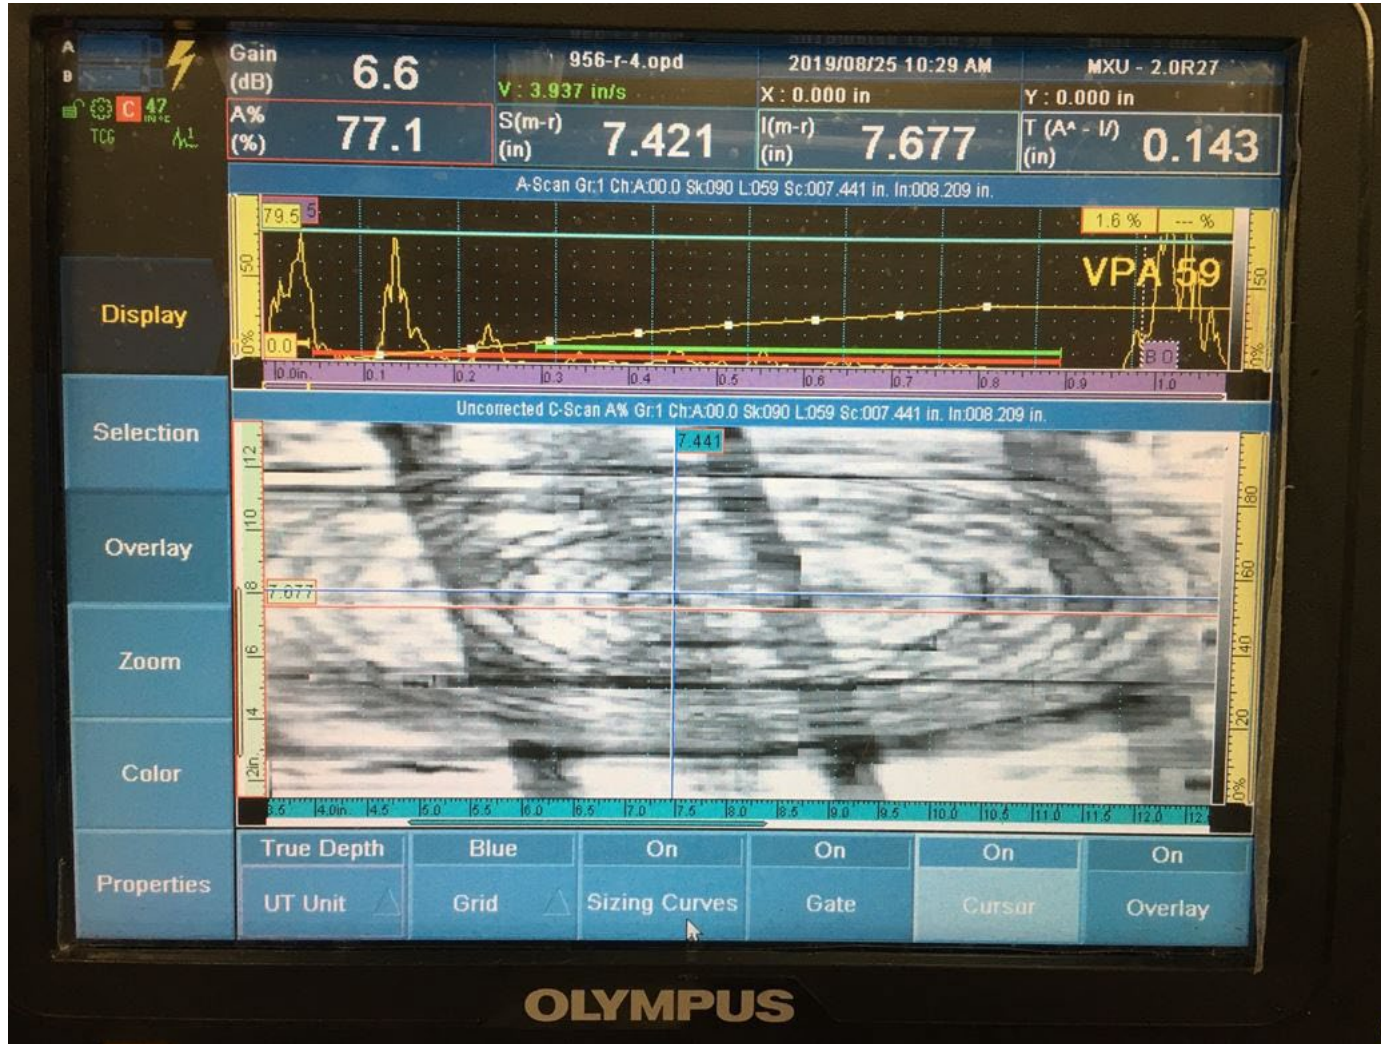
Skin below the area of contact was scanned with Dolphicam 2. No delam was found. Damage was found to the lower chord
