## Use of X-Ray for 717 Wing XRS 164, Lower AFT Skin Cracks

# 717 XRS 164, Lower AFT Skin Cracks

## Background

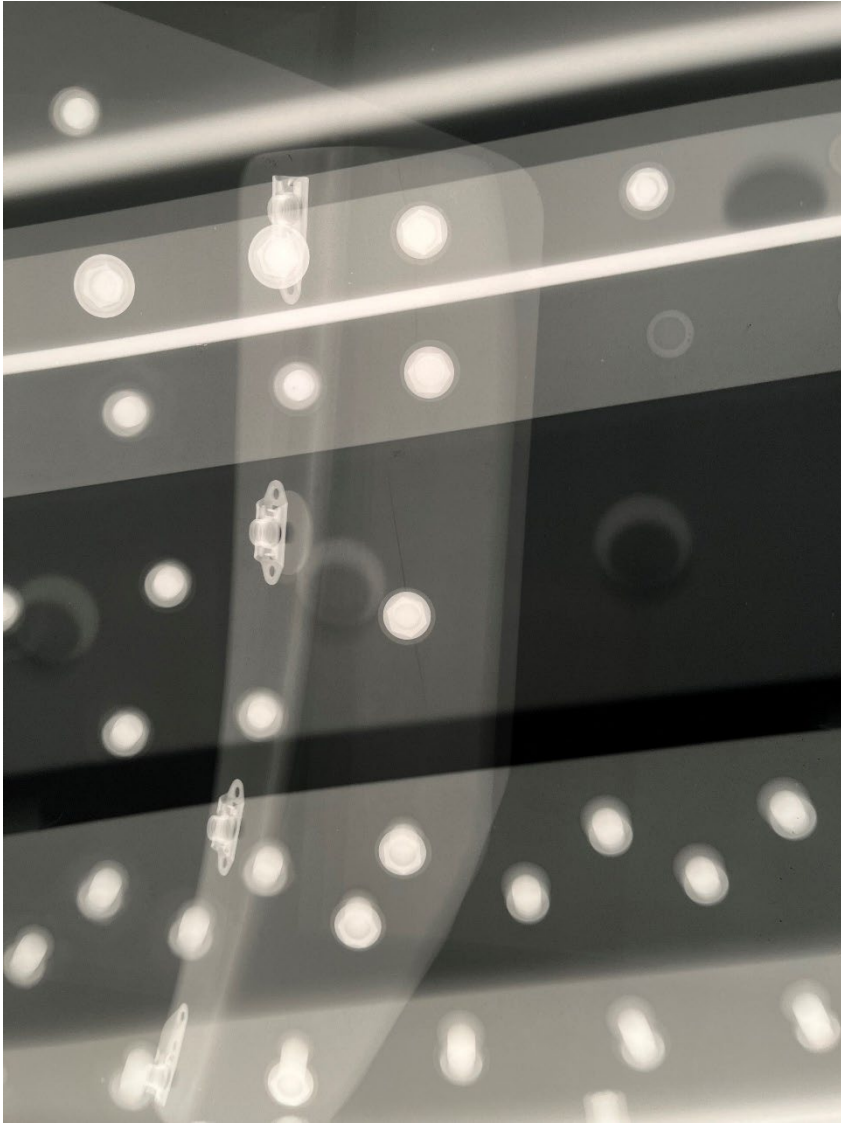
Radiograph Overview IB

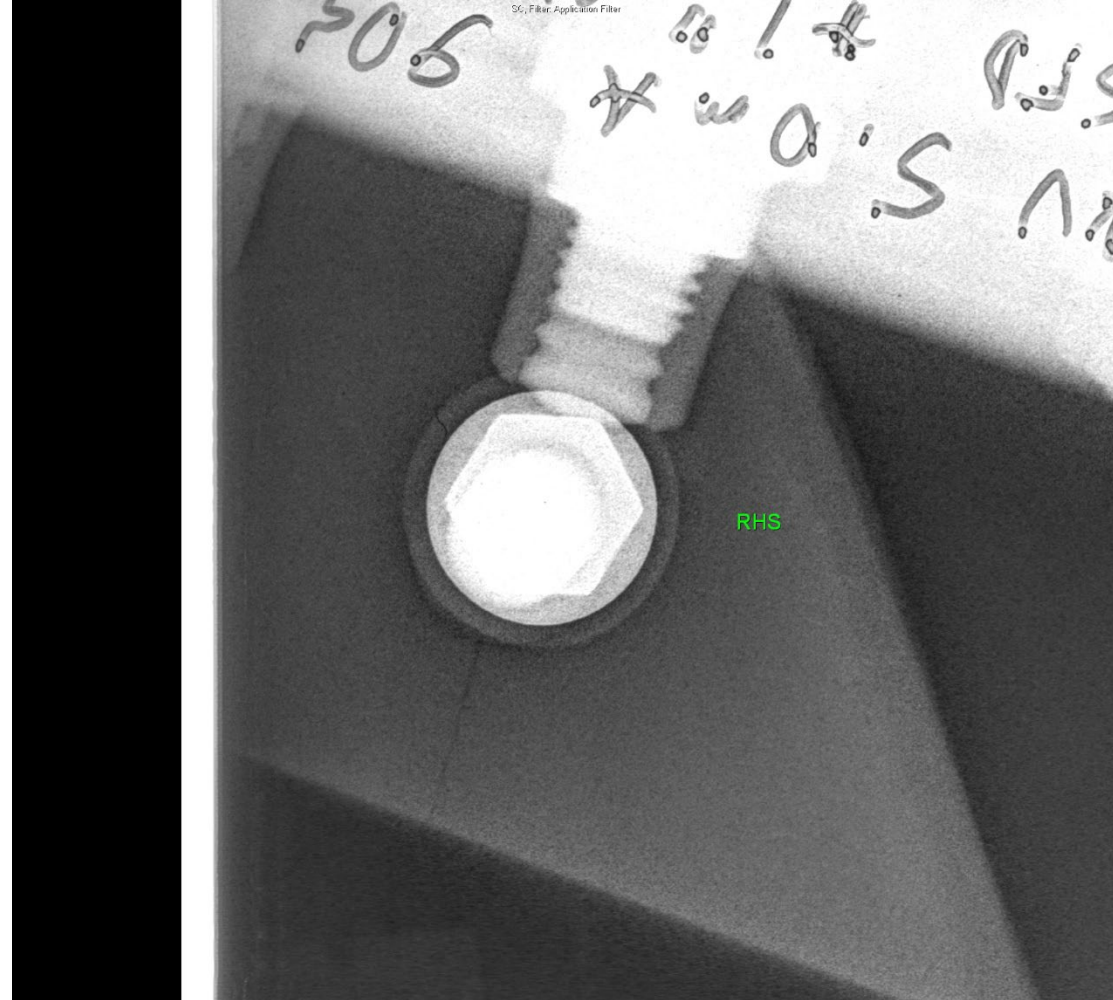
Rear Spar Crack Digitized

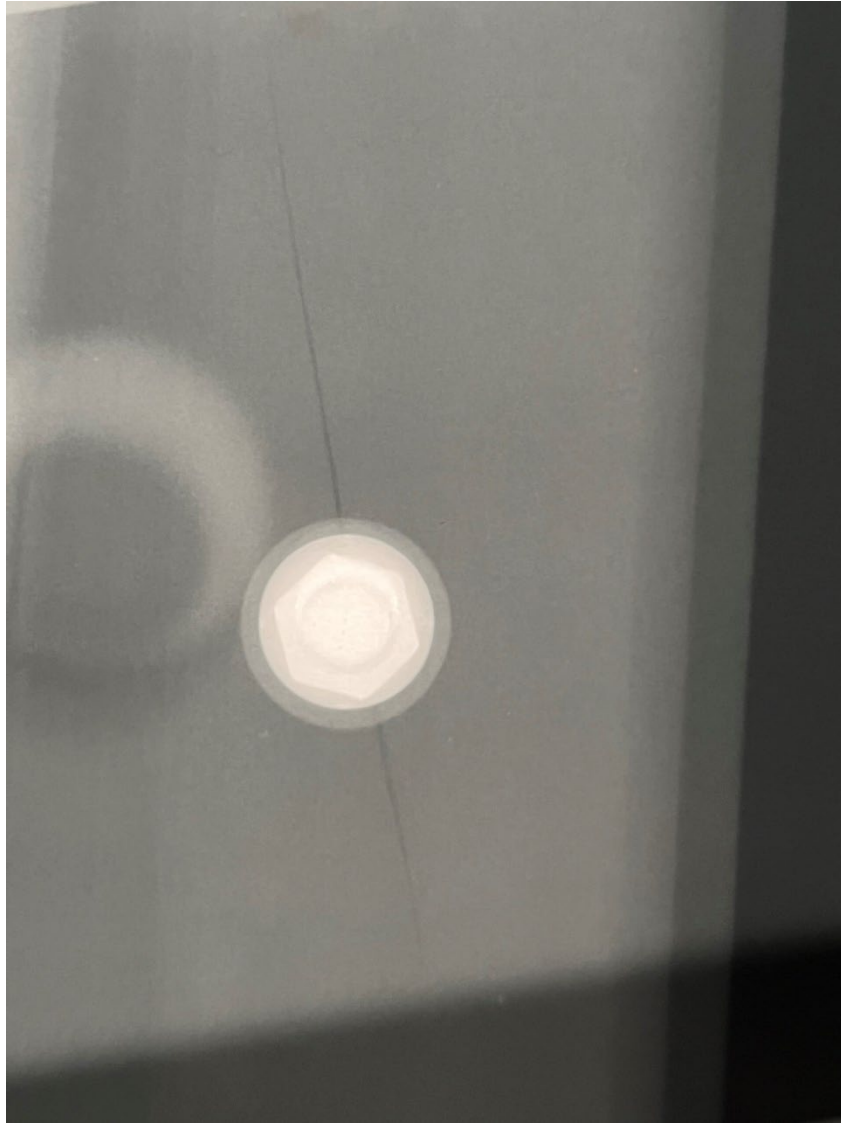
Skin Crack Radiograph

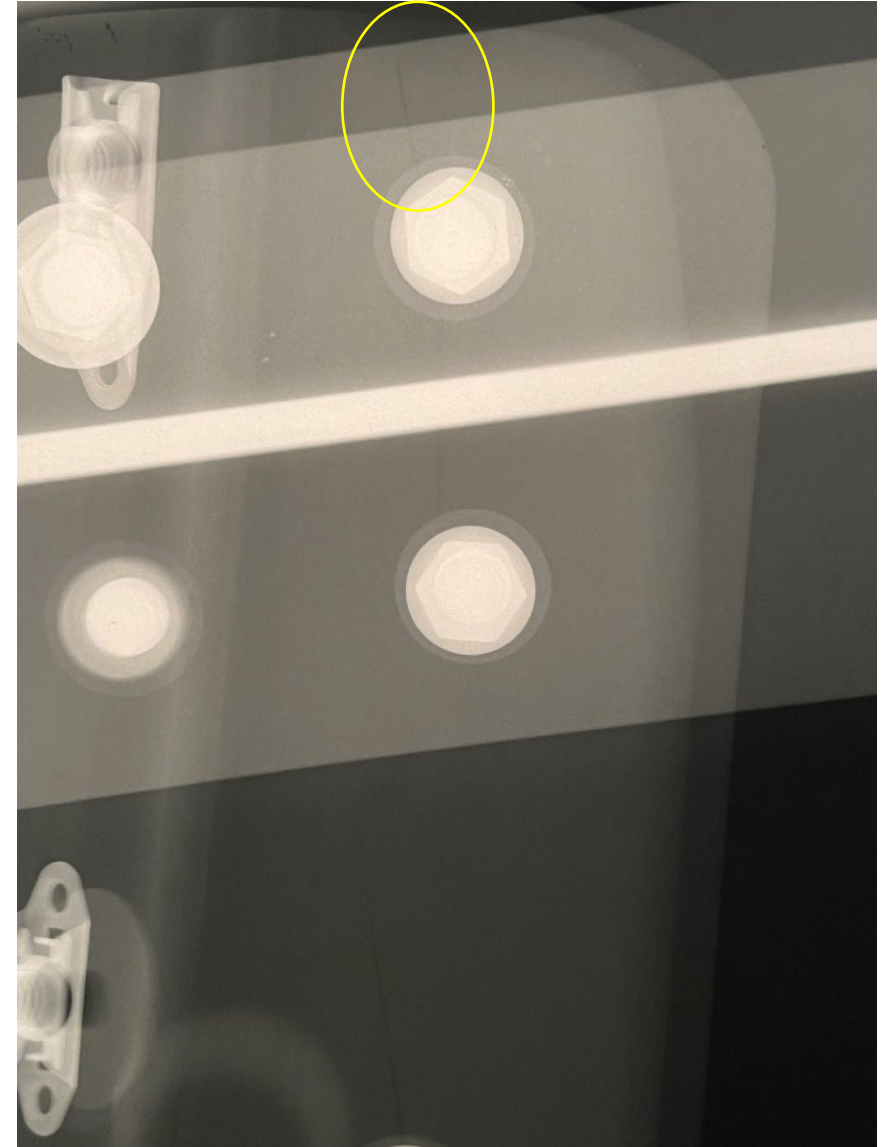
Stringer Crack

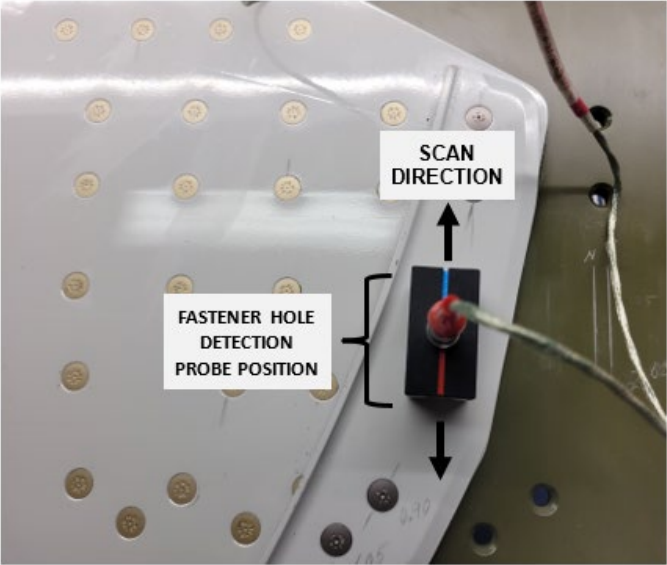
DETECTION OF NORMAL  
FASTENER HOLE  
ON FAIRING ATTACH ANGLE  
AND DOUBLER  
(TYPICAL)

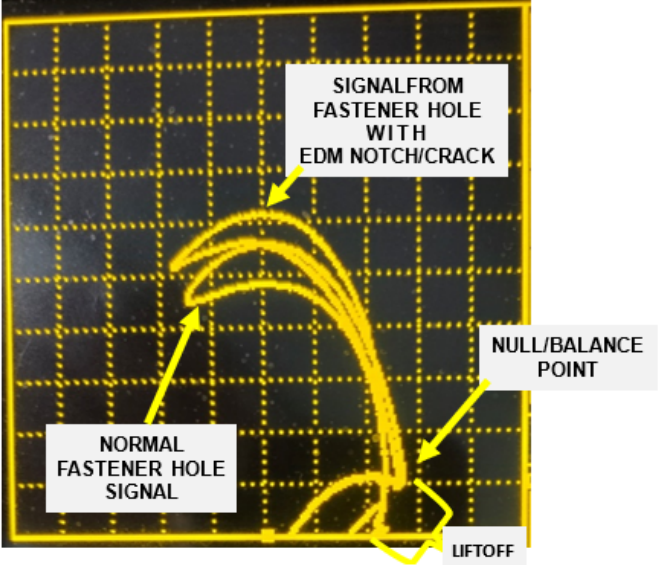
PROBE NULL/BALANCED  
ON FAIRING ATTACH ANGLE  
AND EDM NOTCH INDICATION  
TYPICAL FOR FASTENER HOLE  
NO's: 1, 3, AND 6

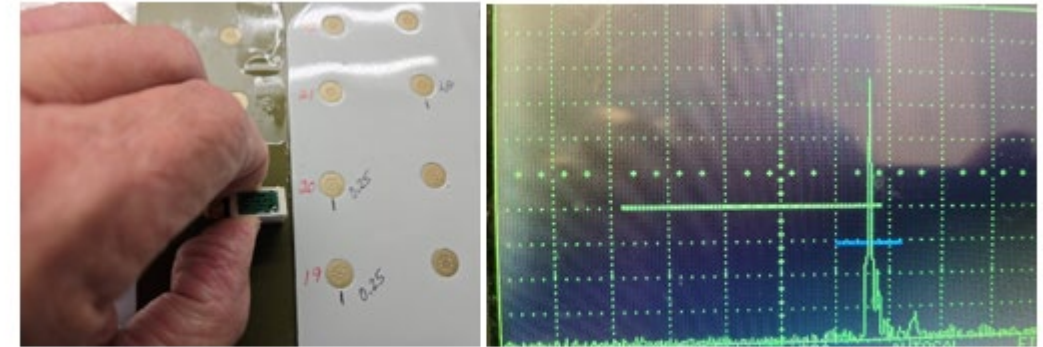
POSITION 20 NOTCH. MAXIMIZED FULL SKIP NOTCH SIGNAL ON A-SCAN DISPLAY

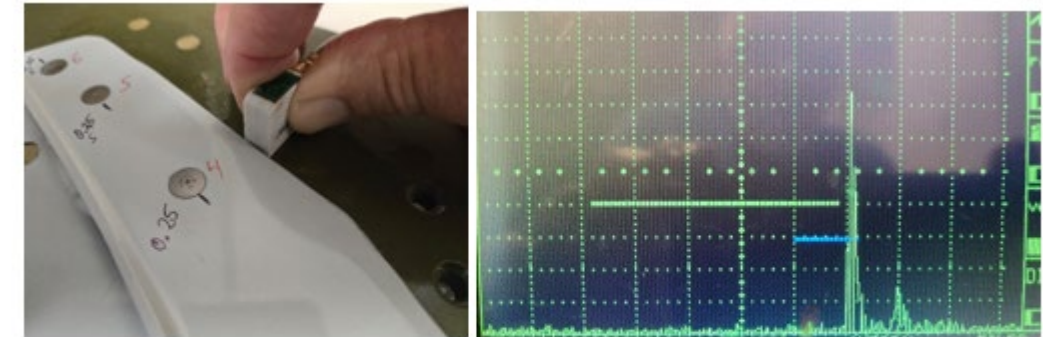
POSITION 4 NOTCH - FULL SKIP NOTCH SIGNAL NOT ABLE TO MAXIMIZE DUE TO DOUBLER INTERFERENCE WITH FRONT EDGE OF TRANSDUCER
