# 737NG Failsafe Strap STA 663 PZT Detection

Walt Jarecki, ATF, Aircraft Inspection - Customer Support

Zeb Tidwell, ATF/E-UM, Airframe Engineering - Customer Support

# STA 663.75 Frame Fitting and Failsafe Strap - Inspection

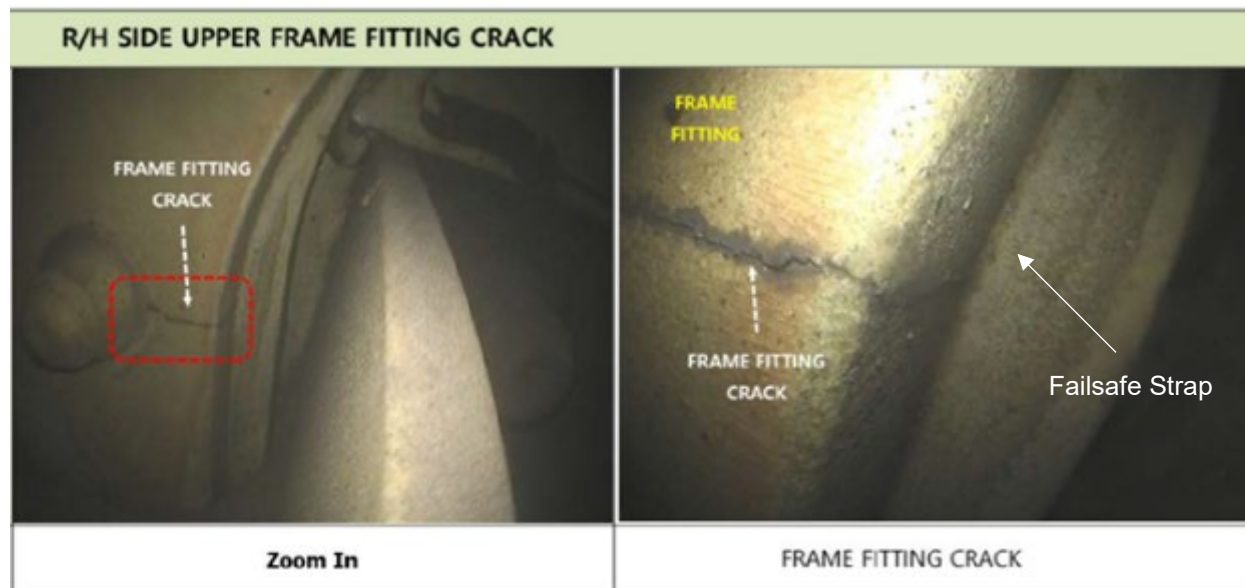
- During routine visual inspection (26 NOV 2024), a crack was found on the RH side frame fitting of the SHM-equipped 737-900 aircraft

Visual crack confirmed only on Frame Fitting Side

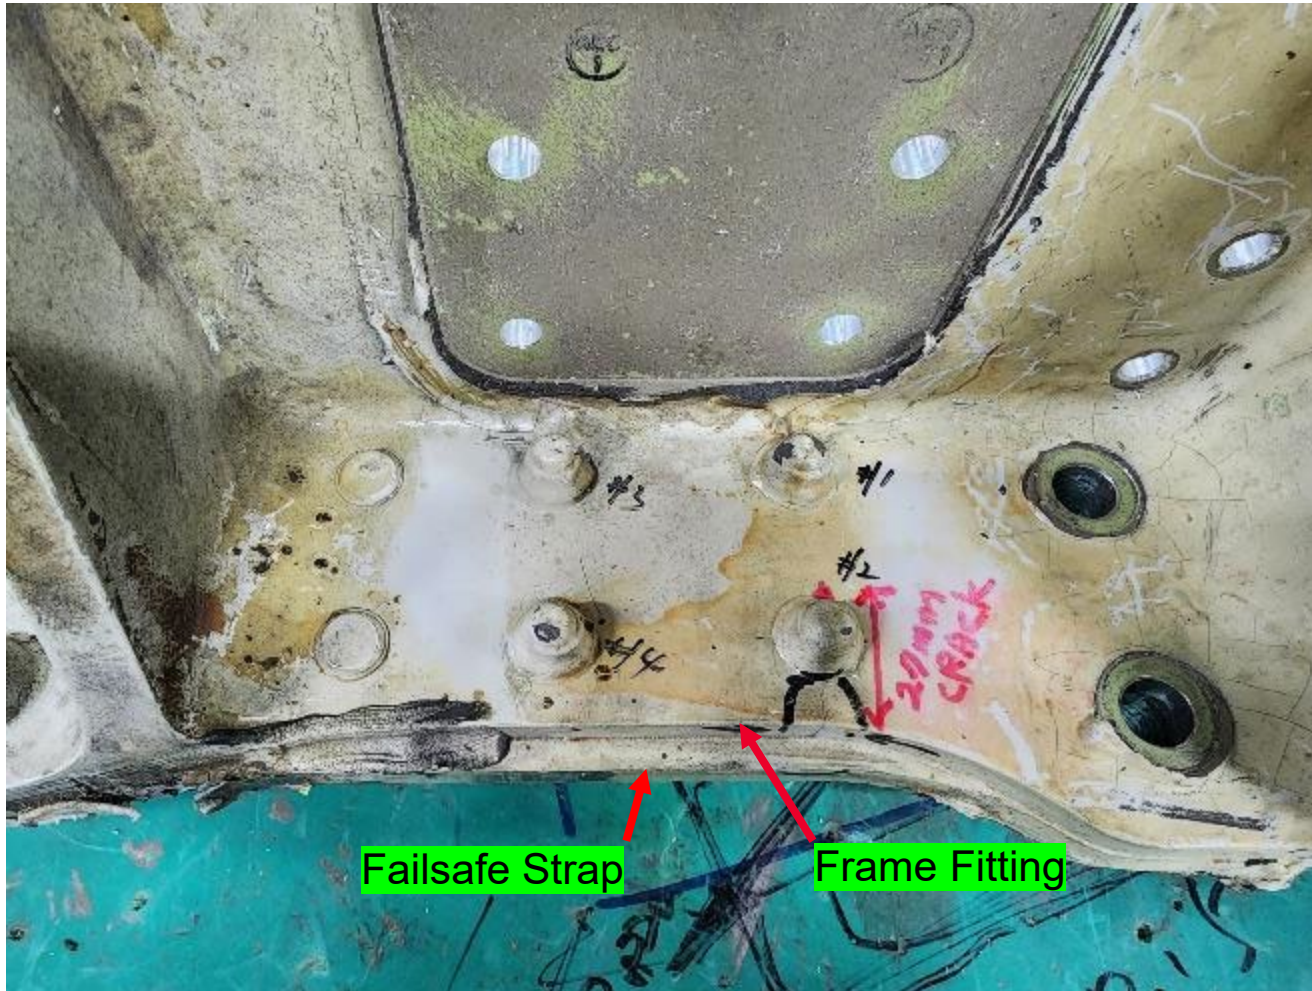
| No. | Hole Location | Criteria |
| 1 | Hole 1 | Acceptable |
| 2 | Hole 2 | Rejectable |
| 3 | Hole 3 | Acceptable |
| 4 | Hole 4 | Acceptable |

- Initial detection was a visual inspection.
- PZT showed an increased damage index.
- Lab results yielded cracks in both parts.

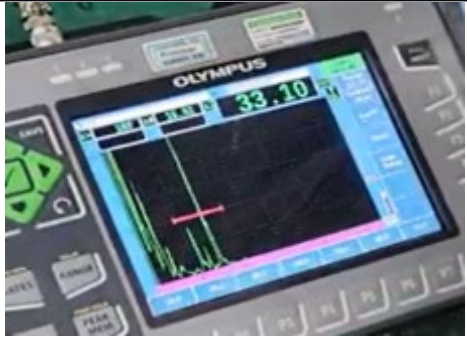
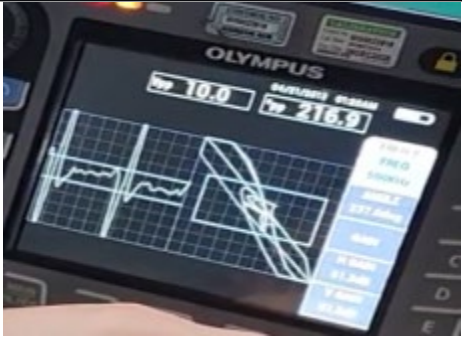
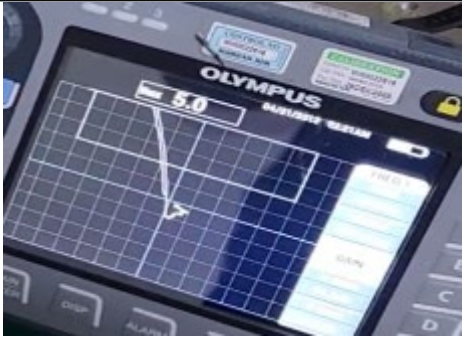
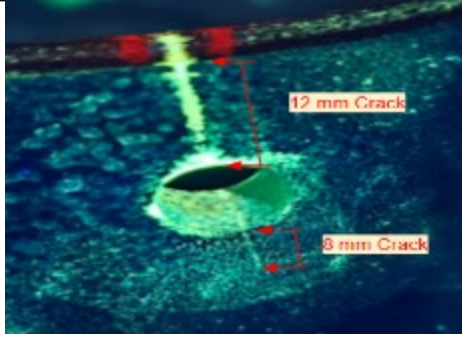
## RHS Frame Fitting

| USI | ECI (Hole) | ECI (Countersink) | ECI (Surface) | FPI |
| | | No Countersink | | |
| Crack | 12 & 6 O'clock Crack | N/A | Crack | Crack |

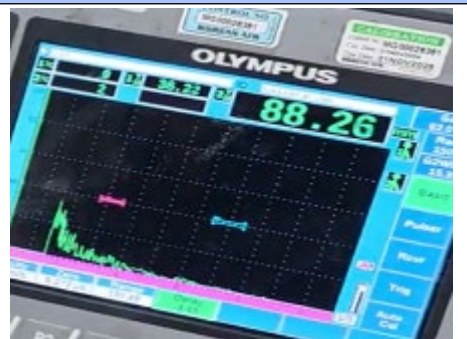
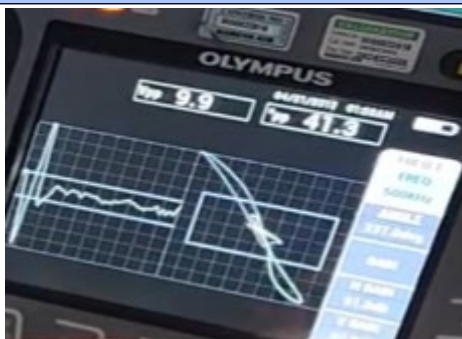
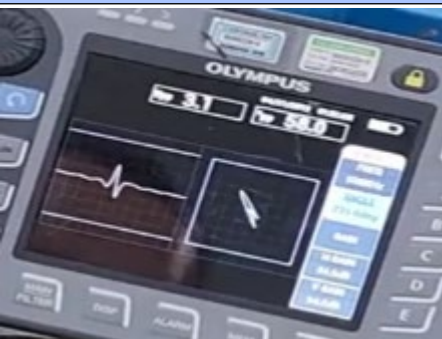
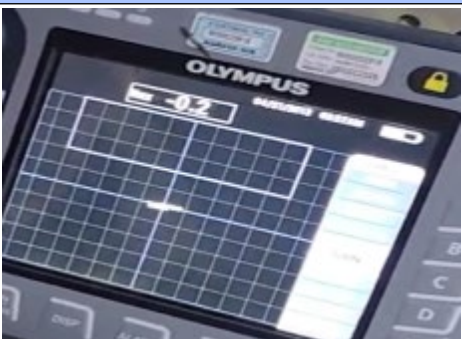
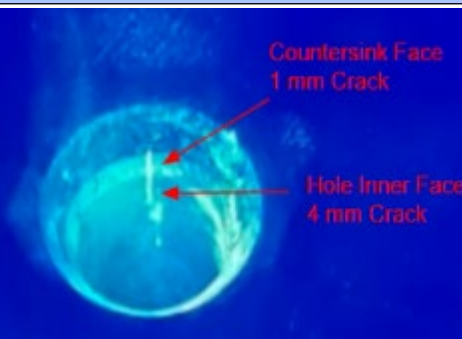
## RHS Failsafe Strap

| USI | ECI (Hole) | ECI (Countersink) | ECI (Surface) | FPI |
| | | | | |
| No Crack | 12 O'clock Crack | 12 O'clock Crack | No Crack | Crack |

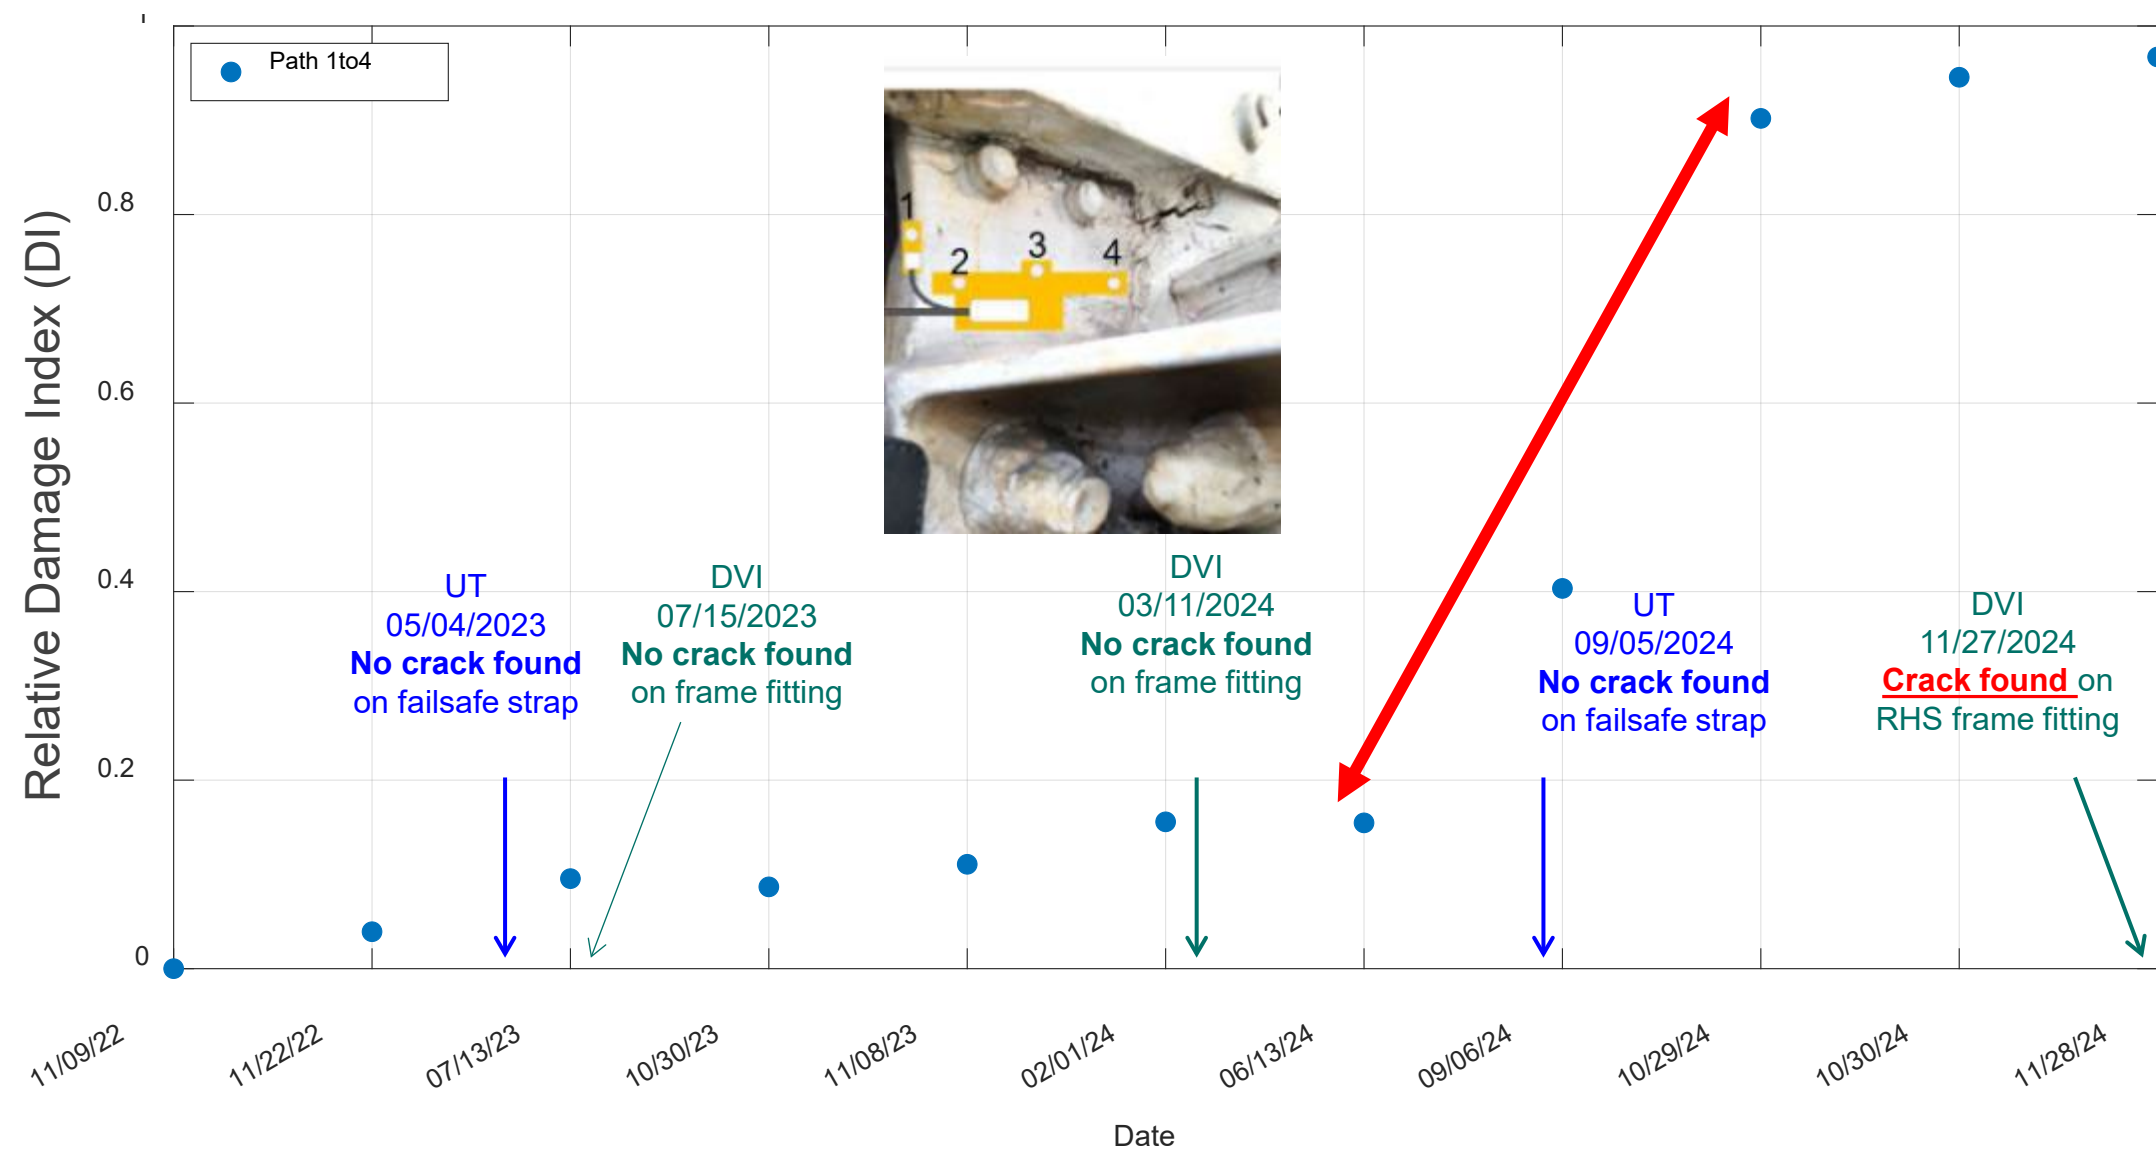
# PZT Damage Index & NDI vs Date (RH STA 663.75 Frame Fitting)
