Target Inspection Techniques Using Eddy Current Technology

A4A 2023 NDT Forum, Denver, Colorado
Prepared and presented by James Bittner,
Application Engineer, Technology Specialist, NDT

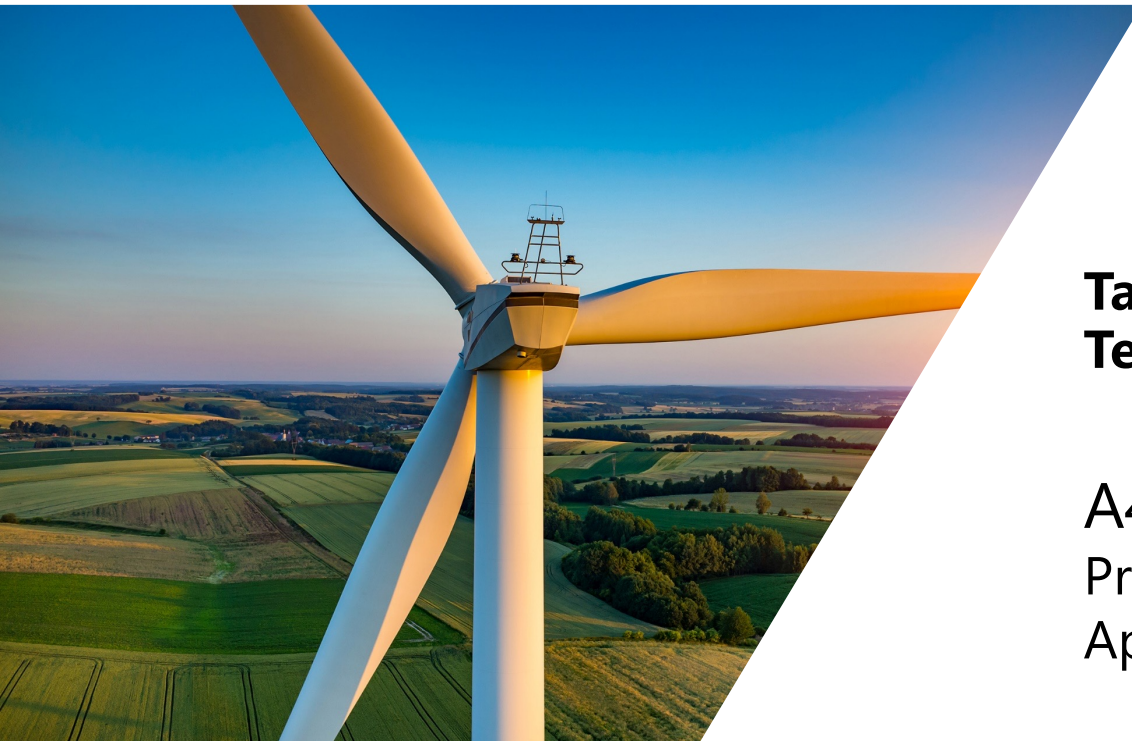
Target Inspection Techniques Using Eddy Current Technology

To take thickness measurements, the most commonly used nondestructive testing (NDT) tools are ultrasonic thickness gauges or flaw detectors. However, there may be a few applications where these technologies are unable to accomplish the task and alternative technologies are needed.

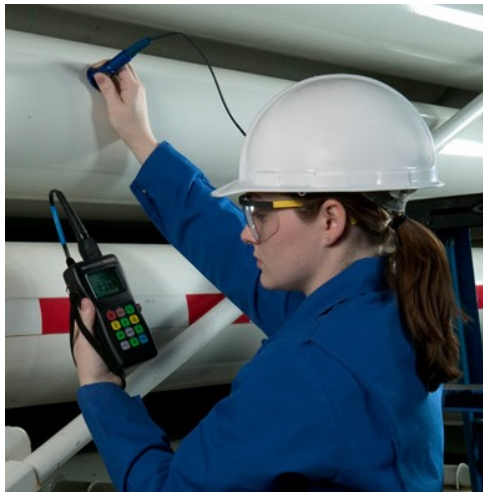
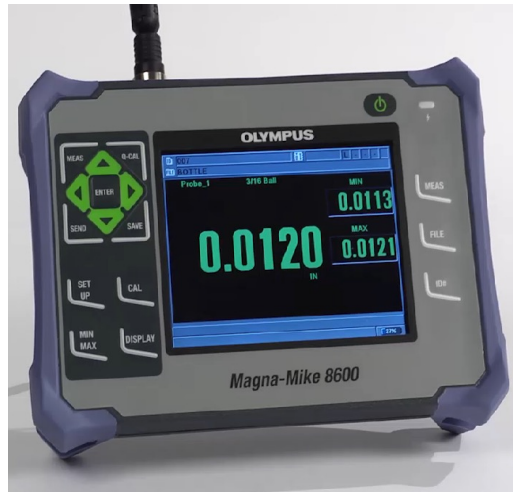
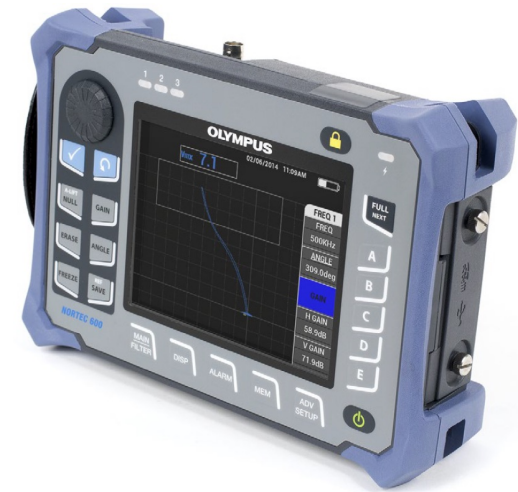
A couple of alternative tools that may be in one's NDT toolbox are eddy current and magnetic Hall-effect thickness gauge technologies. These technologies work on cast, nonferromagnetic alloys. The NORTEC™ 600 flaw detector offers a comparison technique using a reference target or reflector for approximate thickness measurements and the liftoff method. For a higher degree of accuracy, the Magna-Mike™ 8600 uses a similar target technique and offers digital measurement readings.

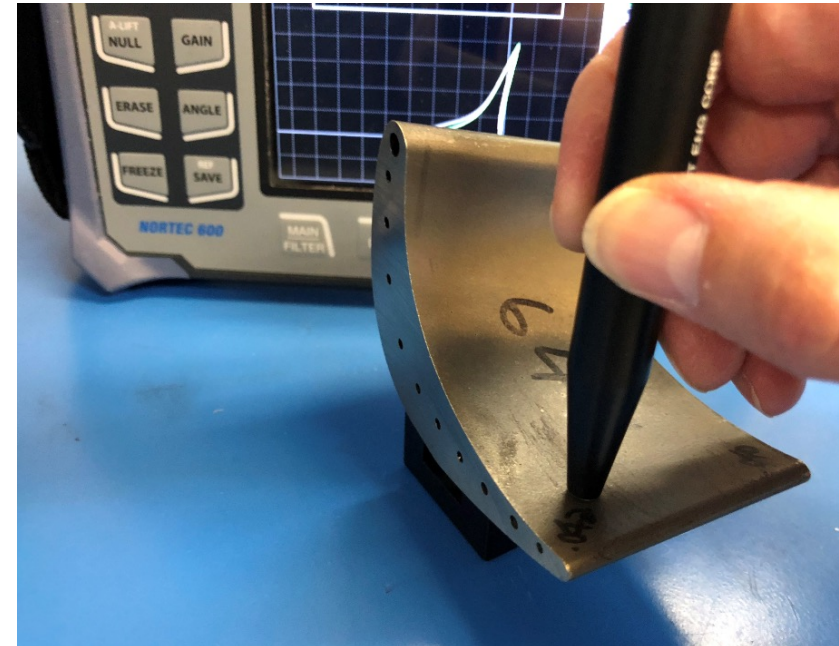
Eddy current target inspection technique for thickness and distance measurement.

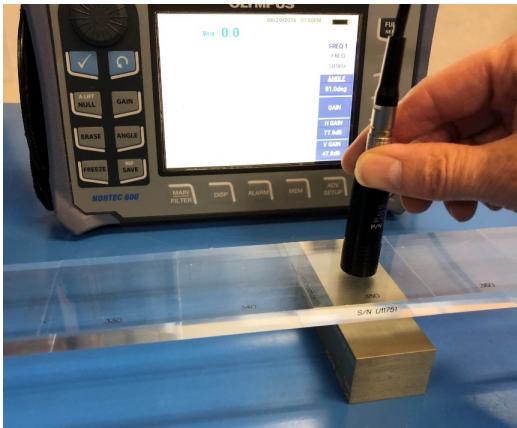
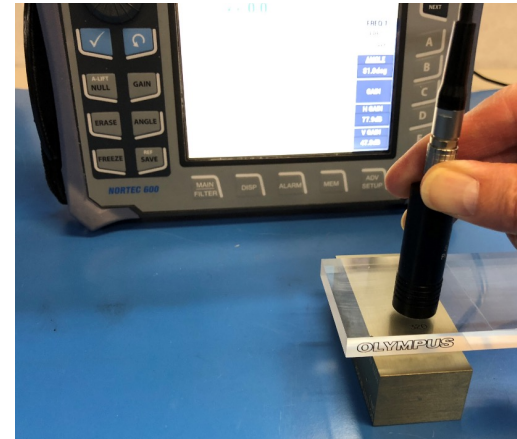
We can quantify the thickness of nonferromagnetic components by using the liftoff distance between the probe and the target and the impedance plane X-Y location of the eddy current instrument.

The target's measured liftoff distance give us an approximate measurement of the part's thickness. This inspection also requires samples or standards to aid in setup calibration and inspection interpretation.

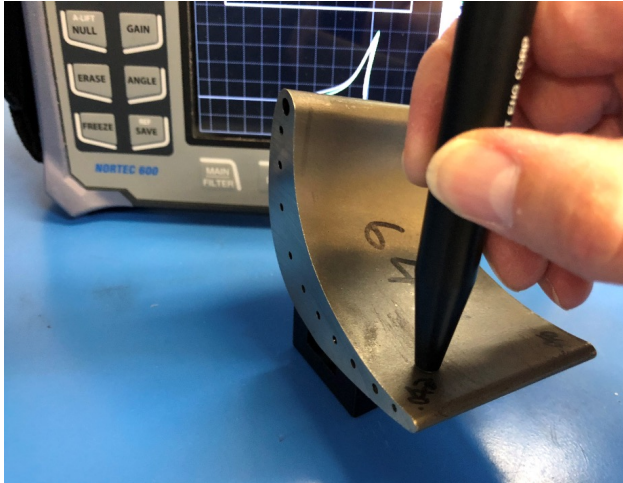
With the steel target installed in the cooling hole, balance the probe on the turbine blade at safe distances from the target and the edge.

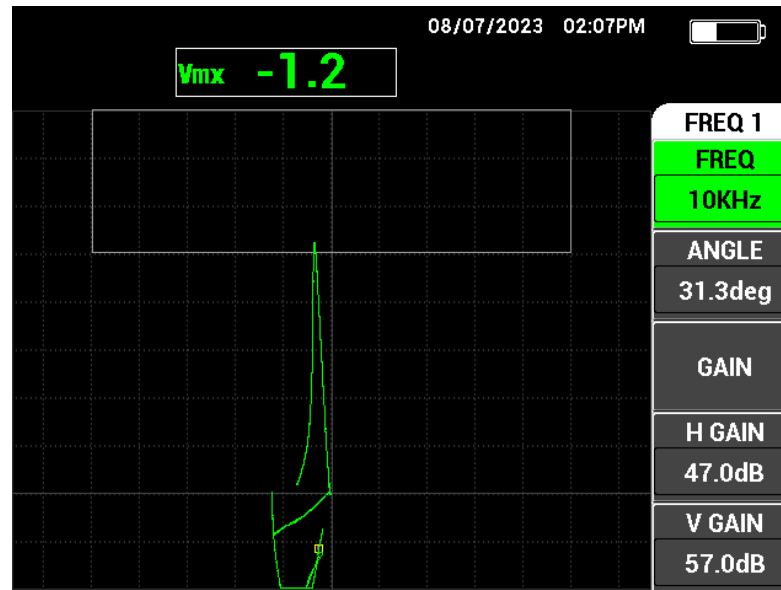
Here is an example of wall thinning. The signal is breaking the alarm gate.

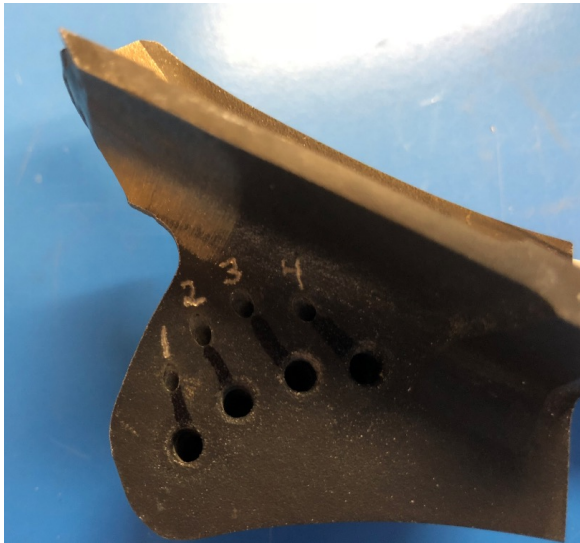
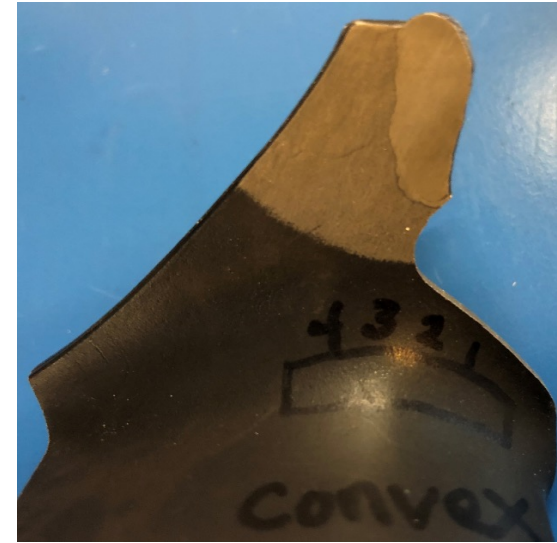
Another cast turbine blade with four cooling holes that are quite close to the outside convex radius will be examined. They need to be examined to make sure that the wall thickness measured from the cooling hole to the convex radius is greater than 0.035 inches (0.889 mm).

The Magna-Mike thickness gauge and other NDT techniques were not able to accurately measure the wall thickness of these cooling holes since they are not through holes and due to the complex geometry. Using these technologies, we cannot get an accurate reading.

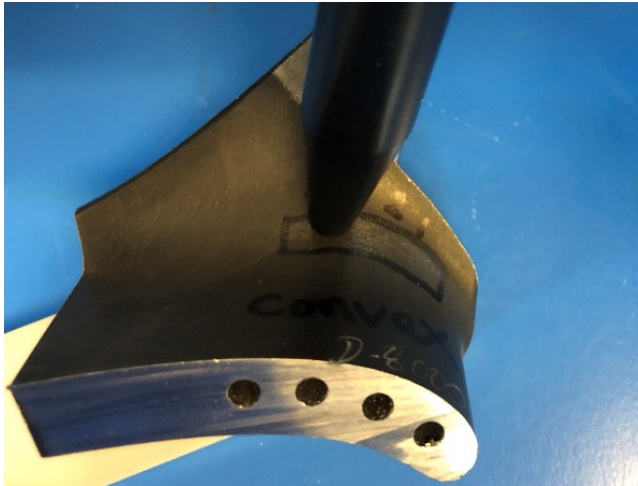
Eddy current examination of cooling holes in the turbine blade's radius

Cooling hole #4 is within tolerance.

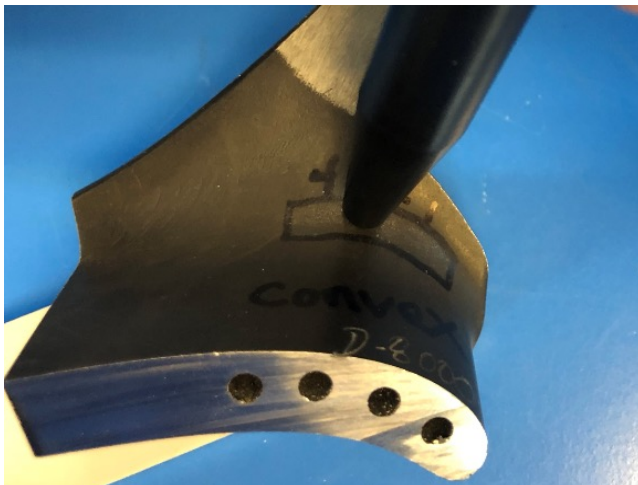
Cooling hole #3 appears to be out of tolerance.

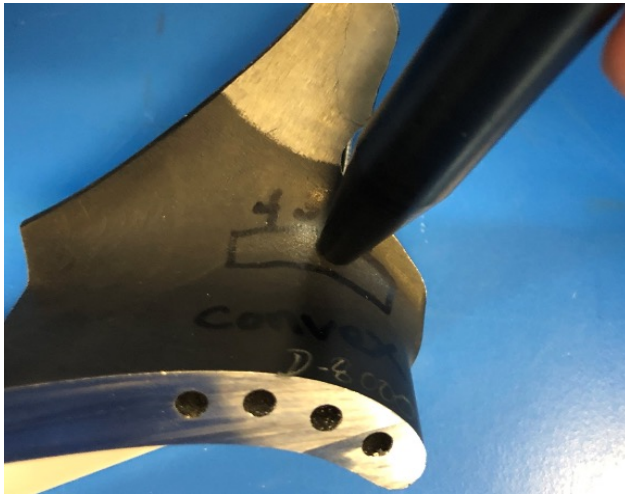
Eddy current examination of cooling holes in the turbine blade's radius

Cooling hole #2 is within tolerance

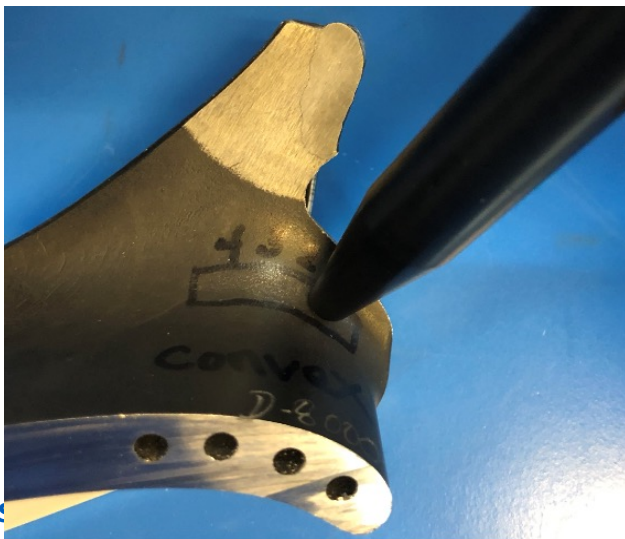
Cooling hole #1 is within tolerance, but very close to being out of tolerance.

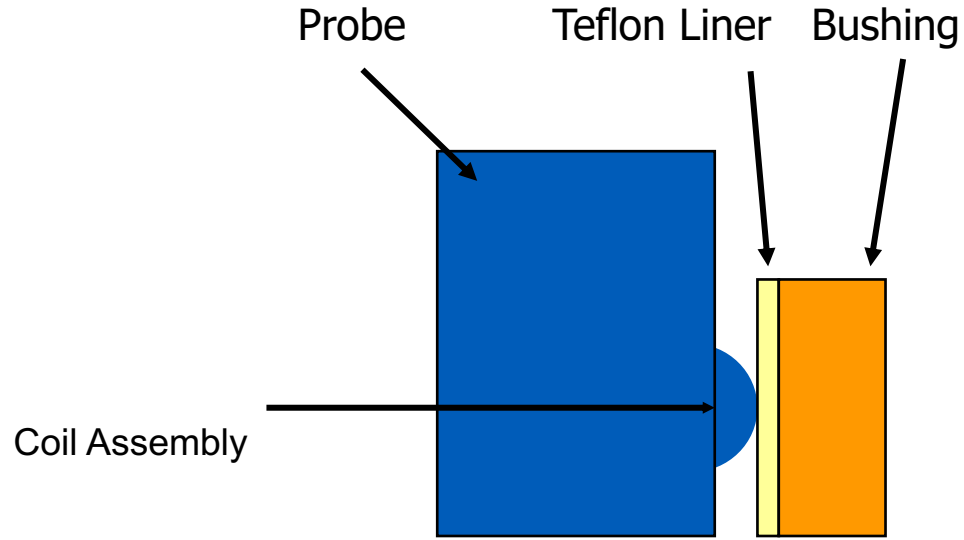
- The probe generated an eddy current in the material under test. If the thickness of the Teflon liner changes, the spring-loaded probe detects the liftoff measurement, or distance from the target base material, which is the bushing in this case.

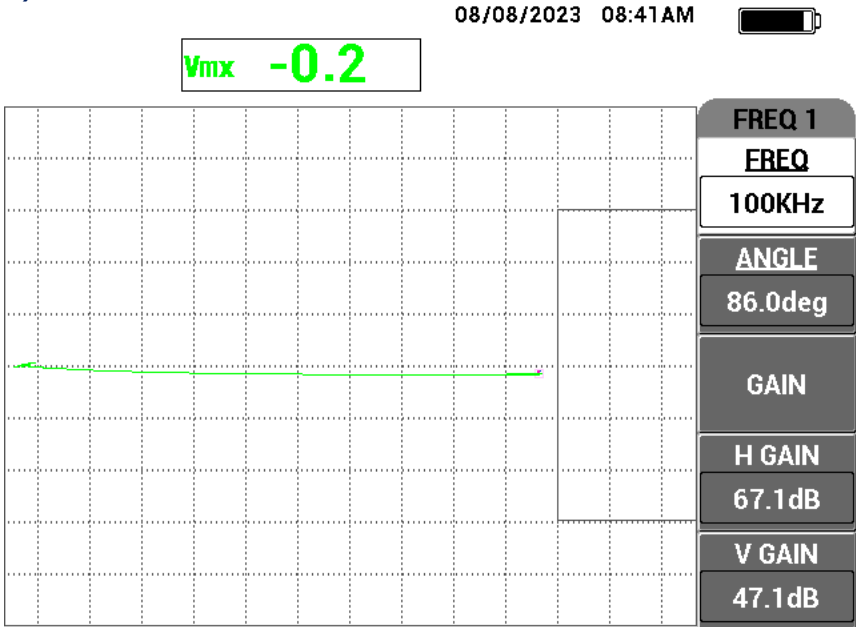
- The Teflon liner in this example is just within safe limits.

The 0.008-inch (0.203 mm) measurement is "within safe limits."

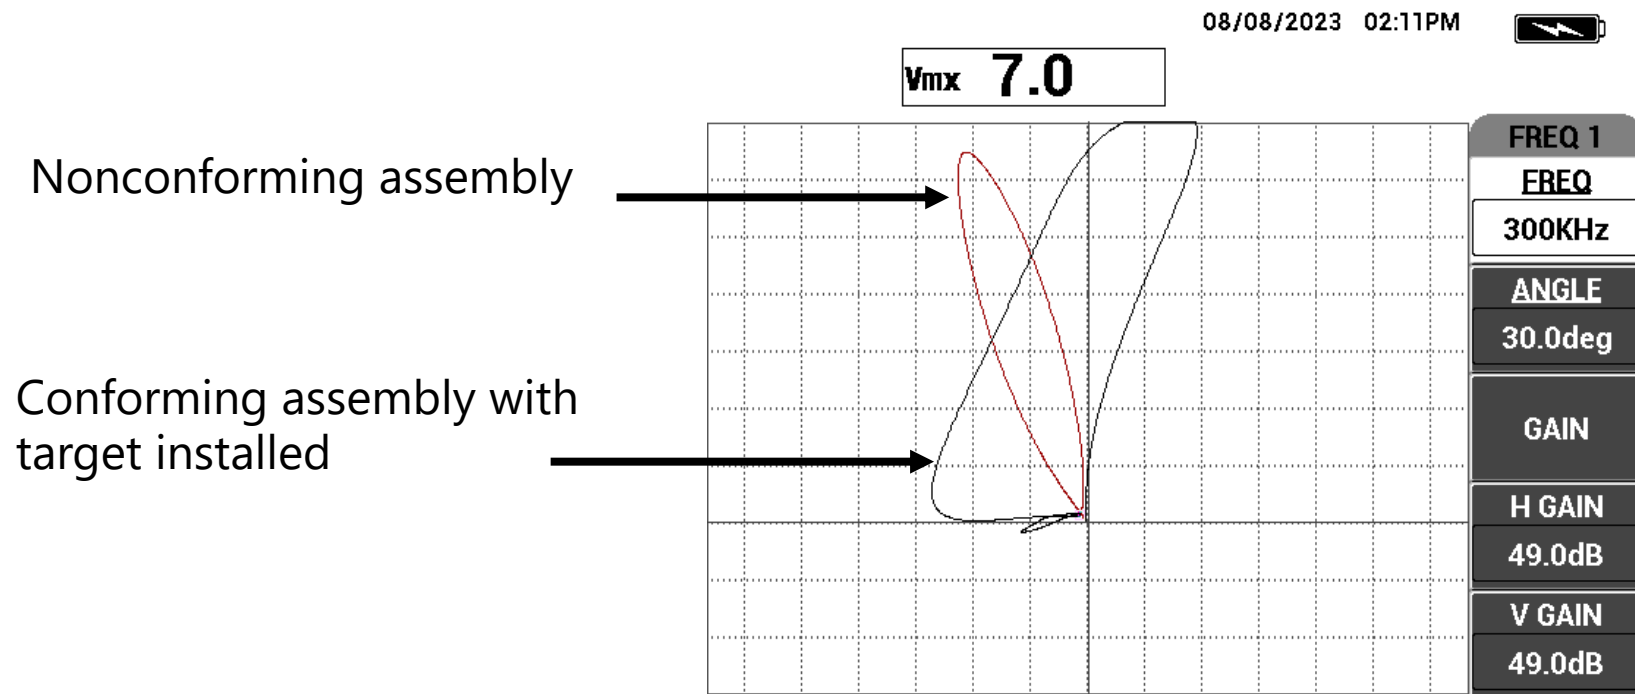
The customer needed a way to confirm the pins were properly installed into a tube housing as part of the injector assembly. The plastic syringe tube housing had two support pins used for a special device.

- **The target in this application is the two supporting pins within the plastic syringe tube housing.**
