FAA Structural Health Monitoring Research Program: In-House Chemical Mill Line Testing

A4A 2023

September 19, 2023

Structural Health Monitoring (SHM) Application on Chemical Mill Line Crack Inspection – In-House Testing

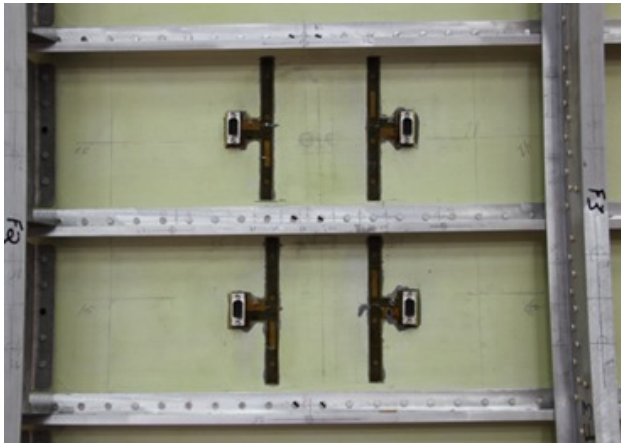
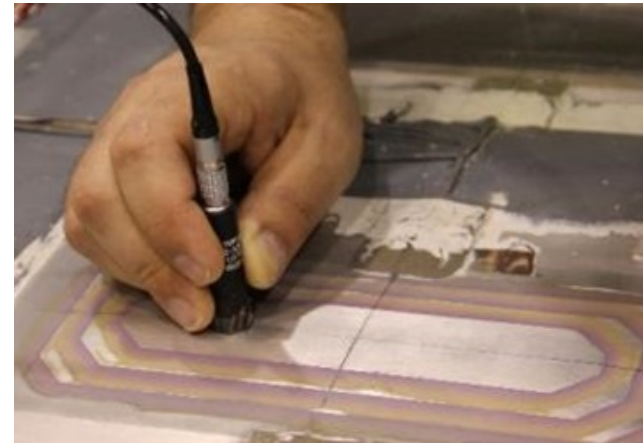
FASTER - Inspection

- **Strain gauges, Digital Imaging Correlation**
- **NDI: EC and Detailed Visual Inspection (DVI)**
- **SHM: PZT (Acellent and Metis), Carbon Nanotube (Metis), and Fiber Optic (FOI) (Luna and DFinder)**
- **Well characterized crack growth with frequent inspection opportunities**

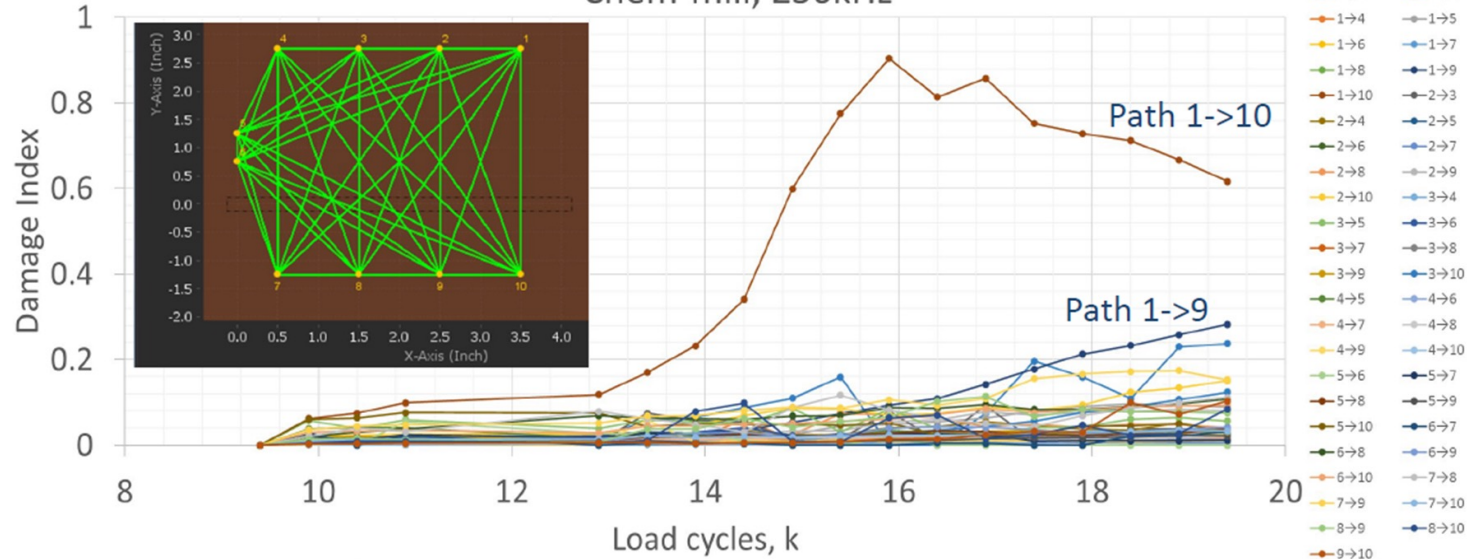
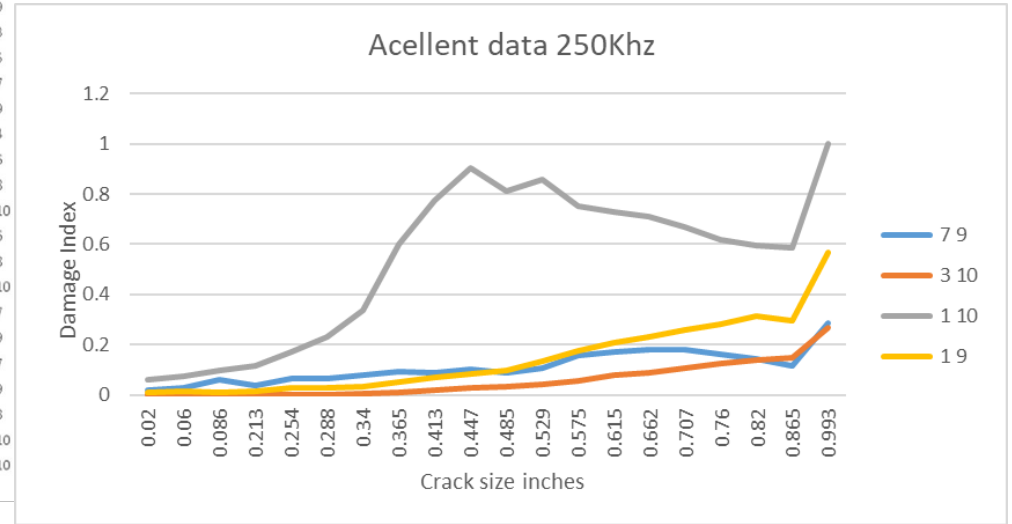
Chem-mill, 250kHz

DI > 0.2
