# NDT of Composites at NIAR (ATLAS)

2023 Airlines for America NDT Forum  
Denver, Co

# FAA/AANC HISTORY and ASSETS

# Airworthiness Assurance NDI Validation Center (AANC) A Unique FAA Facility

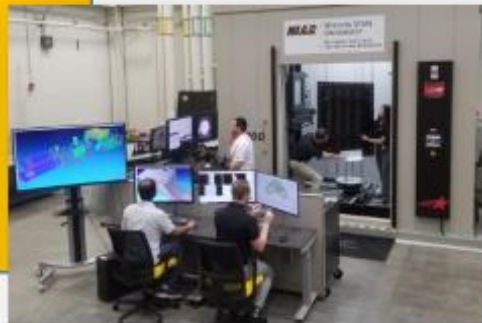
## High-Fidelity Inspections

- X-Ray CT (XCT)
- MAUS (UT)
- Acoustic Emission (AE)
- Pulse Thermography (PT)
- Laser Shearography (LS)
- Digital Image Correlation (DIC)

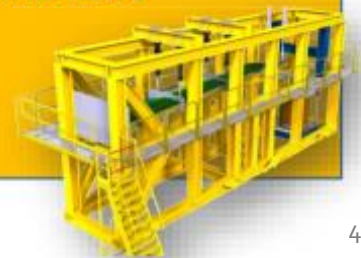
## Structural Test & Evaluations

- Axial-Torsion Biaxial Testing
- Durability & Damage Tolerance
- Structural Health Monitoring
- Aging Evaluations and Life Extension
- Repair Evaluations

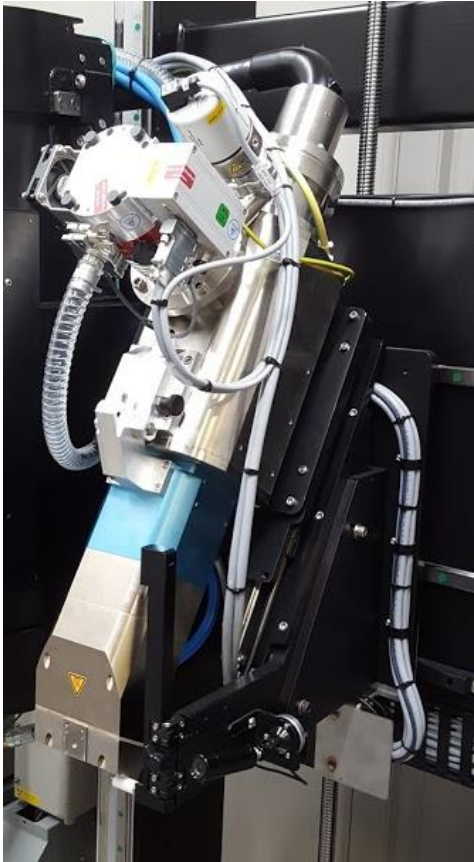
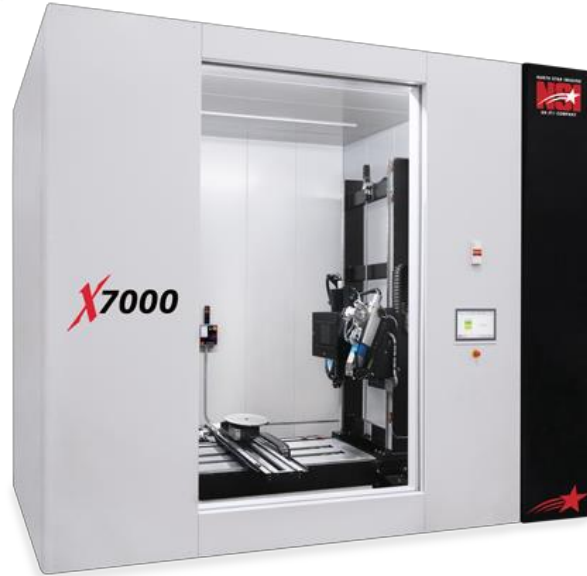
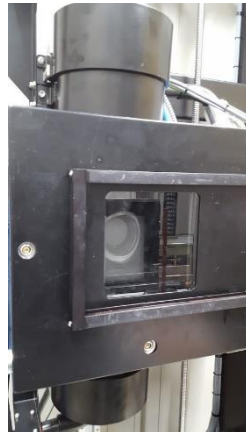
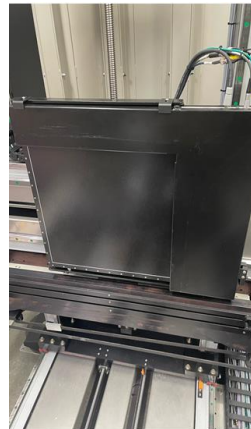
# NSI System Components

- NSI X7000 with ability to accommodate a 60" x 60" part in radiation shielded enclosure.
- X ray tube
  - 225kV Microfocus (6  $\mu$ m) for low attenuating / low density materials e.g. Carbon Fiber Composites.
  - 450 kV Minifocus for high attenuating / high density materials e.g. Metals
- Detector
  - Varian Lo8 flat-panel detector 16" x 16"
  - Linear Diode Array (LDA) allows high precision data acquisition
- Overall 3 different source + detector combinations:
  - 225kV + flat panel
  - 450 kV + (flat panel or LDA)

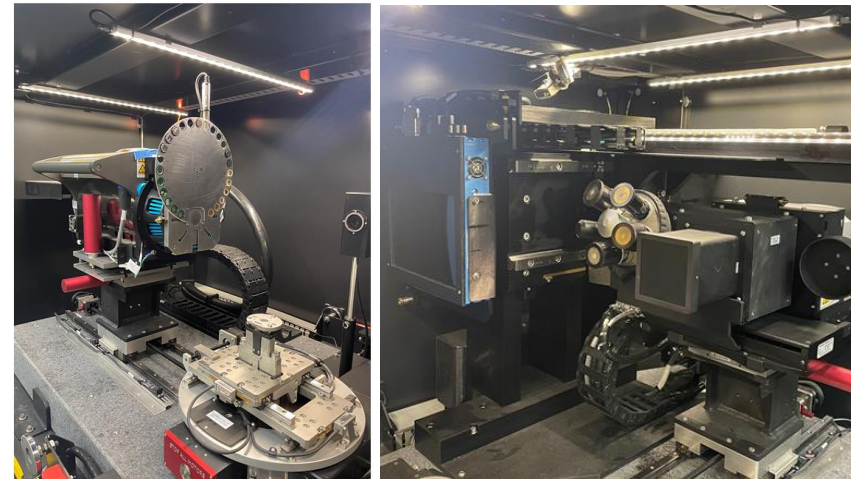
# Zeiss System Components

- Zeiss X-Radia 520 Versa
- Micro-CT
  - Lowest: 70 Nanometer (0.07 microns)
  - Highest: 100 Micron resolution
- X ray tube
  - 30 to 160 Kv
  - 10W maximum
- Detector
  - Objectives 0.4X, 4X, 20X, 40X
  - Flat Panel

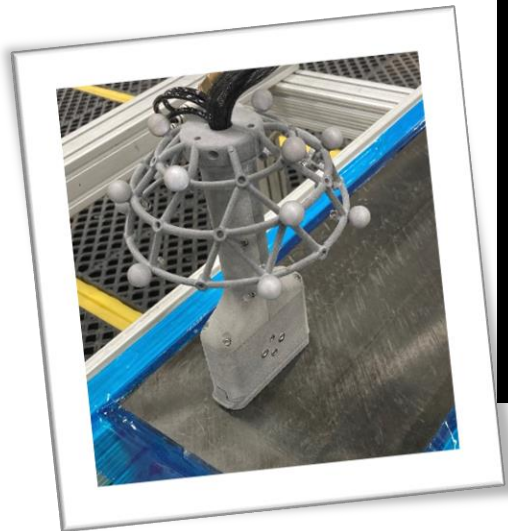
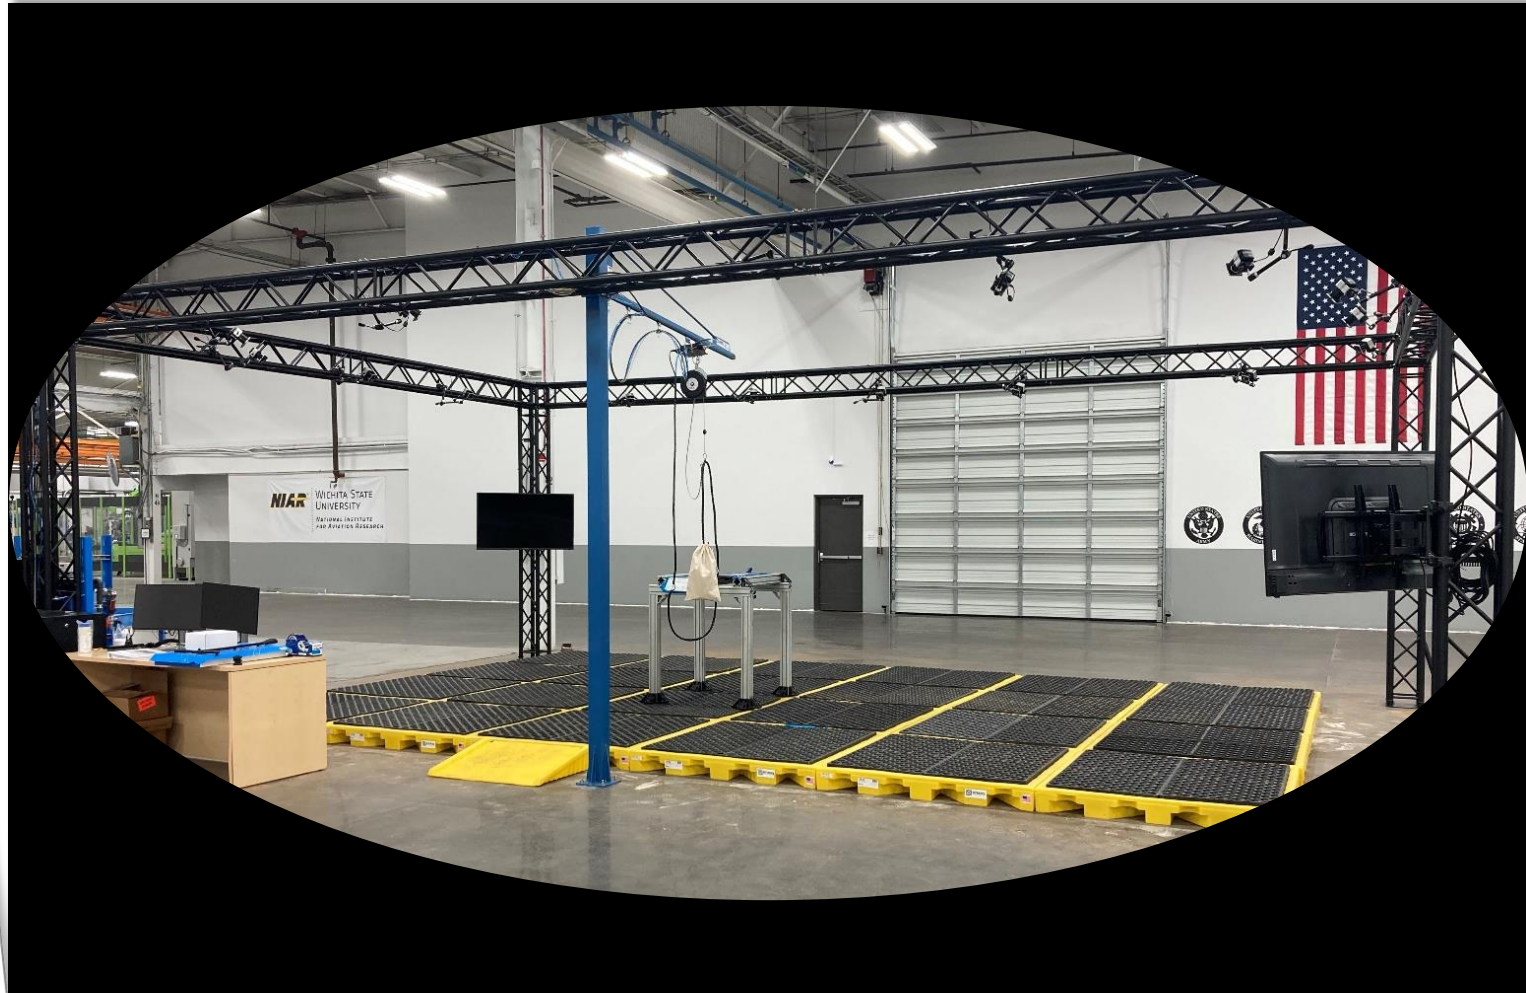
# CAMUS 3D System Ultrasonic

- Innerspec Camus 3D
- Phased Array Ultrasonics
  - 64 Element Array with umbrella
  - 16 Thermal Cameras on truss
  - Two-50" tv's
  - 24 skids for water recirculation
  - Vicon Tracker Software

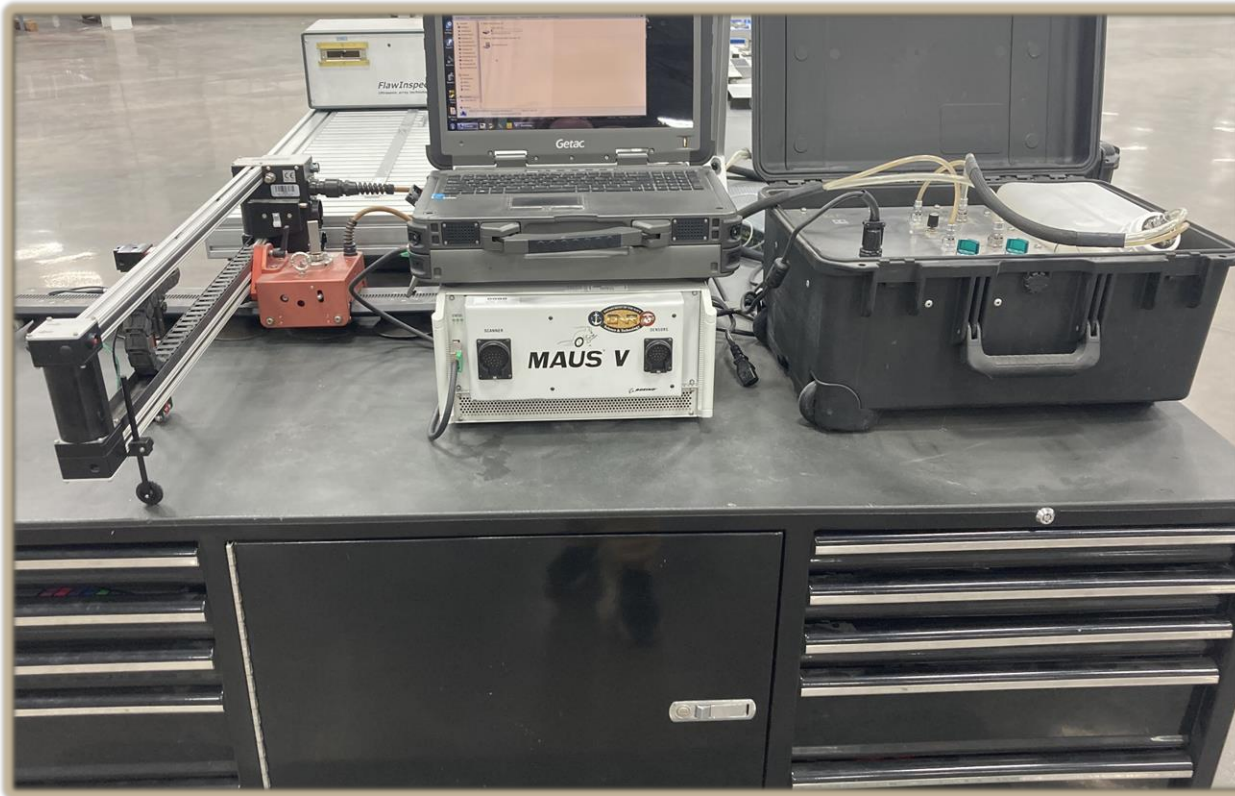
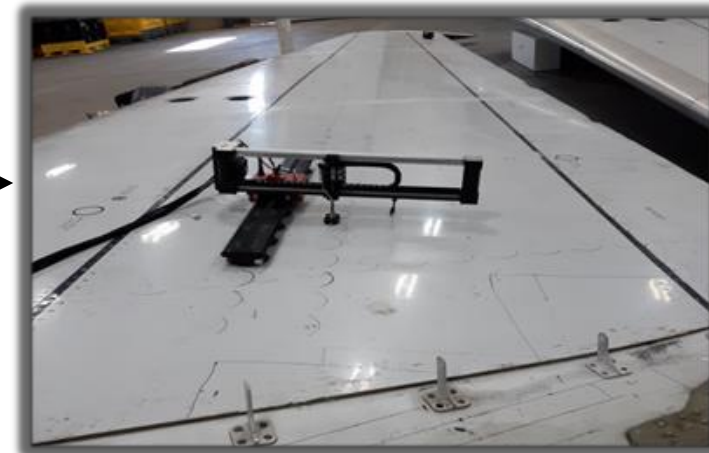
# MAUS Inspection System

- **Single Element Pulse Echo**
- **64 Element Phased Array**
- **Resonance Scanning**
- **Pitch Catch**
- **Mechanical Impedance**
- **Capability for Eddy Current**

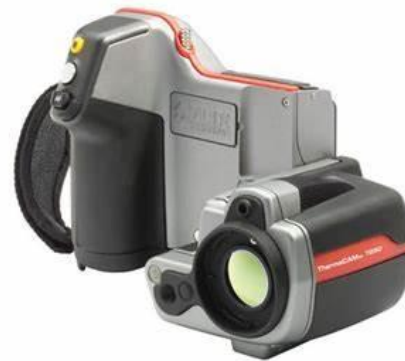
FLIR T400

- **FLIR T400**

- 320x240
- -4F-662F
- 8x continuous zoom

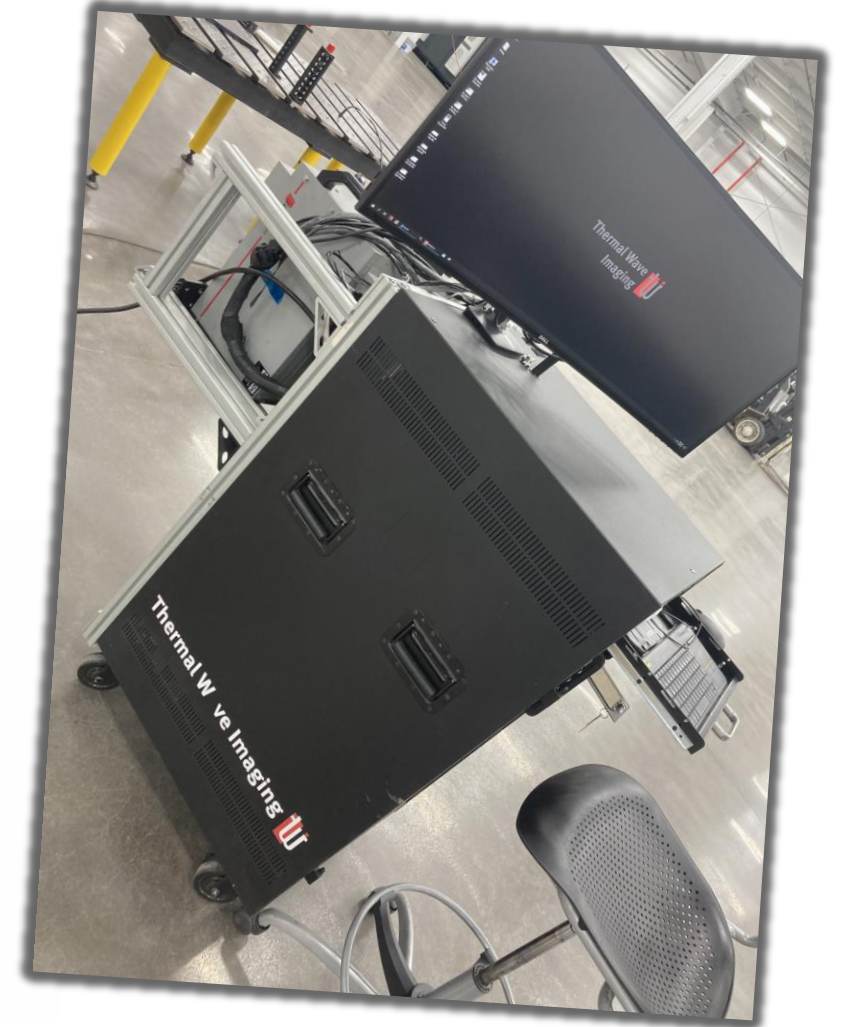
- **Thermal Wave Imaging Pulsed Thermography**

- Camera FLIR X8500SC
- 25mm lens 1280x1024 FOV: 10.5x8.4”
- 17mm lens 1200x870 FOV: 13.2x9.6”
- High Frequency Frame Rate of 180Hz
- 14 Bit Digital Image
- Windowing down FPA can induce higher frame rates
- 12um pixel pitch

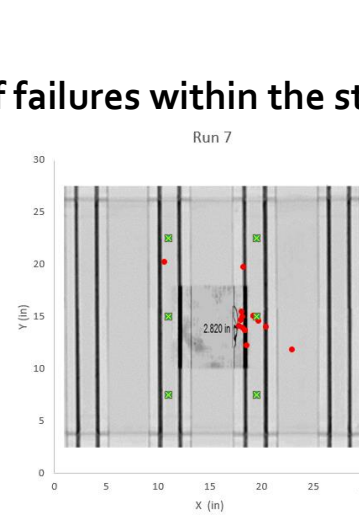
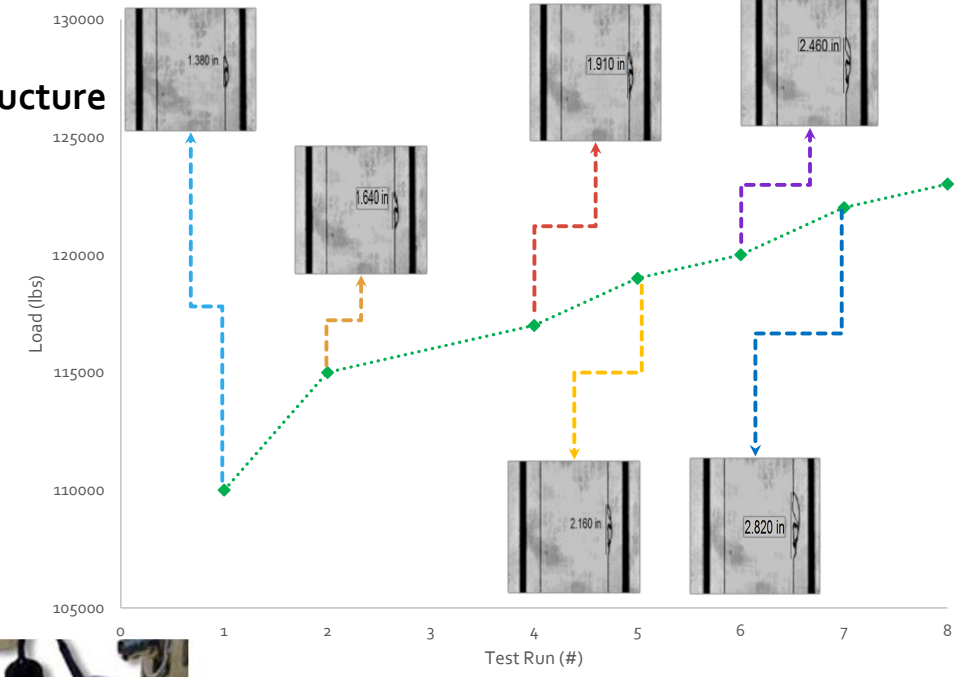
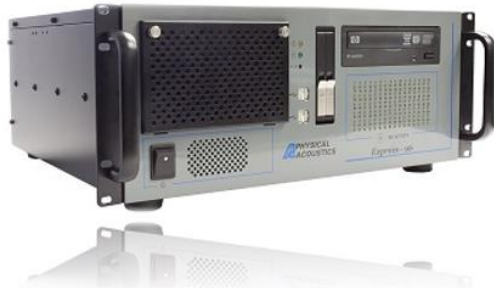
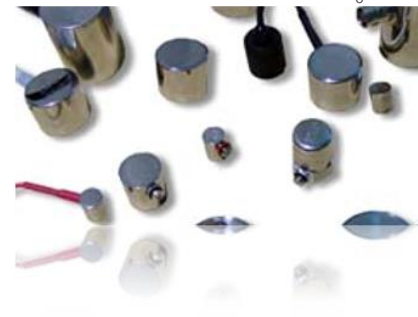
# Acoustic Emission Testing

- Acoustic Emission Principle
  - AE system detects transient elastic waves generated by the rapid energy release from the microstructural changes
- Implementations
  - Real time, in-situ inspection for instant detection of failures within the structure
  - Failure location triangulation
  - Structural Health Monitoring (SHM)
- AE System Apparatus
  - Sensors: PICO, NANO, R15I, R6I
  - Preamplifiers: 2/4/6
  - Computer: Express-96 Chassis
  - Data acquisition & Post Processing : AEwin software & NOESIS software

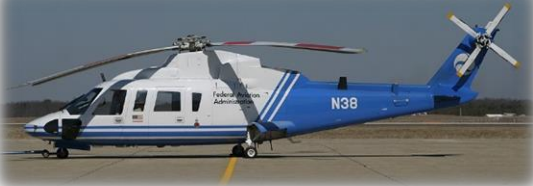
## A. Sikorsky S-76A

### Blade Details

- **Quantity**
  - Two main rotor blades
- **Historical Information**
  - Hours: 3,274

- **Inspections**
  - Shearography: **Complete**
  - Thermography: **Complete**
  - Ultrasonics: **Complete**

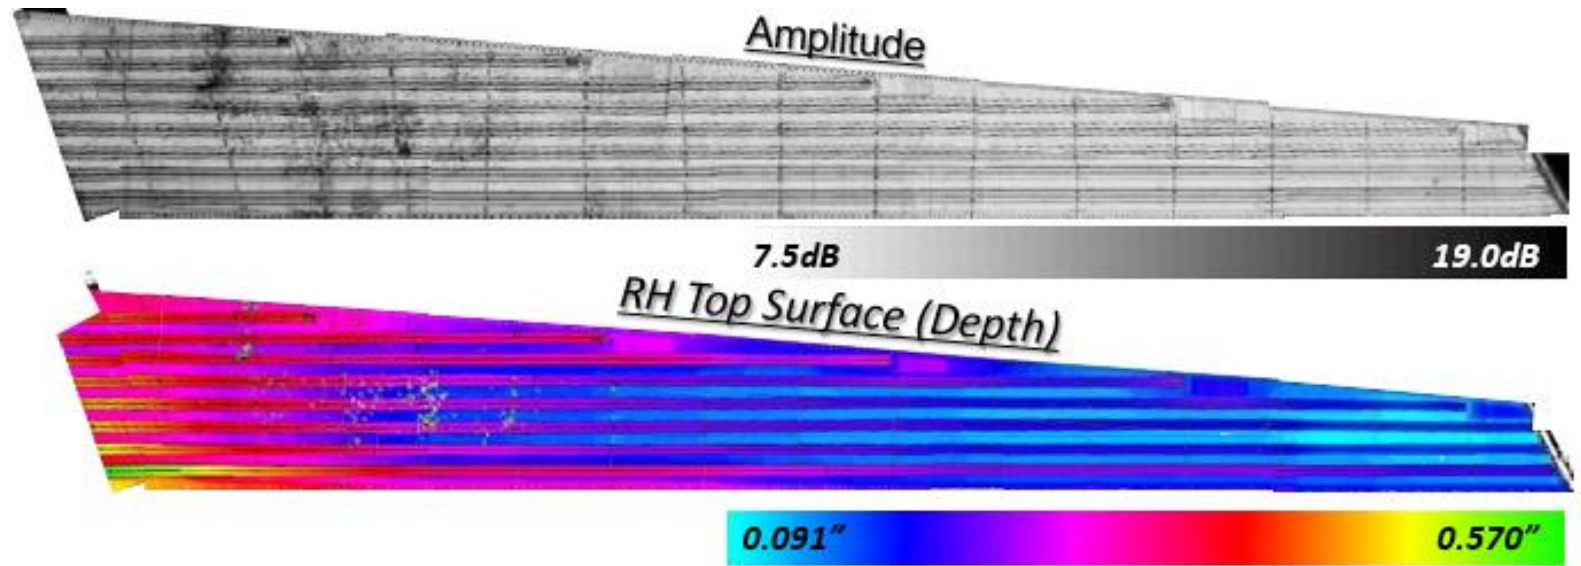
- Ultrasonic Pulse Echo
- MAUS

- Loss of data toward the inboard section of the scan due to surface roughness of the specimen.
- No major defect indications found on the global scan level.

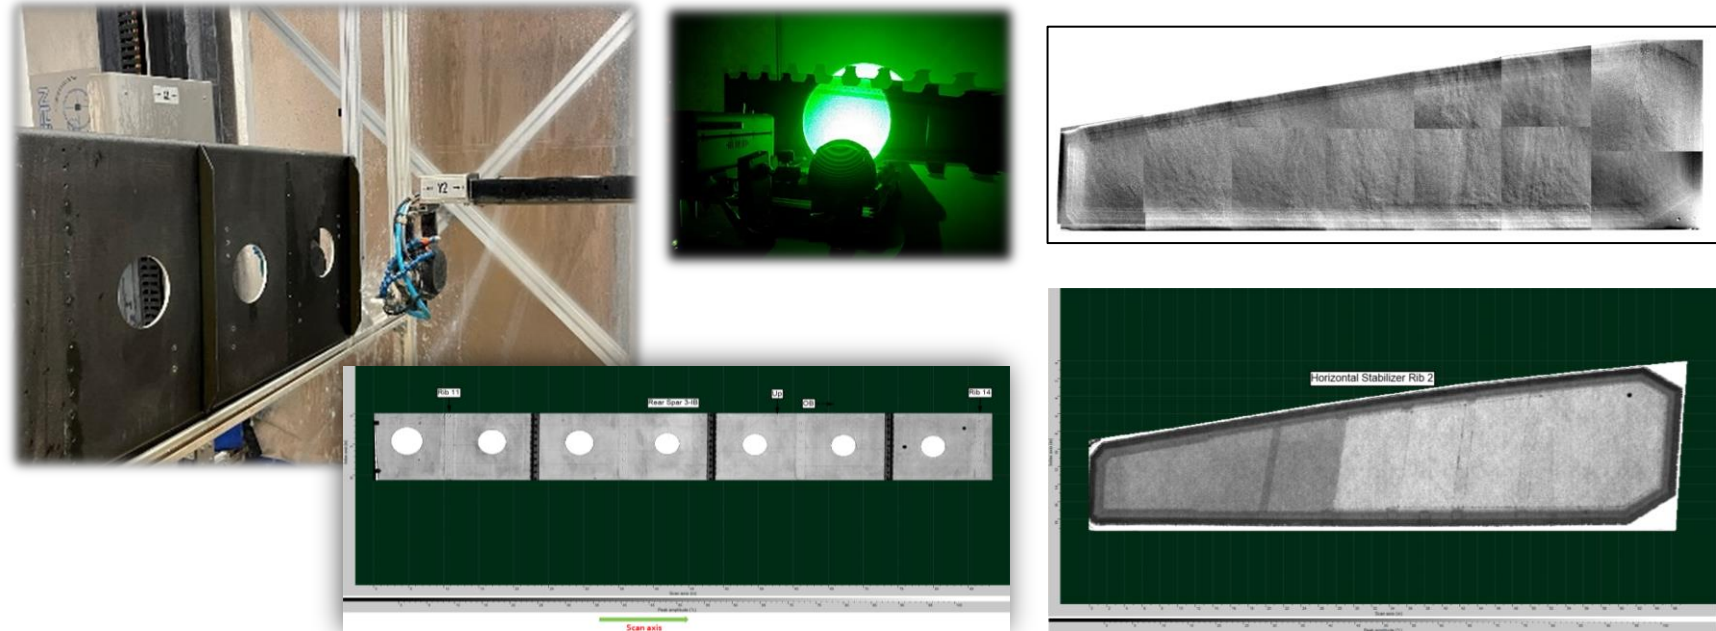
- Ultrasonics
- Infrared Thermography
- Laser Shearography
- Microscopy
- X-ray CT

- No major deviations to note from the component baselines due to defects found in the composite structure.

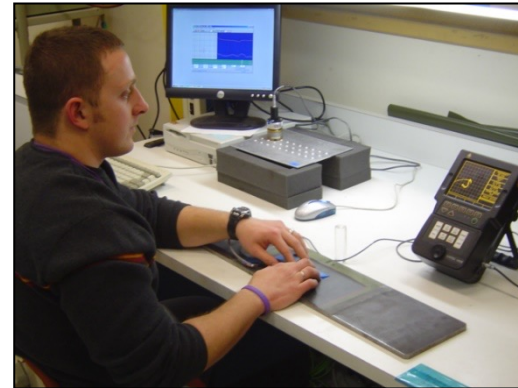
**AANC Test Specimen Library – engineered test specimens, complete aircraft test beds, sections cut from aircraft (> \$5M value)**

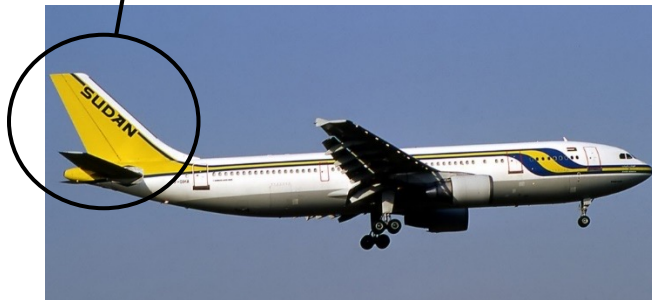
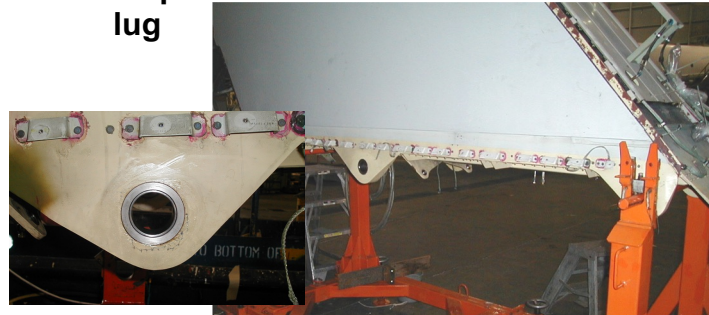
Developed Pulse-Echo Ultrasonic inspection – added for carbon laminate lug
