A4A NDT FORUM

Use of Small Unmanned Air Vehicles (Drones) to Enhance Aircraft Structural Integrity Programs

Walt Jarecki (ATF)

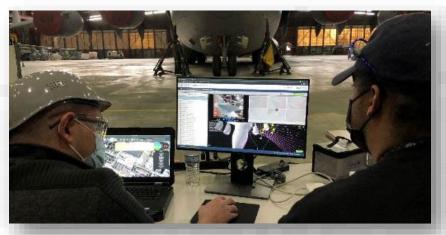
Analysis - Data Collection with Auto flight sUAS

Graphical User Interface

Auto flight: sUAS takes off, locates and maps the aircraft using preplanned trajectories - "flight plan"

- Technician monitors inspection trajectories around aircraft
- Collects HD images tagged with 3-D location on aircraft

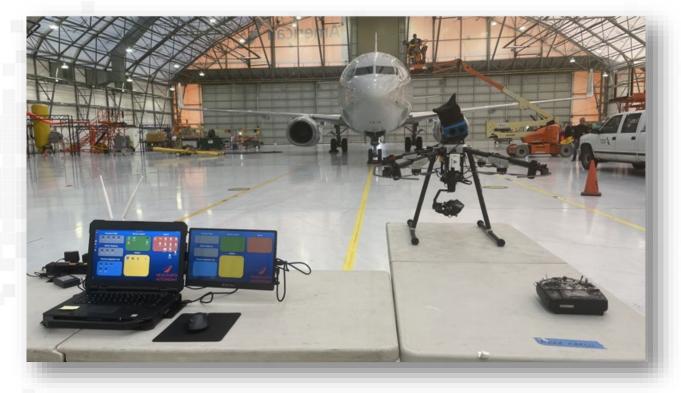
Navigation

Inflight Monitoring

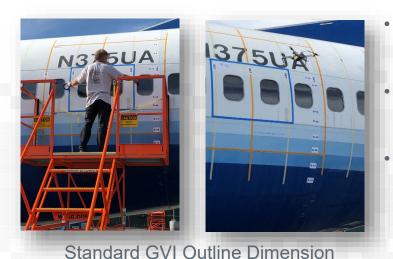
Analysis - Recommended Approach

The image should simulate as if it the AMT captured from touching distance

- Any zooming images may become blurry and pixelated
- Image inspection procedure criteria will be provided to AMT or UI

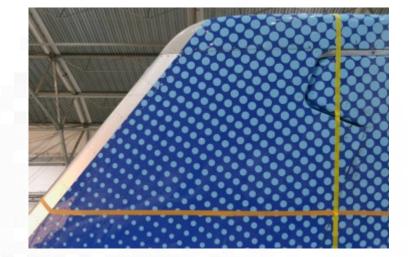
The Maintenance Steering Group-3 (MSG-3) GVI definition:

"Visual examination of an interior or exterior area, installation or assembly to detect obvious damage, failure or irregularity, made from within touching distance and under normally available lighting condition such as daylight, hangar lighting, flashlight or drop-light". Adjustments for equivalency
