Advanced Ultrasonic Spectroscopy for Improved Inspection of Highly Attenuative Components

A4A NDT Forum, September 2024

Kratos Defense & Rocket Support Services

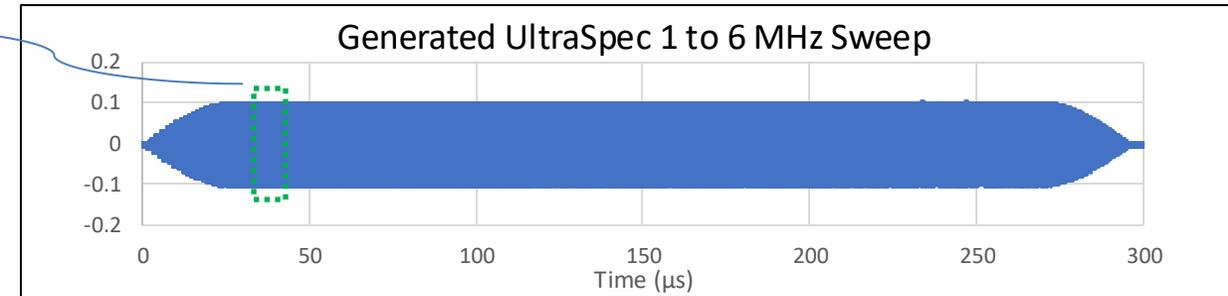
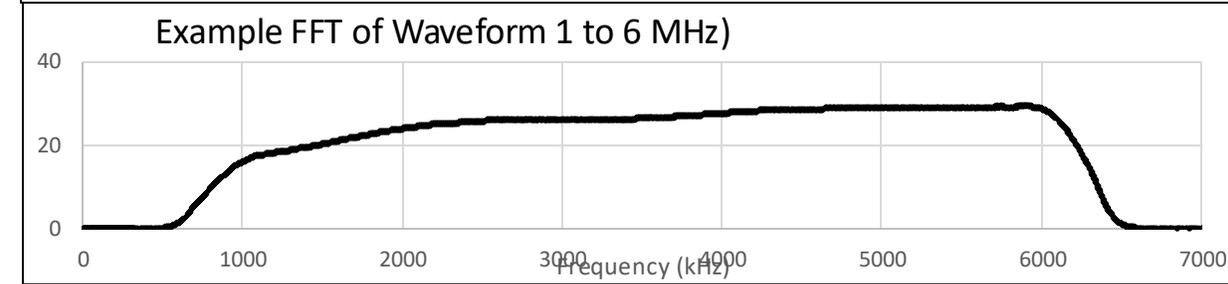
Traditional UT: Single Frequency
Time-of-Flight
Amplitude

UltraSpec™ – Swept-frequency ultrasonic spectroscopy

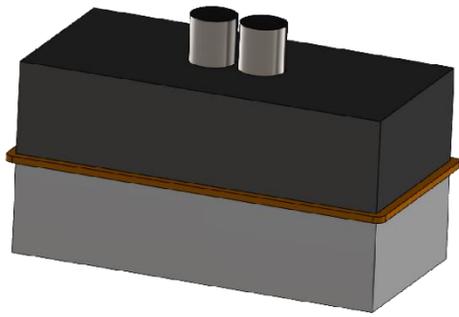
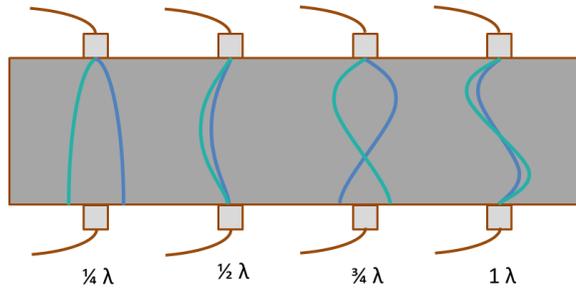
$$\text{Resonant Frequency} = \frac{\text{velocity}}{2 * \text{thickness}}$$

Spectral Response (Signature)

- Very Repeatable
- Contains Resonances of Each Layer Individually
- Contains Resonances of Full Thickness or Combinations of Layers

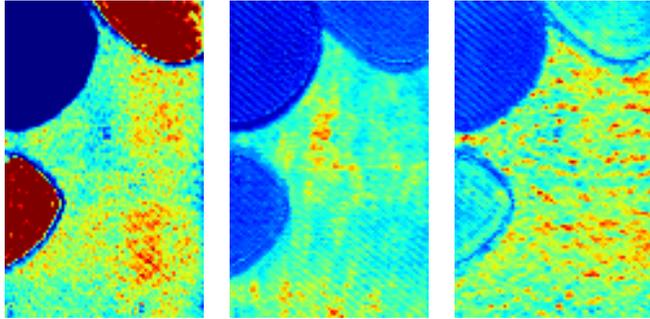
Peak/Valley Fits with Physics Calculator

FREQ (kHz)	TIME (µs)
1 Layer	900	3.8
2 Layers	450	4.9
3 Layers	300	6.0
4 Layers	225	7.1
5 Layers	180	8.2
6 Layers	150	9.3

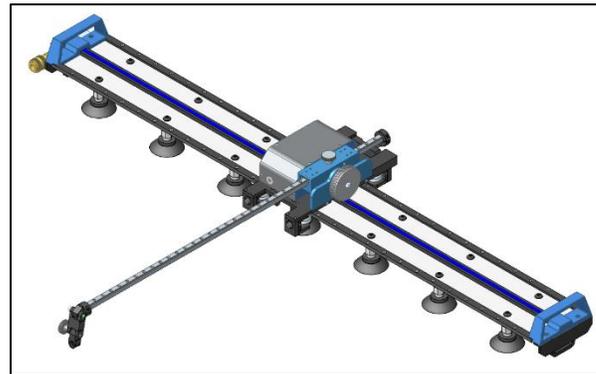
Customized Probe Fixture
TecFlex: Improved Design for
Aircraft Mounting (Complex
Curvatures)

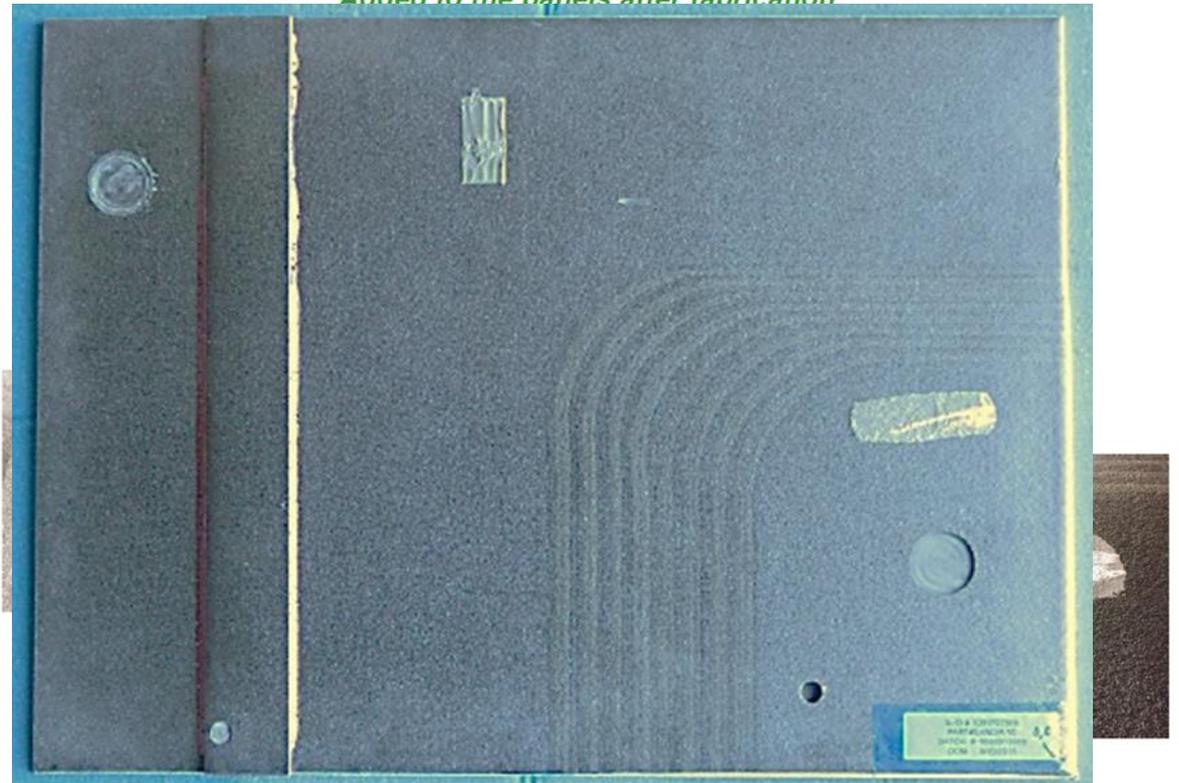
Engineered Flaws in Proficiency Specimens

Added to the panels after fabrication

Grinder Disk Groove
***Gouge or deep scratch**

***Raised material, not a flaw**

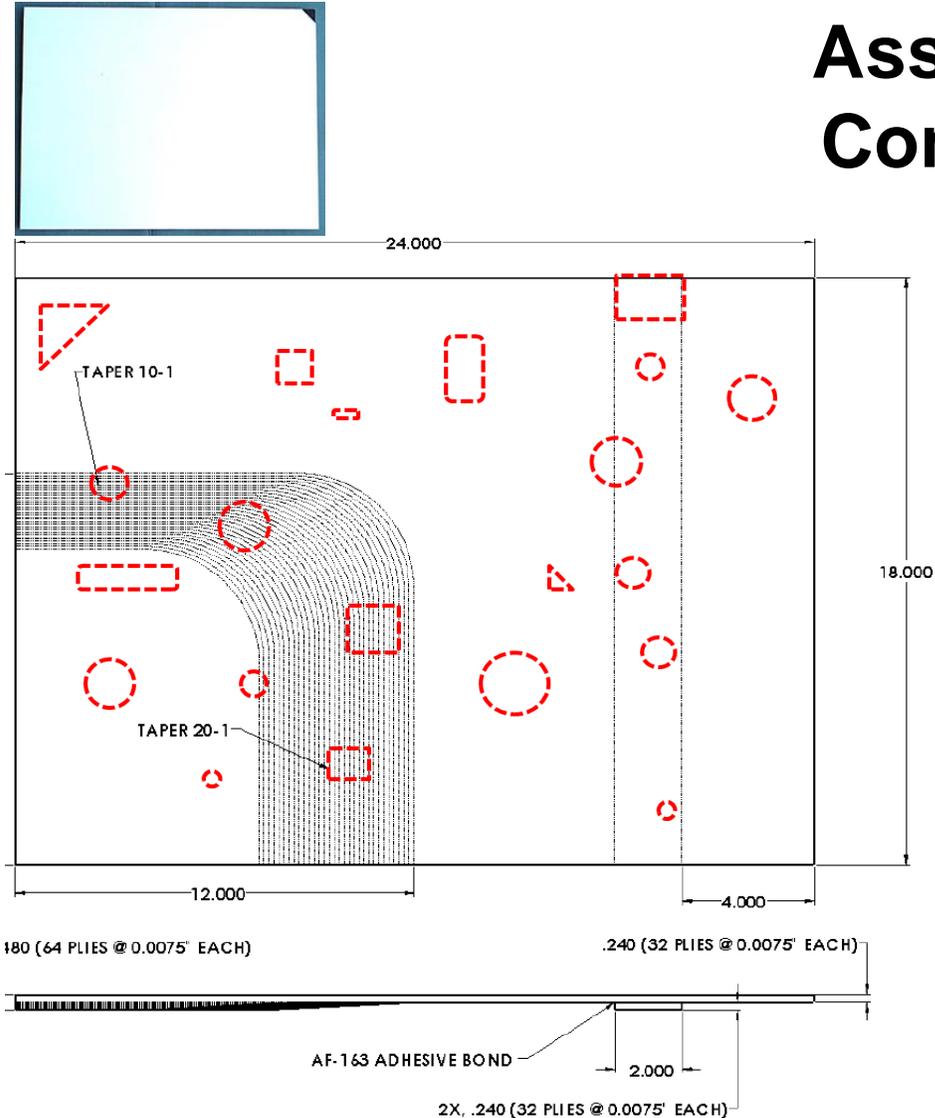
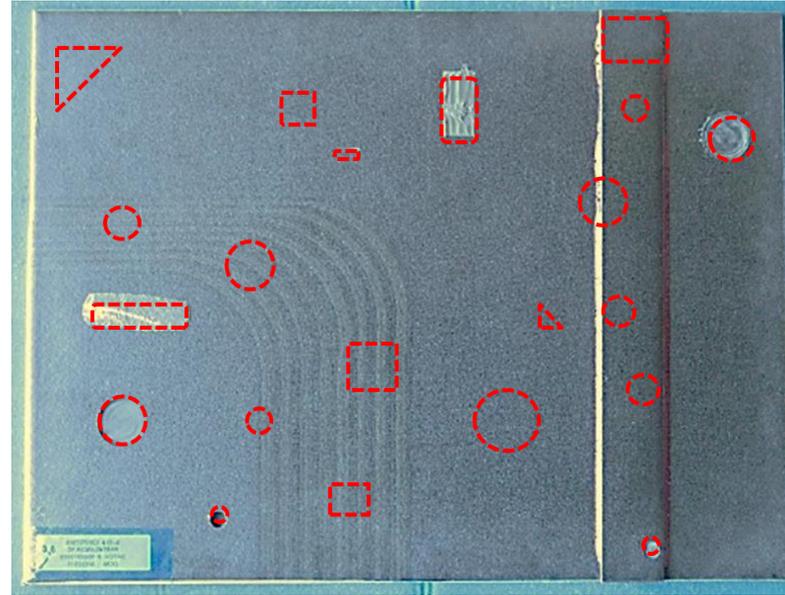
Assess UltraSpec Flaw Detection Performance Composite Laminate Proficiency Specimen 1C

Inverted Image to Match Front

ITEM #	FLAW TYPE	SIZE	PLY LAYER
1	IMPACT	Ø1.50	SEE SECTION B-B
2	CARBOSPHERES	Ø2.00	BTN PLYS 16 & 17 (50%)
3	PILLOW INSERT	Ø1.50	BTN PLYS 8 & 9 (25%)
4	PILLOW INSERT	Ø0.75	BTN PLY 32 & ADHESIVE
5	PILLOW INSERT	Ø1.00	BTN PLY 16 & 17 OF SUBSTR
6	PILLOW INSERT	1.00 X 1.00	BTN PLY 10 & 11 OF TAPER
7	PILLOW INSERT	1.00 X 1.00	BTN PLY 24 & 25 (75%)
8	PILLOW INSERT	Ø1.50	BTN PLY 4 & 5 OF TAPER
9	PILLOW INSERT	Ø0.75	BTN PLY 26 & 27 OF TAPER
10	PILLOW INSERT	1.50 X 1.50	BTN PLY 24 & 25 (75%)
11	GREASE	Ø1.00	BTN PLY 1 & 2 OF TAPER
12	GRAFOIL	Ø1.00	BTN PLYS 16 & 17 (50%)
13	FLAT BOTTOMED HOLE	Ø1.50	0.120" ∇ (BTN PLYS 16 & 17)
14	FLAT BOTTOMED HOLE	Ø0.50	0.360" ∇ (BTN PLYS 48 & 49)
15	FLAT BOTTOMED HOLE	Ø0.50	0.060" ∇ (BTN PLYS 24 & 25)
16	PREPREG BACKING	0.75 X 0.75	BTN PLYS 8 & 9 (25%)
17	PREPREG BACKING	2.00 X 2.00	BTN PLYS 24 & 25 (75%)
18	ADHESIVE BACKING	2.00 X 1.50	BTN ADHESIVE & PLY 1 OF SUBSTR
19	SEALANT BLOB	2.00 X 1.00	32 FLY BACKSIDE

20	SEALANT BLOB	3.00 X 0.75	64 FLY BACKSIDE
21	GRIND DISK GROOVE	0.10 x 0.75	APPROX. 0.070" ∇

FLAWS Detected

Traditional Methods
UltraSpec Method

18/21 86%
21/21 100%

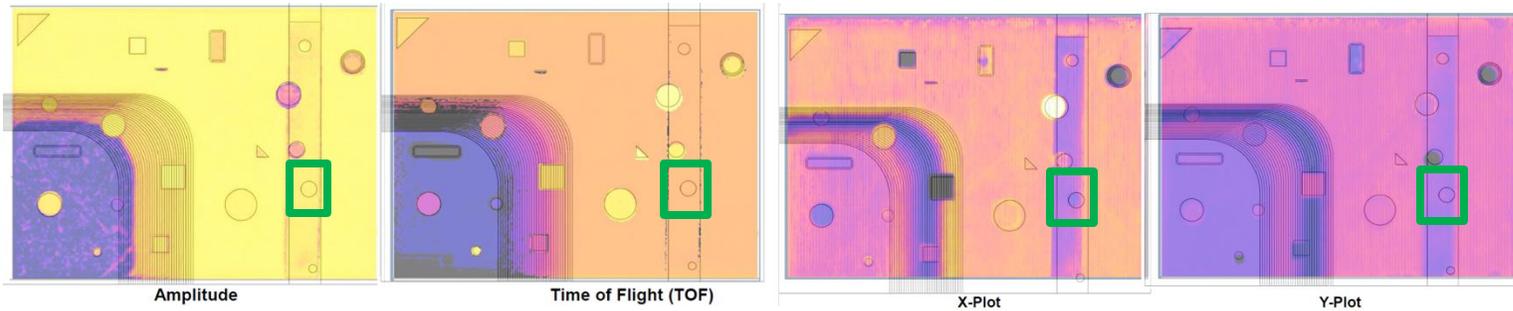
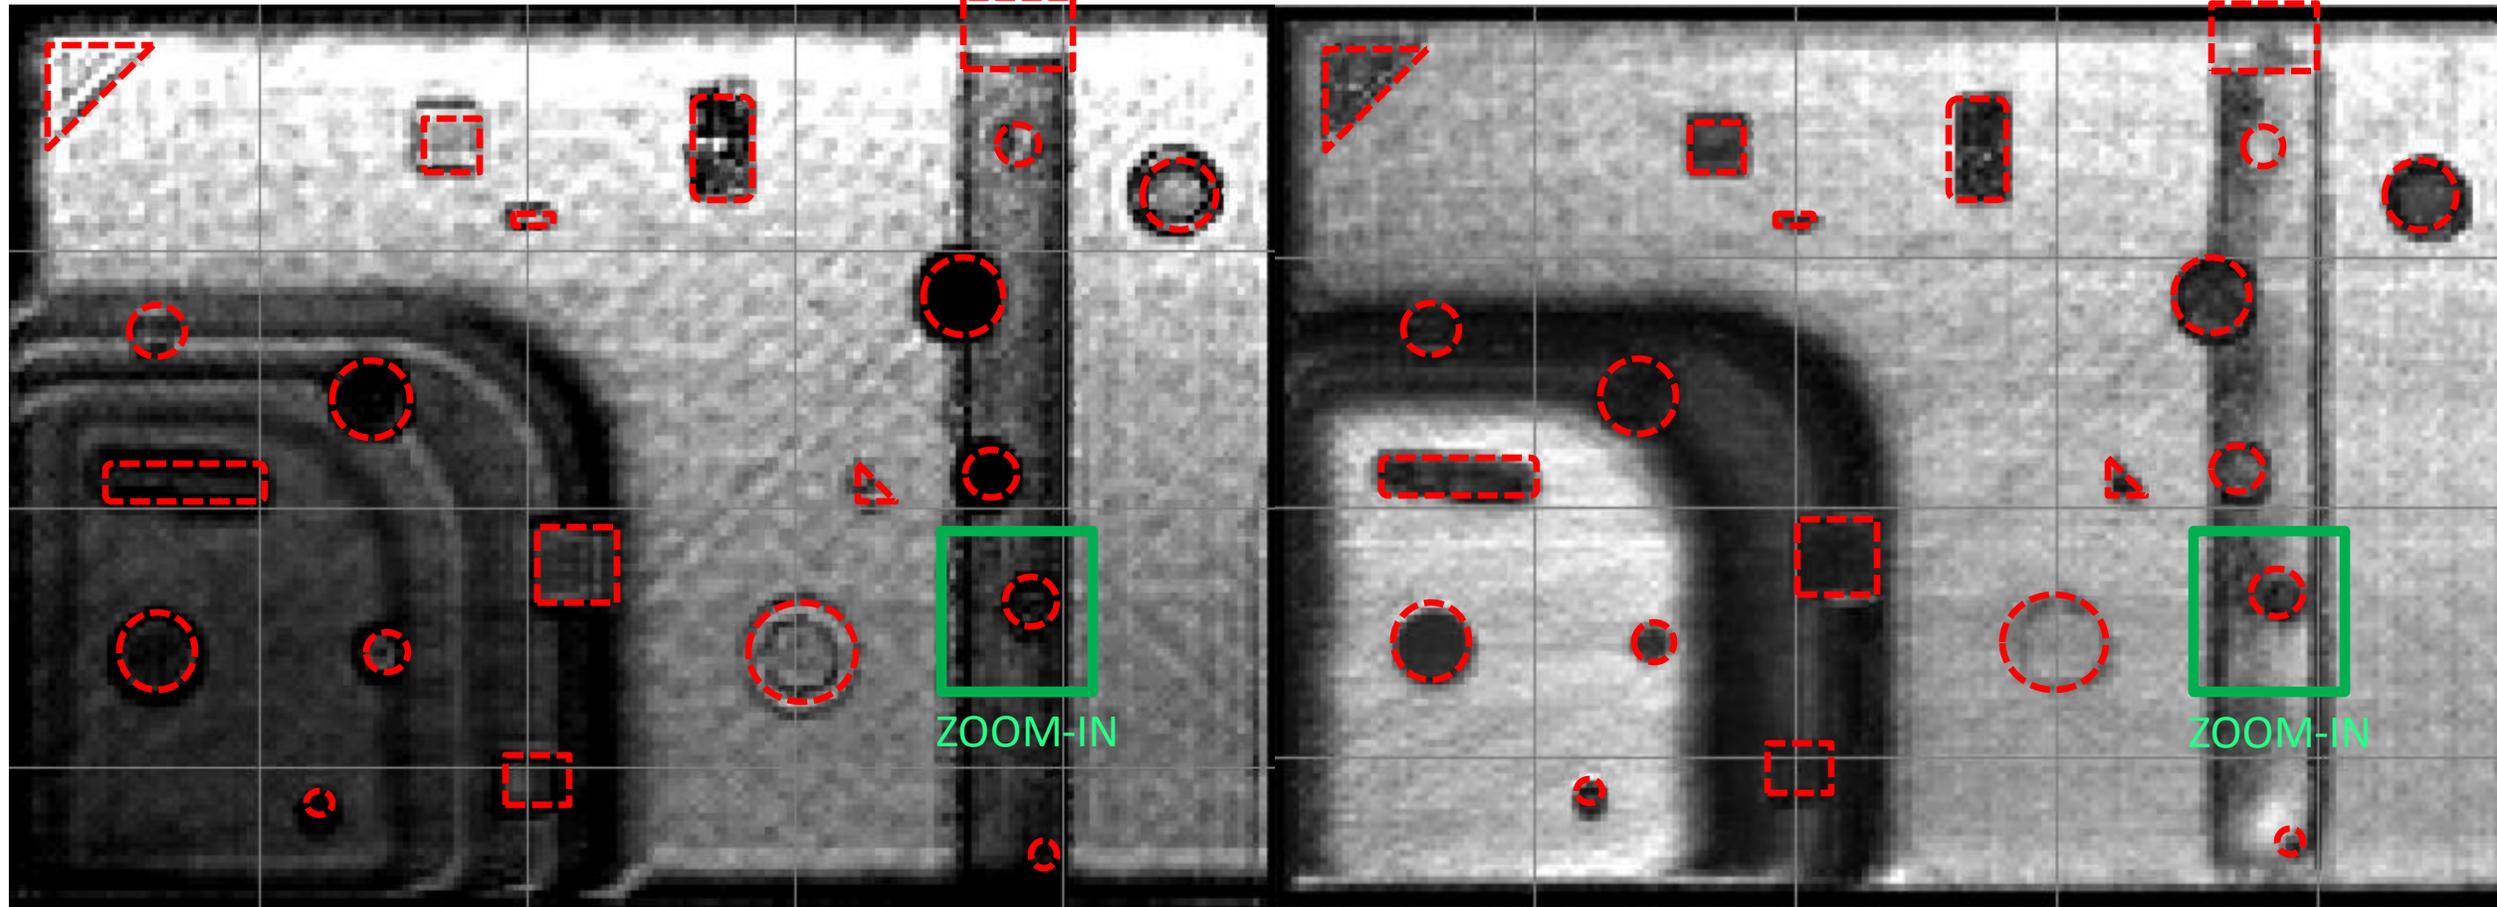
1C Panel: PEUT vs UltraSpec™ Results

Spectral Amplitude $\sim 720\text{kHz}^*$
 $^*3^{\text{rd}}$ harmonic of 32 ply skin, 6^{th} harmonic of 64 ply full thickness

Time Amplitude near 64 ply backwall

Traditional UT
Misses with Flaw
Outline Overlay
PE 5 MHz Amplitude

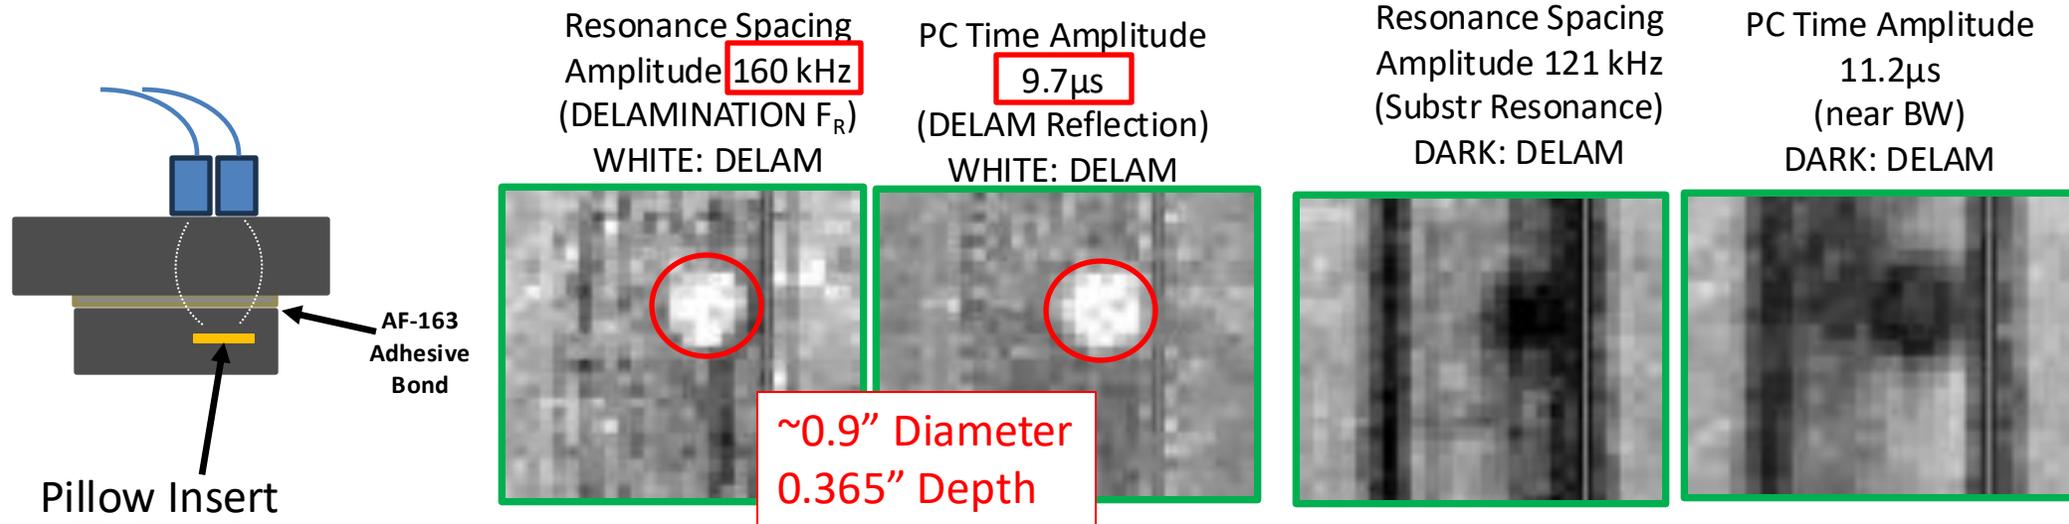
1C Panel (Flaw #5): PEUT vs UltraSpec™ Results

5	PILLOW INSERT	Ø 1.00	BTN PLY 16 & 17 OF SUBSTR
---	---------------	--------	---------------------------

Description	Layup	Depth (in)	Velocity (in/μs)	F _R (kHz)	PC BW (μs)
Skin	32 plies 0.0075ea	0.24	0.117	244	7
Skin+Adh+Substrate	32 plies+ADH+32 plies	0.485	0.117	121	11.2
DELAMINATION	32 plies+ADH+16 plies	0.365	0.1166	160	9.7

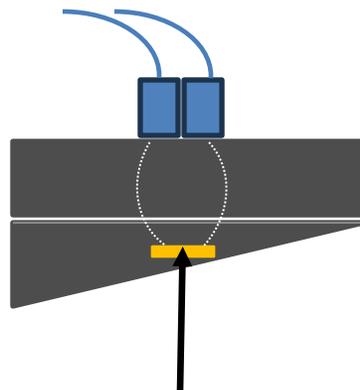
1C Panel (Flaw #6): PEUT vs UltraSpec™ Results

6	PILLOW INSERT	1.00 X 1.00	BTN PLY 10 & 11 OF TAPER
---	---------------	-------------	--------------------------

Pillow Insert

Pillow insert
*Delamination

Resonance Spacing
Amplitude **185 kHz**
(DELAMINATION F_R)
WHITE: DELAM

PC Time Amplitude
8.5μs
(DELAM reflection)
WHITE: DELAM

**~1" Square
0.315" Depth**

Resonance Spacing
Amplitude 162 kHz
(~Taper Resonance)
DARK: DELAM

PC Time Amplitude
9.5μs
(~Taper BW)
DARK: DELAM

Description	Layup	Depth (in)	Velocity (in/μs)	F_R (kHz)	PC BW (μs)
Skin	32 plies 0.0075ea	0.24	0.117	244	7
Skin+Center of Taper	32 plies+16 plies	0.36	0.1166	162	9.5
DELAMINATION	32 plies + 10 plies	0.315	0.1166	185	8.5

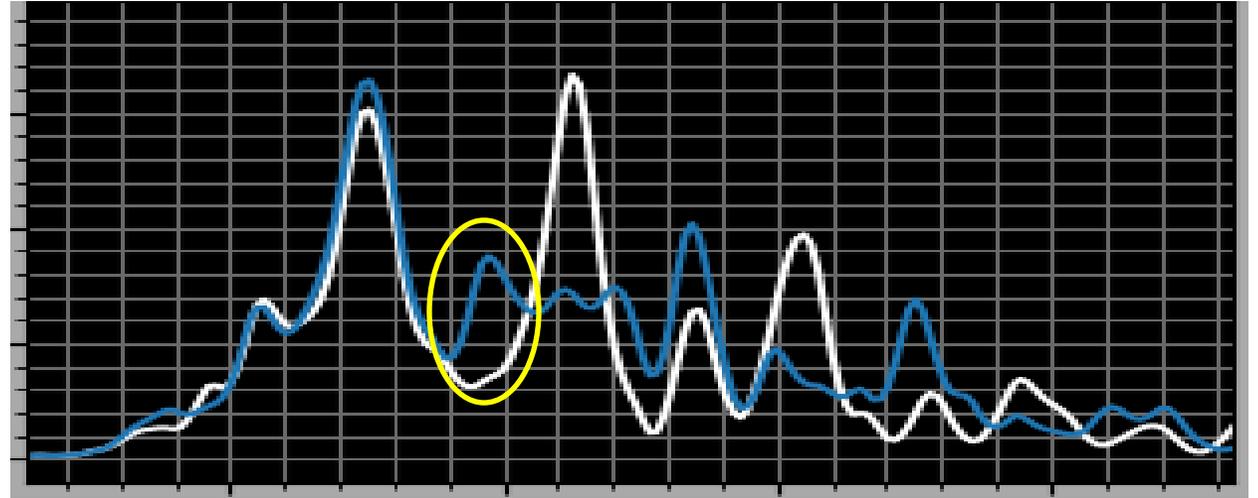
UltraSpec™ Pulse Compression (Flaw #5)

Processed Time Domain: More Robust
PEAKS represent where full sweep aligns in time.

See things that might not otherwise be found in traditional A-Scans.

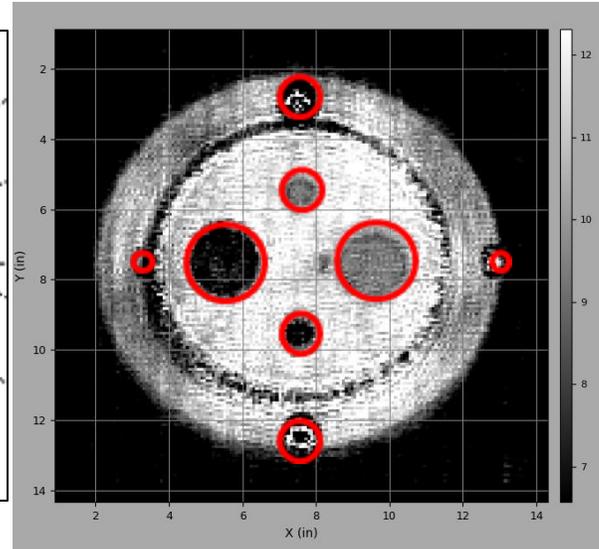
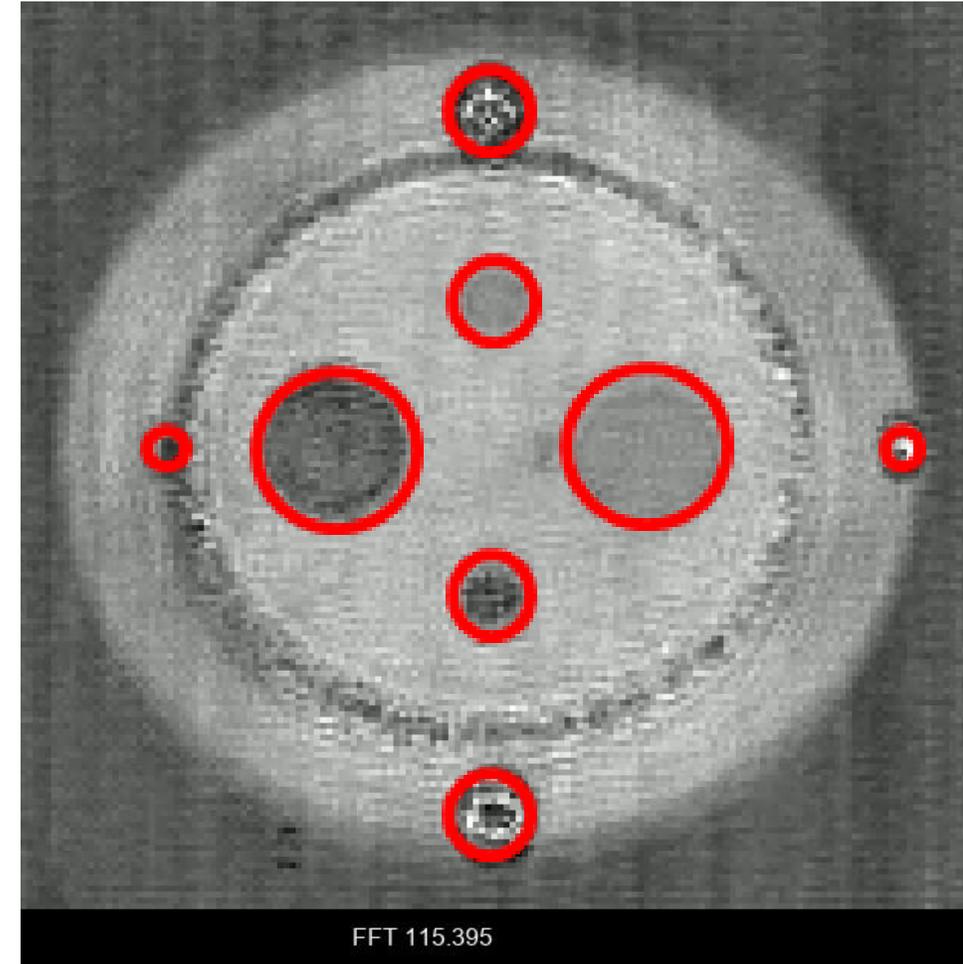
Scarf Repair SK 12595-R1

UltraSpec™ Results
116kHz

UltraSpec™ Spectral Amplitude Movie

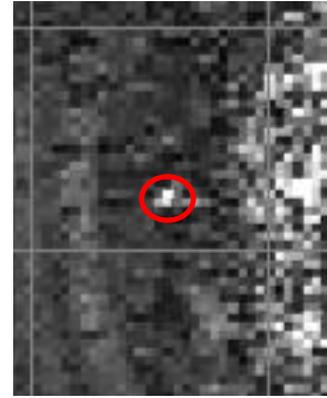
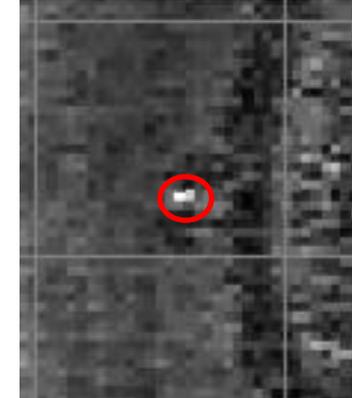
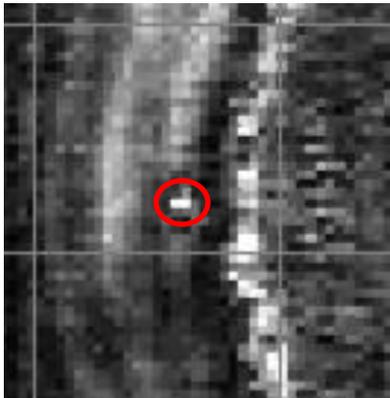
Scarf Repair SK 12595-R1

Early Reflection
 $\sim 14\mu\text{s}$

Spectral Amplitude
226 kHz

Spectral Amplitude
157 kHz

Very small flaw, but visible in multiple frequencies and times (very dramatic change in signal/signature).

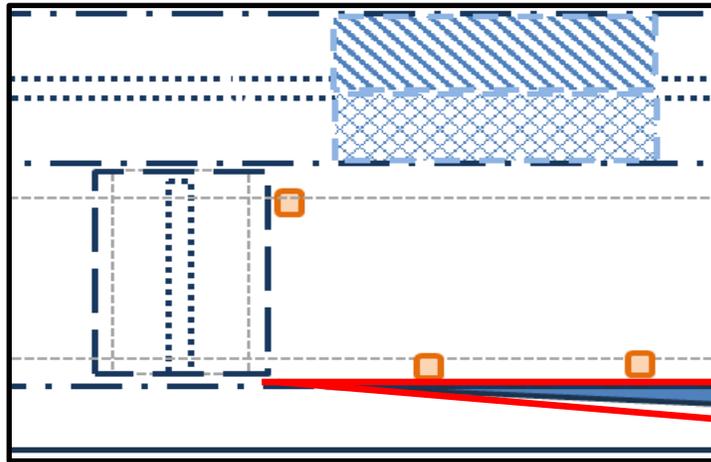
FAA Composite Laminate Aircraft Structure Sample

UltraSpec™ Results

More detail than traditional UT results.

Stringer Delamination/Disbond
-

Stringer Partial Disbond

Clearly found partial disbond.

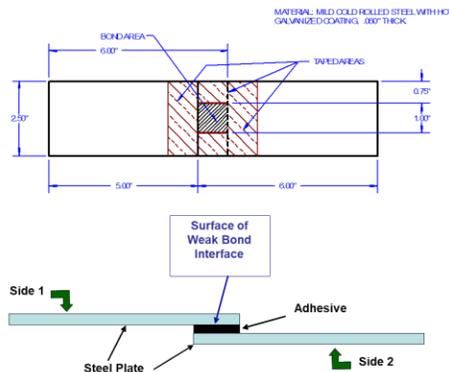
Coupon Masked, Clamps & Wires Used to Control Adhesive Thickness (0.4 mm)

Schematic Showing Position of Weak Bond Surface Relative to Inspection Sides 1 and 2

(a) Nominal Bond	(b) Uneven Adhesive Application	(c) Bad Surface Preparation, No Pressure	(d) Contaminant on Surface (Wax)	
(i) Amplitude of Spectral (Frequency) Response at Resonance					
(ii) Amplitude of Time Response Near Back Wall
