## **First Regulatory Acceptance of Automated Aircraft Inspection via Drone into an Operator's Maintenance Program**

David Piotrowski– Senior Principal Engineer, Technology Development Engineering

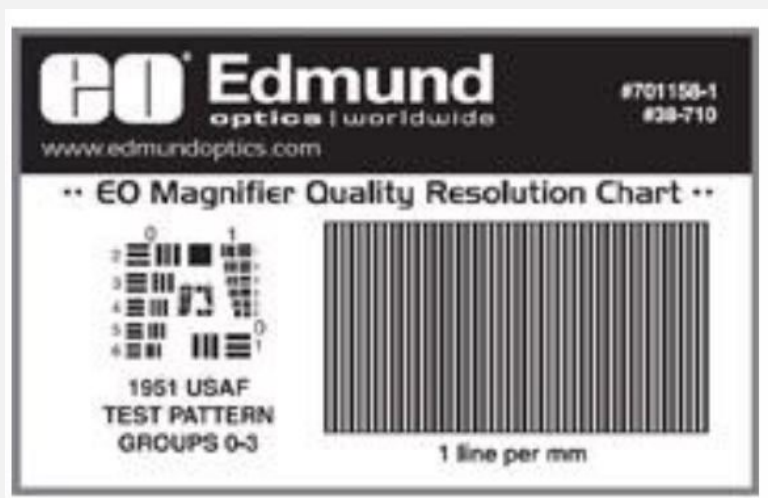
USAF-1951 Resolution Target

Asses the reproducibility and repeatability of current GVI procedures and drone assisted GVI procedures.

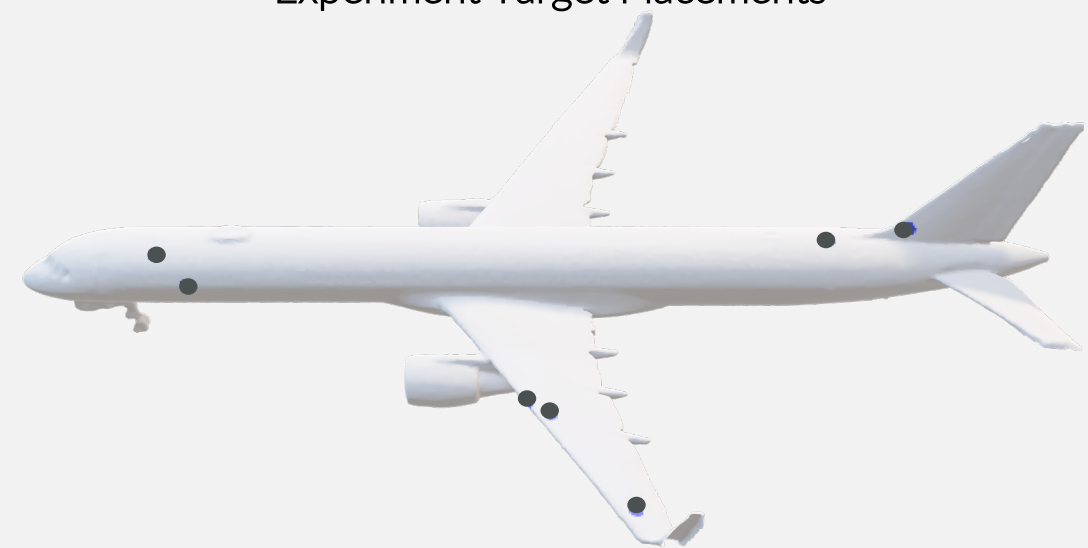
Experiment Target Placements

Inspectors set up to perform standard GVI on A/C and report maximum resolution from the resolution target.

Drone flies autonomous path capturing photos of targets. Inspectors review photos and report maximum resolution from resolution target.

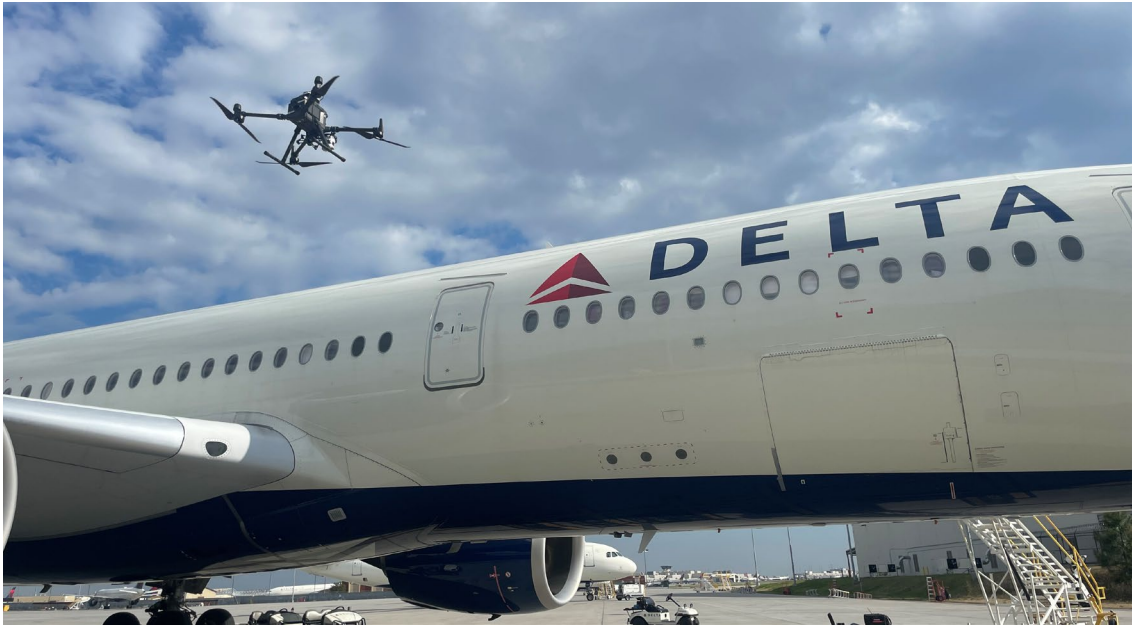
TASK A350-C-05-51-18-90001-281A-A

Inspection - Camera Based Drone Inspection for Portions of the  
External Check
