# – T700 / CT7 Quality Event Field NDE Response

– 20 May 2025

# T700 / CT7 Turboshaft Engine

# Quality Event

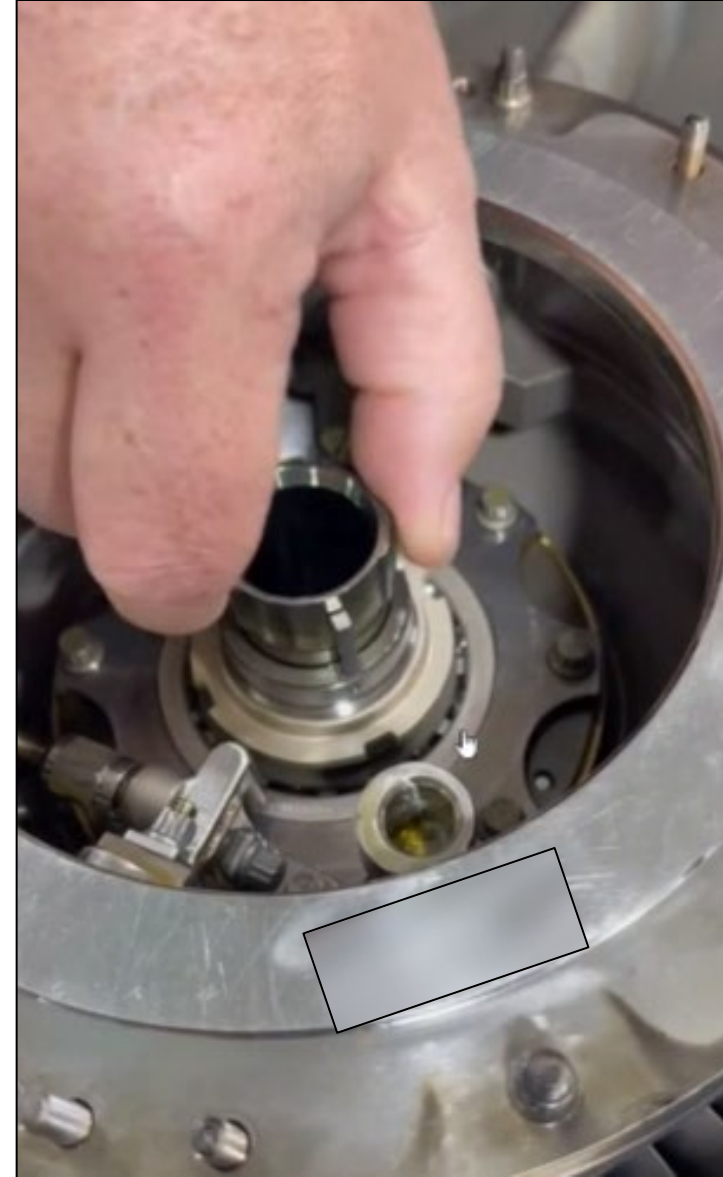
- During a routine maintenance check of the PT Shaft, the mag end of the torque sensing tube was pulled away from the tube body by hand.
- After removal of the remainder of the torque tube it was discovered that the braze joint between the mag end and tube body had failed.

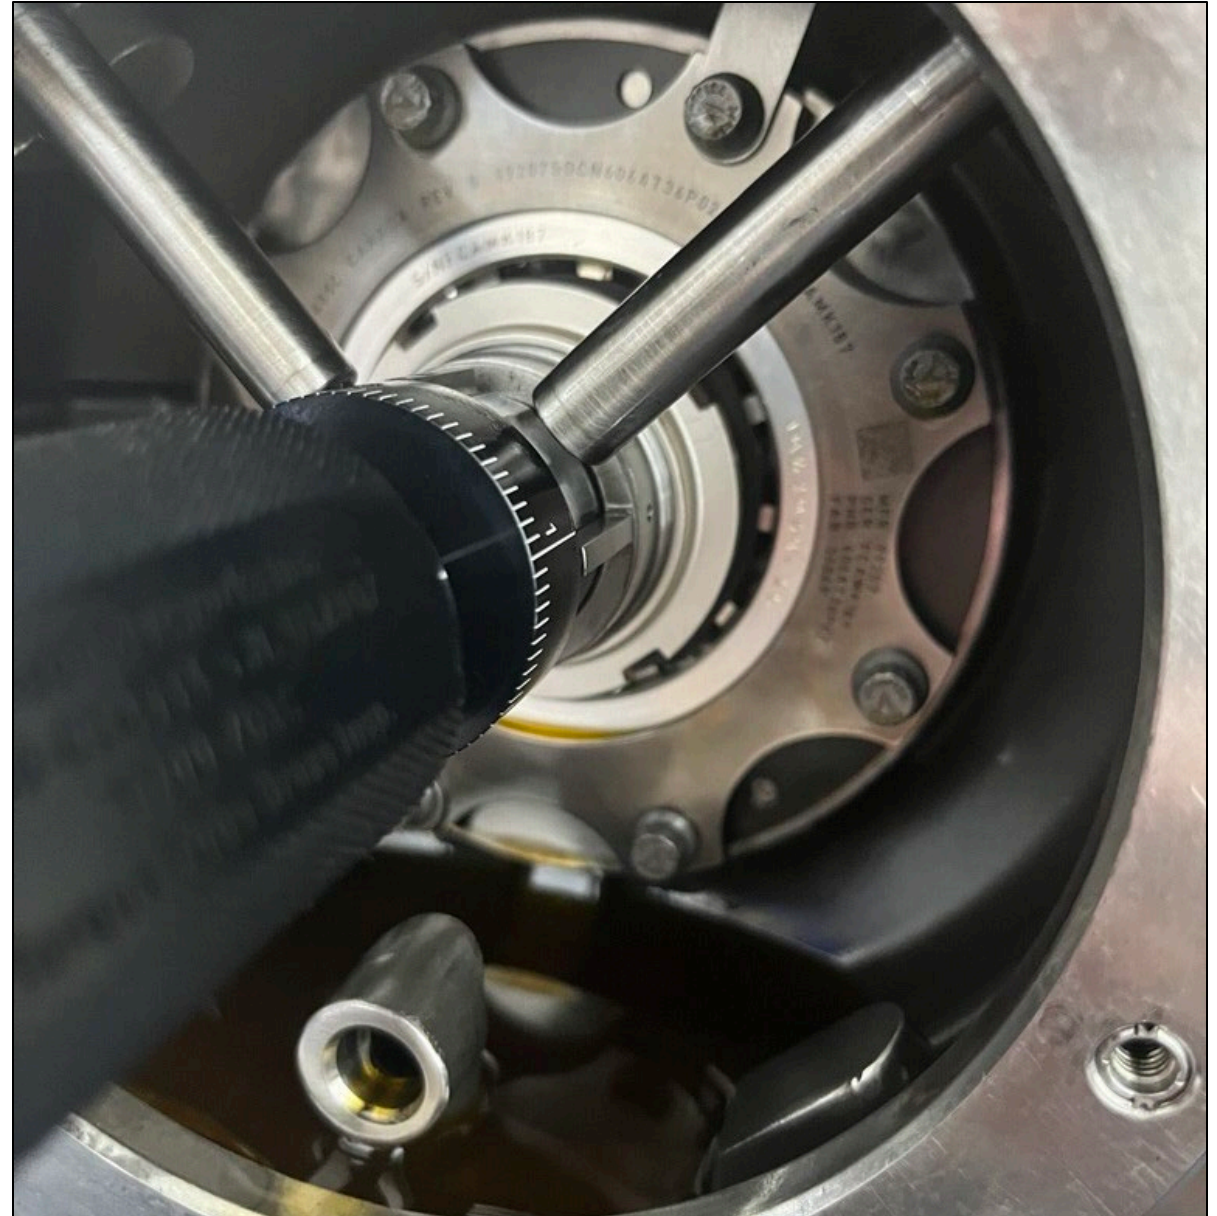
# Single Element Transducer Inspection

- Inspected by either rotating the transducer or the shaft.
- Inspection is stopped and the circumferential distance is measured between an area of braze and an area of no braze.
- Continuing circumferentially, the inspection process is repeated until 360° coverage is obtained along all 4 index positions
- An Excel Spreadsheet is used to document the distances of braze or lack of braze and used to create a map of the entire braze.
- An overall percentage of braze coverage is provided and used for reject criteria.
- Inspections begin 1 month after concern was brought to the Field NDE group at AIS at 3 different locations.

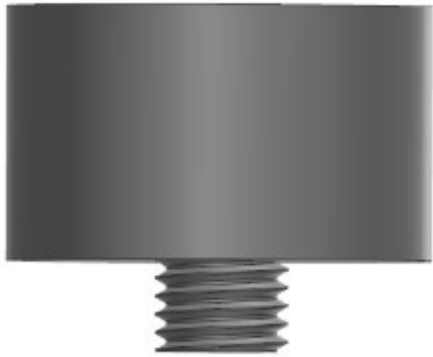
# Immersion Fixture

fixture was developed to thread into the  
Immersion Tanks table base.

This fixture allowed for the mag end to be inserted  
and keep the torque tube in the vertical position  
for an effective scan.

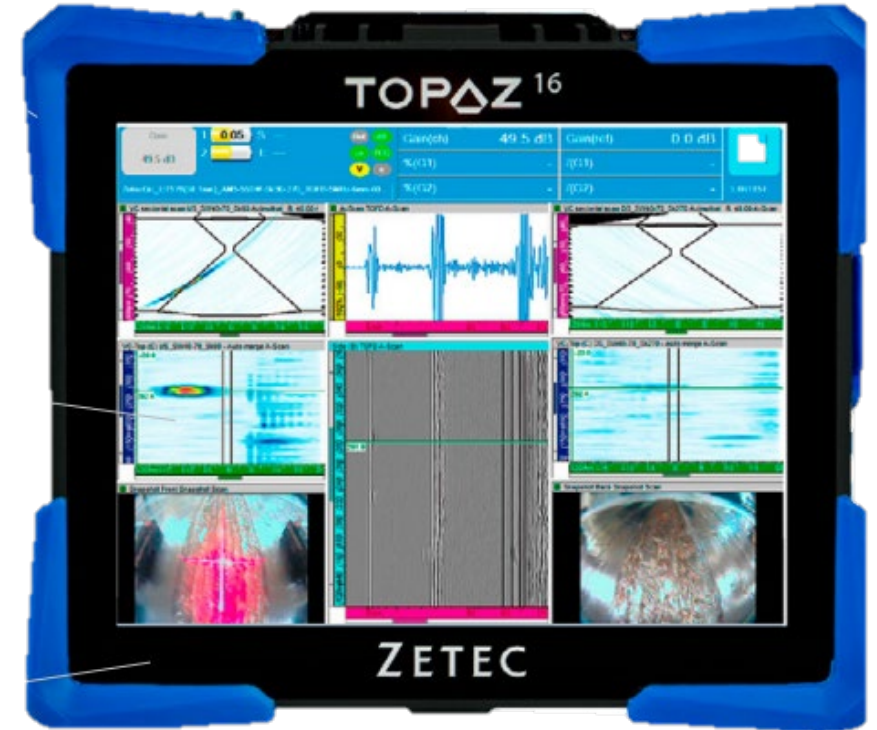
# Topaz 16

- Collaboration between Sensor Networks Inc. & Eddyfi Technologies allowed for software development specific for this inspection.
- A simple file selection sets all parameters required for the instrument to begin calibration.
