# Springfield Hail Damage Mapping

A dentCHECK® Case Study

# What Happened at Springfield

325 CRJ-900 N325PQ 15325

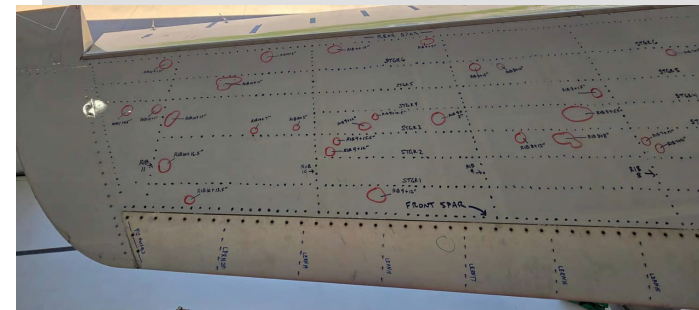
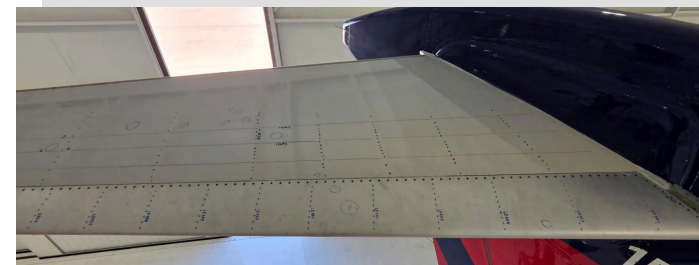
The hail event resulted in multiple dent damage across the aircraft structure, affecting numerous areas including fuselage, wings, nacelles, and empennage

Damage location overview on RH H-stab upper skin, RHS

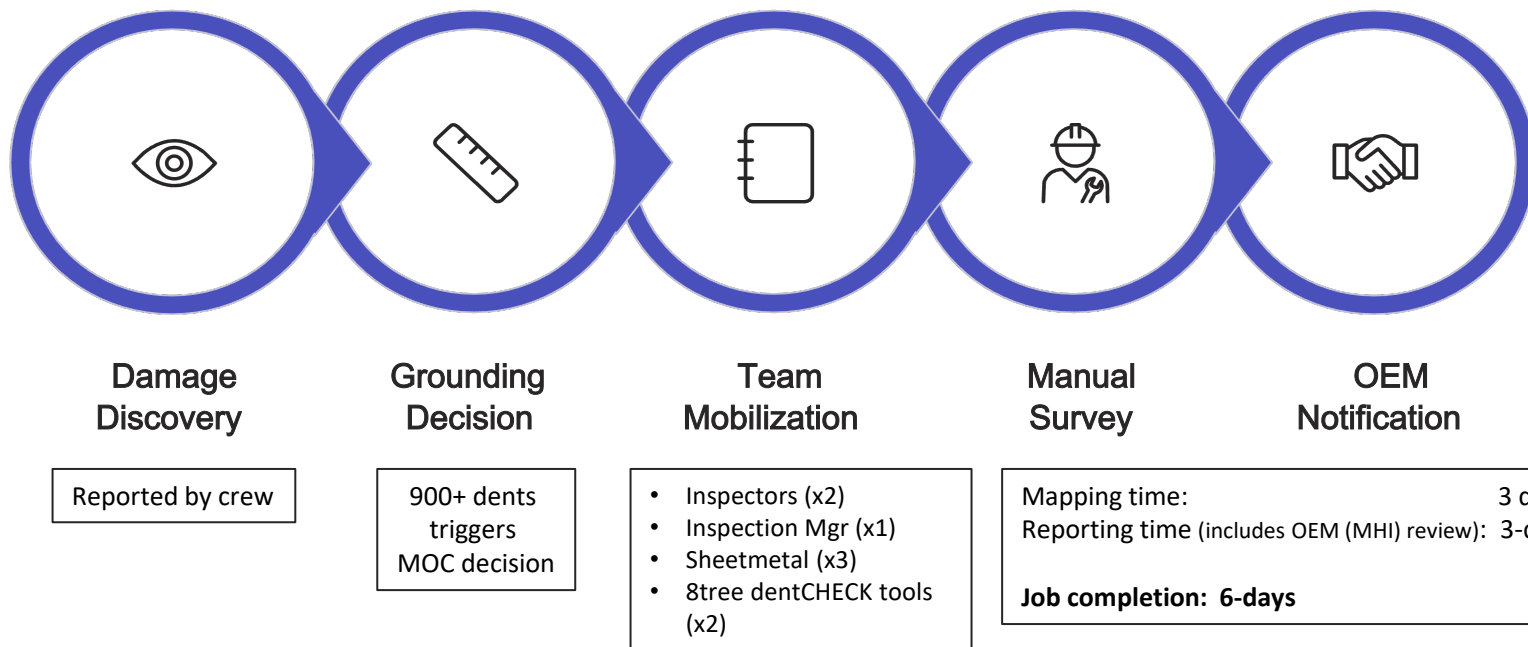
Deployed three scanners and a team of 7 to SFG to map damage and categorize by structural zones and severity.

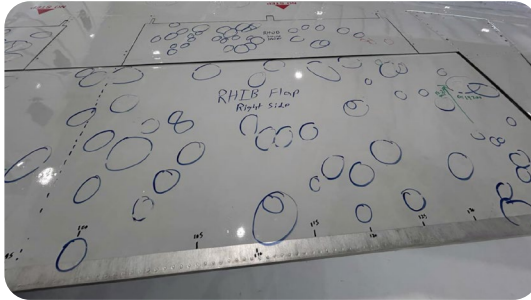
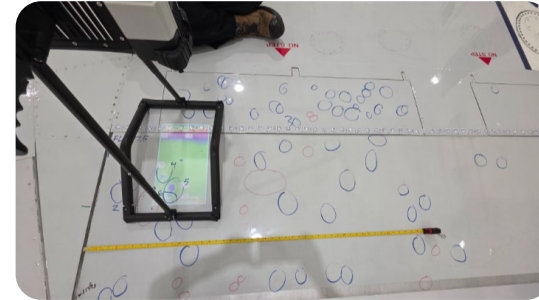
- High dent volume
- Requirement for consistent, repeatable measurement.
- Several years of dentCHECK use (for spot checks) made it a natural decision

Once on site the tool was immediately ready after a quick validation.

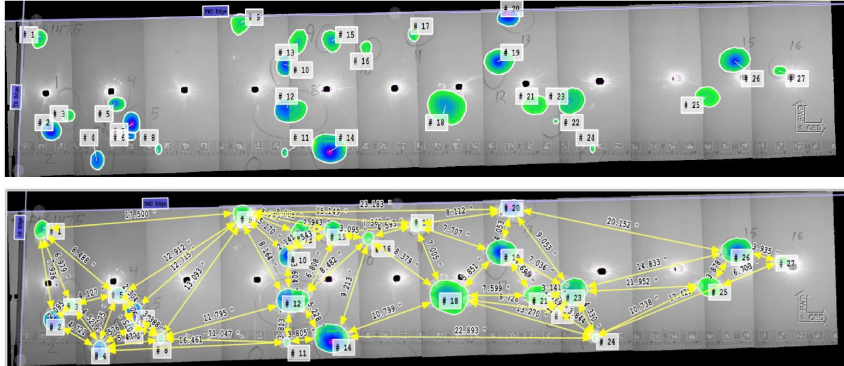
900 Plus

Took approximately 6 days to map and process reports

Full engineering package submitted for evaluation around D -5

28 Days for mapping and dent repair
