# **Validates Remote Robotic NDT for Aerospace Maintenance: Eddy Current and Ultrasonic Inspection Results**

Dr. Christian Dürager, Managing Director  
IMITec GmbH, Switzerland

## Eddy Current and Dent measurement: Damage at Fuselage STA 500C/S-20R (Boeing 737)

**Eddy Current Inspection Task 57-20-007 – “LOWER WING PLANK – WS148.00, STRINGER 8 TO 10 AND STRINGER 15” (Bombardier Challenger 650)**

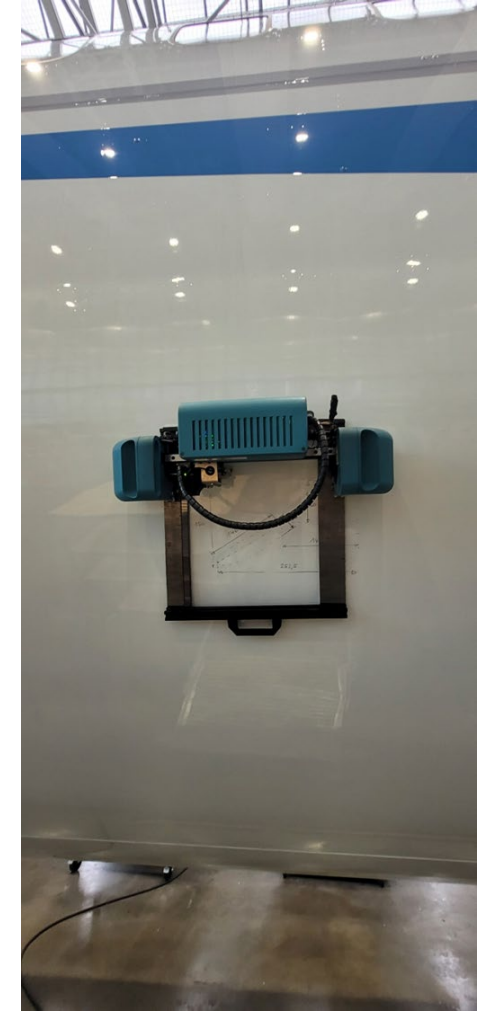
Photo of ACID on the rail frame

1. Automatic calibration on the **ET reference** standard (Al2024-T3 with 3 EDM notches) and **depth sensor** on a step wedge
2. Rails applied to the fuselage (Operator)
3. Device applied to the Rails (Operator)
4. Compensation and **Lift-off** correction on AC skin
5. Start Remote ET Inspection
6. Impedance plane data and C-Scan data transmitted to **Remote NDT Inspector** in real time
7. Afterwards, automatic **Post-calibration** on ET reference standard.

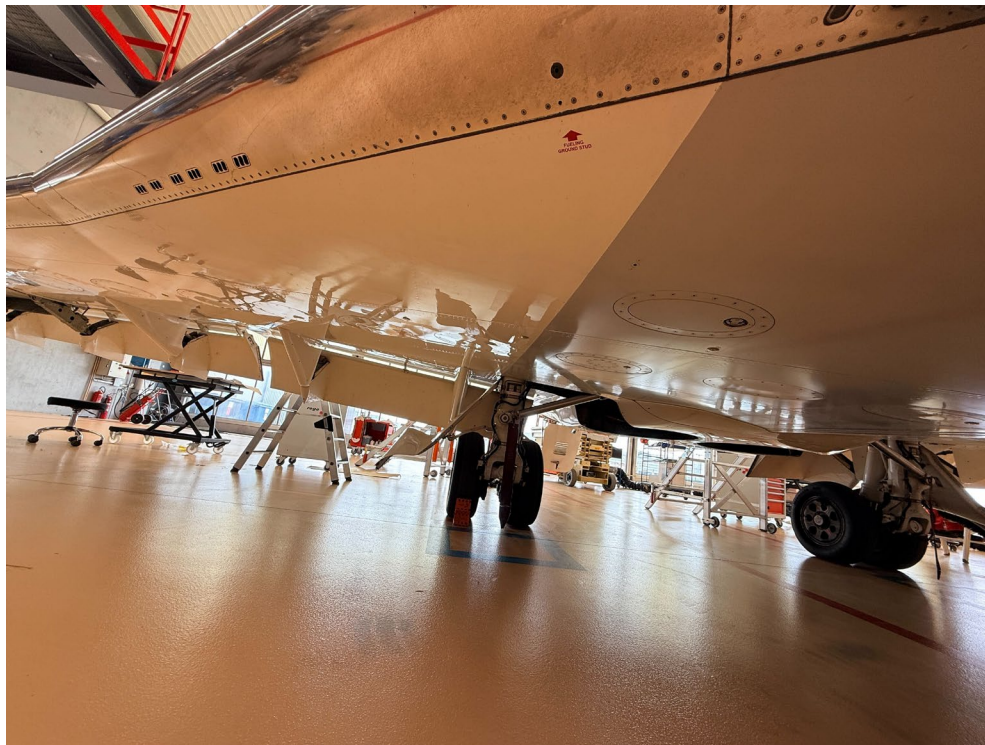
- Complete ET inspection performed at **lower wing surface**
- Inspection **remotely controlled** from IMITec office
- Communication between **Operator** (Hangar) and **Remote NDT Inspector** (Office) via mobile phone

- The remote ET device was mounted at lower wing plank
- The required inspection area was scanned by using the remote ET device
- Inspection was **controlled remotely from IMITec office** by an **NDT Level 2 inspector** qualified on EN4179
- The **ET measurement results** of the Remote scan were **cross check by manual scanning** the damage area with an Impedance plane instrument and all required standards as per Boeing NDT manual 55-10-27, Part 6, Rev. Jul 01/2016

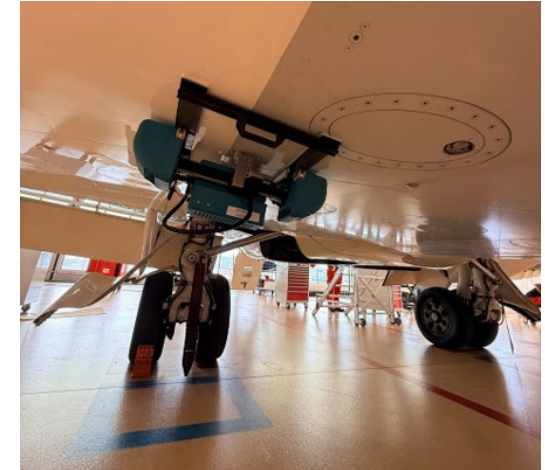
**CHALLENGER 650**  
CL-650 NONDESTRUCTIVE TESTING MANUAL  
PART 6 – EDDY CURRENT  
ET-57-20-016

- **Pre-Calibration** based on NDT manual ET 57-20-016, PART 6 – Eddy Current, Section 8
- **Lift-off compensation:**
  - Based on ET 57-20-016, PART 6 – Eddy Current, Section B
- **Post-calibration**
  - Based on ET 57-20-016, PART 6 – Eddy Current, Section B

**NOTE:** The instrument settings listed may vary from instrument to instrument.
