# Inspections After Blending-out Scratches on Aircraft Fuselage Made of Aluminium Alloy

A4A NDT Forum 2026

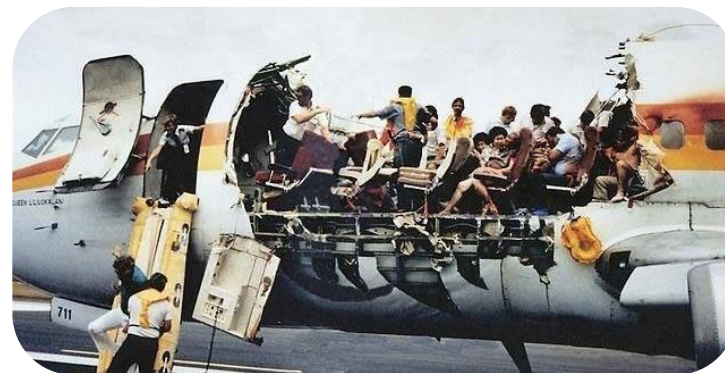
Aloha Airlines Flight 243 - Boeing 737-200 - 04/1988  
Cause: fatigue cracks + corrosion [2]

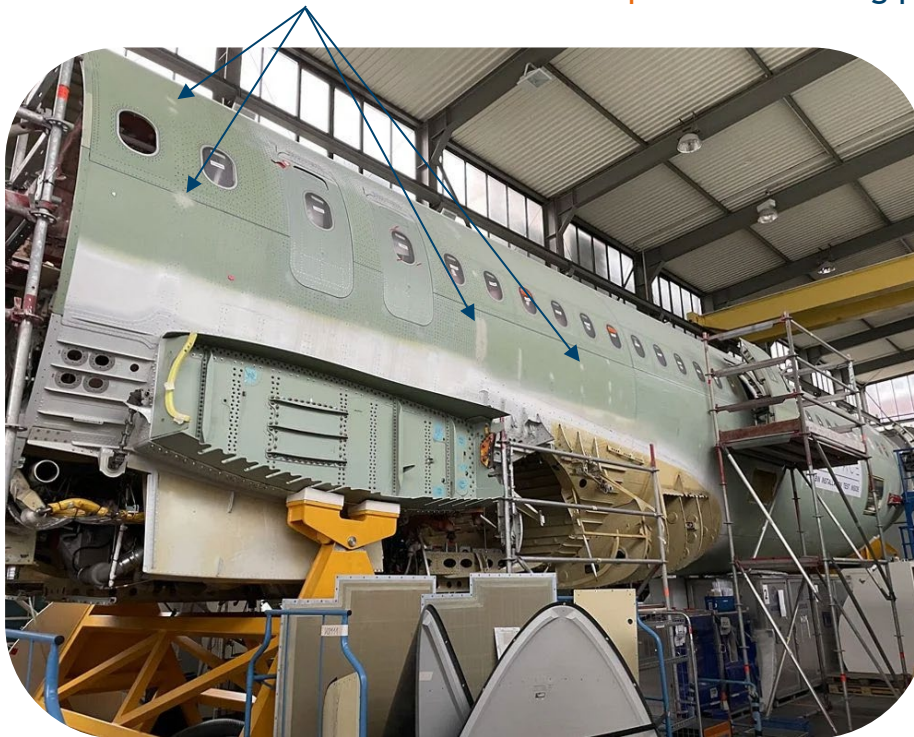
Any accidental **scratch** must be **blend-out** then the areas must be **inspected** following procedures...

AITM6-6002 (ET)

AITM6-4016 (UT)

in **production**

NTM 51-10-30 (ET)

NTM 51-10-04 (UT)

in **maintenance**

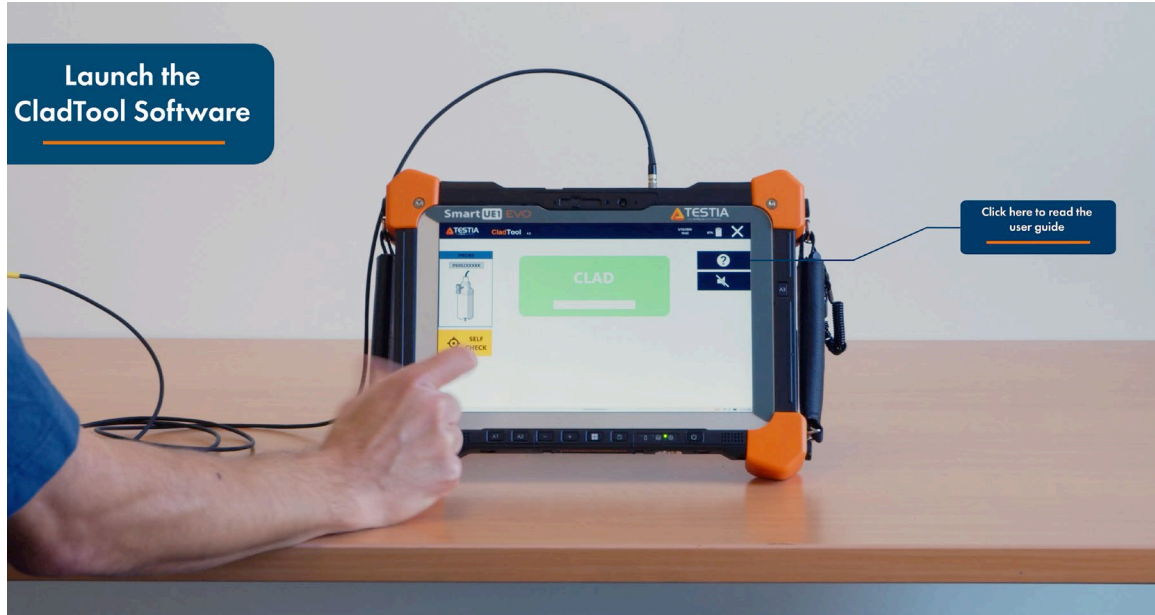
### 3.3.1. Tailored solution for Level 1 Limited

Ref. block  
2024

Instrument  
SmartUE1

Software  
CladTool

ET probe  
2MHz

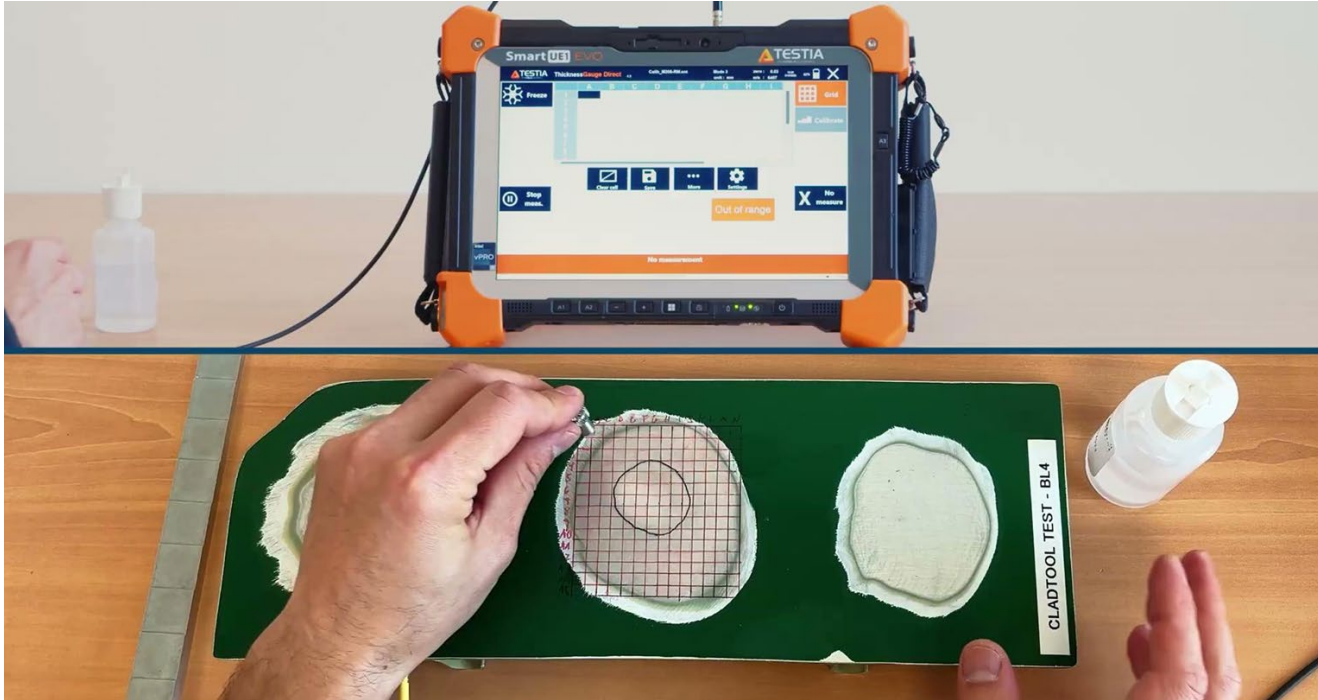
### 3.3.1. Tailored solution for Level 1 Limited

Instrument  
SmartUE1

Ref. block  
2024

Software  
TG\_direct

UT probe  
20MHz

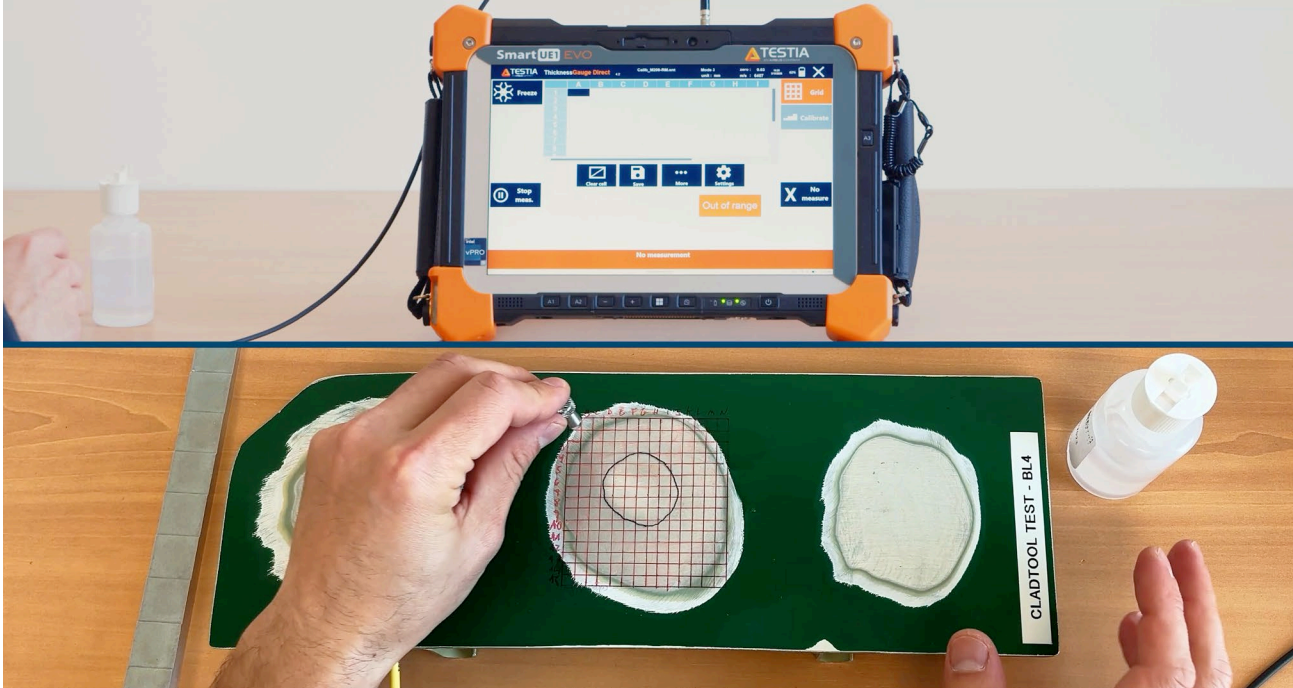
## 3.3.2. Tailored solution for Level 2

Instrument  
SmartUE1

Software  
Galvano

ET probe  
2MHz

Ref. block  
2024
