CFM56 TRF Eddy Current

Sam Tucker
NDT Process Engineering
SFOEP

2015 A4A NDT Forum
Fort Lauderdale, FL

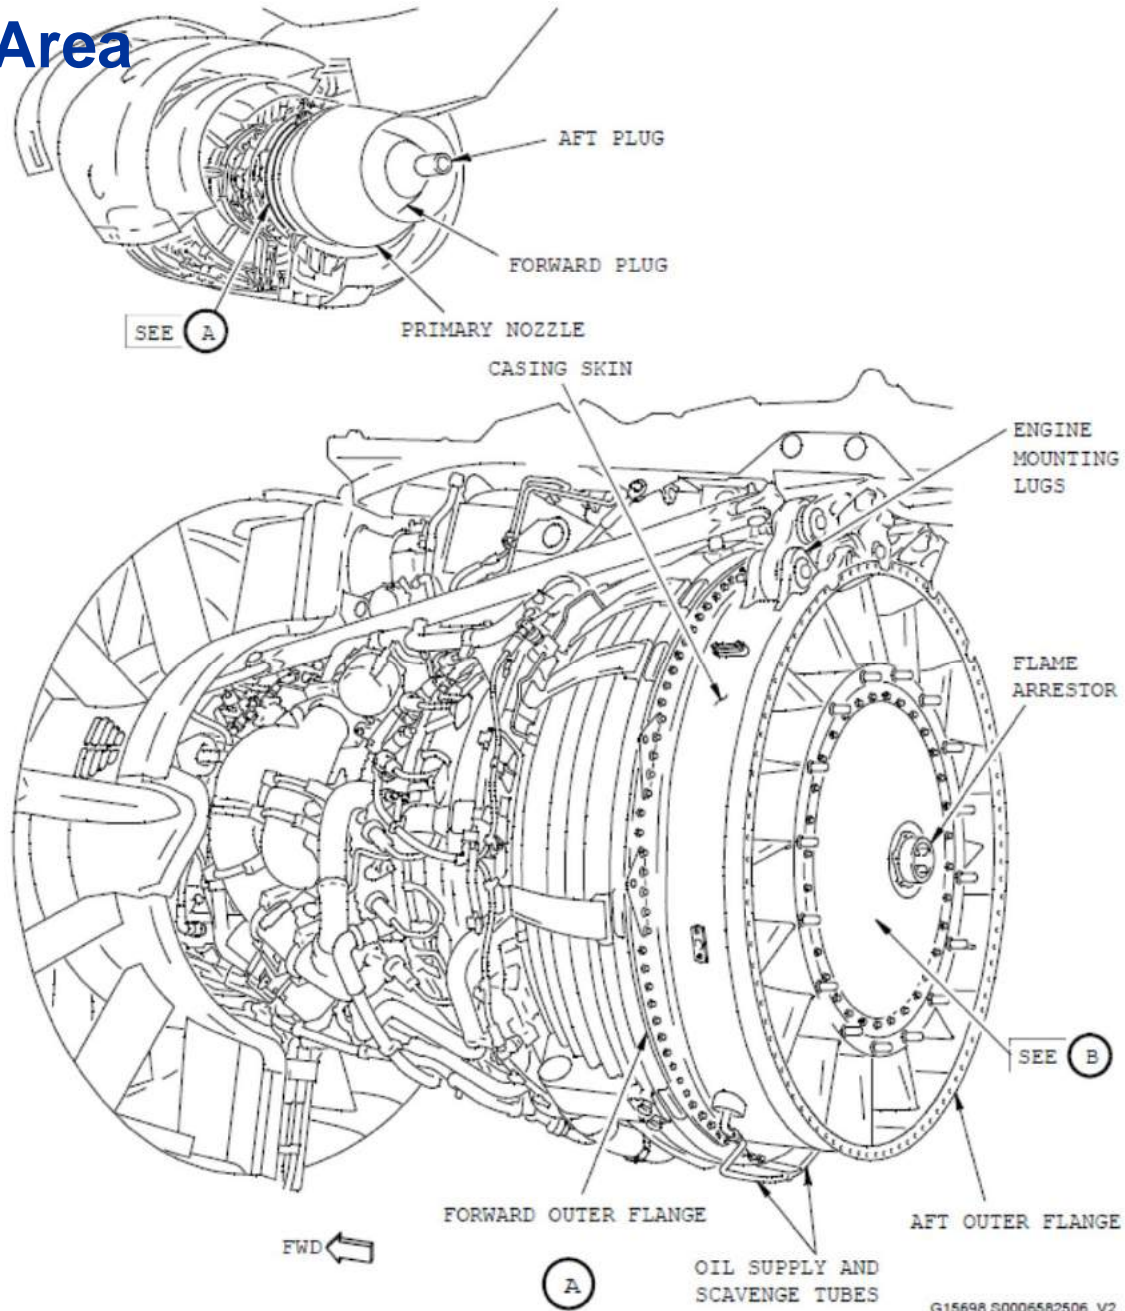
Inspection Area

CFM SB's 72-0568 and 72-0579 provide the inspection details for the repetitive on-wing eddy current inspections. SB effectivity is dependent upon TRF part number. AD is applicable only to part numbers in SB 72-0579 .

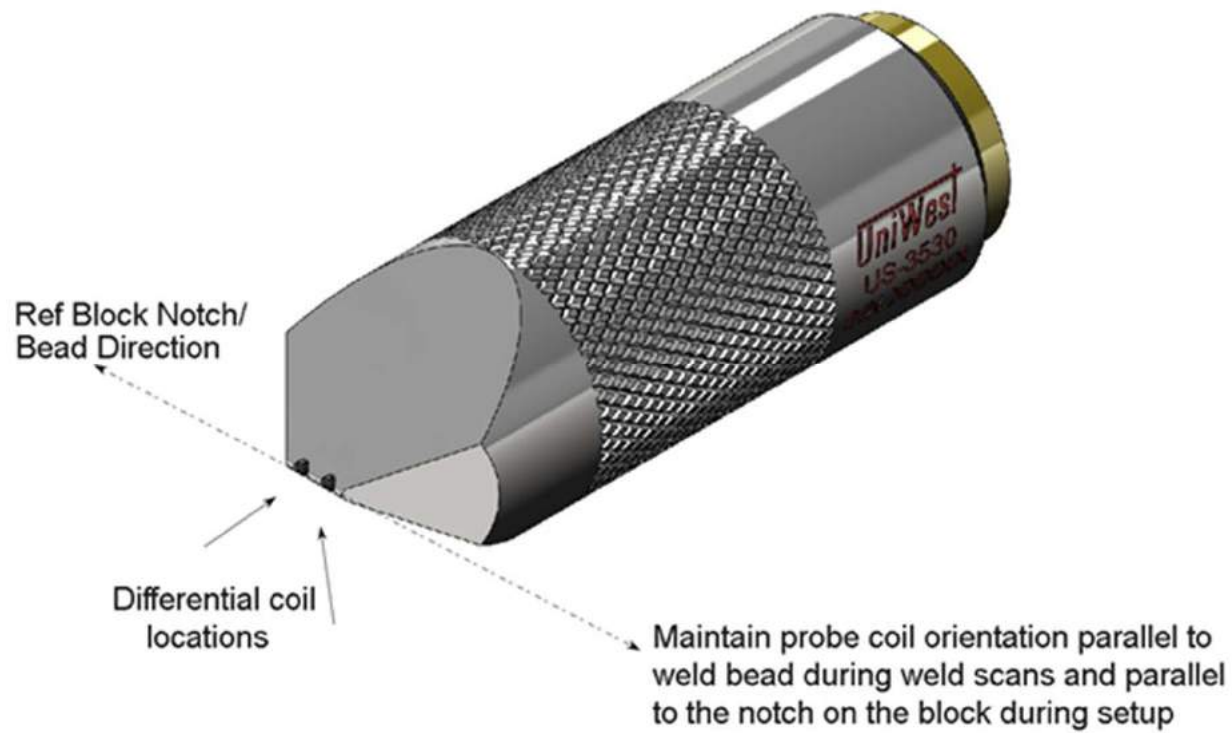
We need a shorter version- Uniwest comes through with US-3530
