Inspection and Teardown of Aged In-Service Bonded Repairs

Waruna Seneviratne, John Tomblin, and Brandon Saathoff

National Institute for Aviation Research (NIAR)
Wichita State University (WSU)

2018 Airlines for America NDT Forum
Seattle, Washington
September 18, 2018

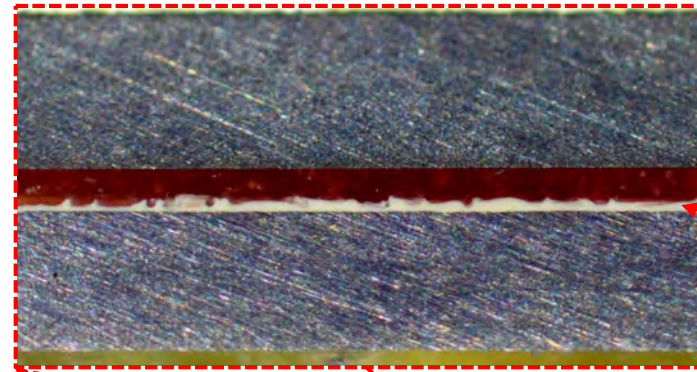
C14-RA-1 Cross-Section

← Doubler (External Patch)

← Adhesive

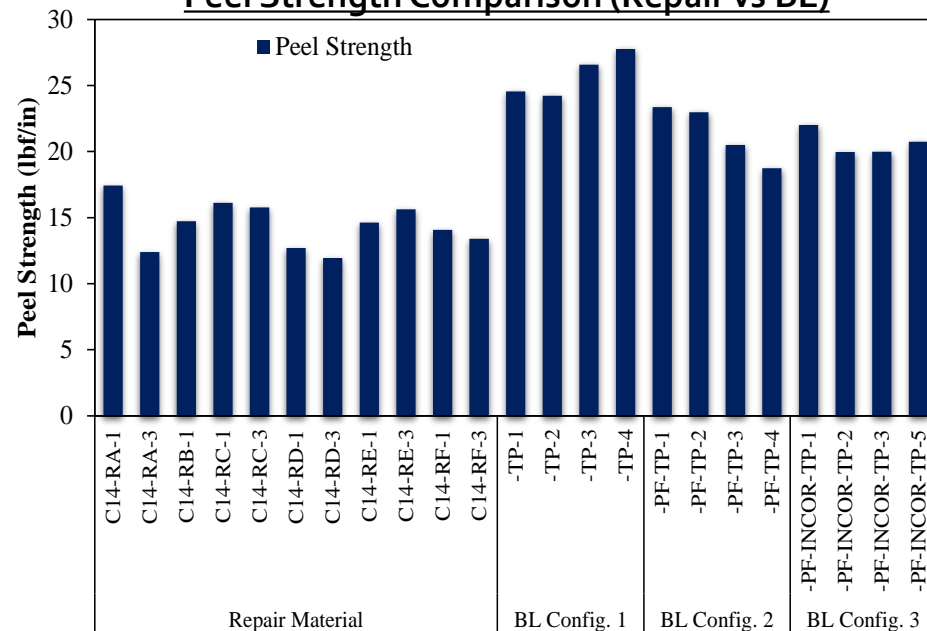
Peel Strength Comparison (Repair vs BL)

- T-Peel (ASTM D1876)
 - Repair Peel Strength: $\approx 64\%$ of BL panels
 - Repair failure along interfacial anomaly
 - BL specimens: Cohesive failures

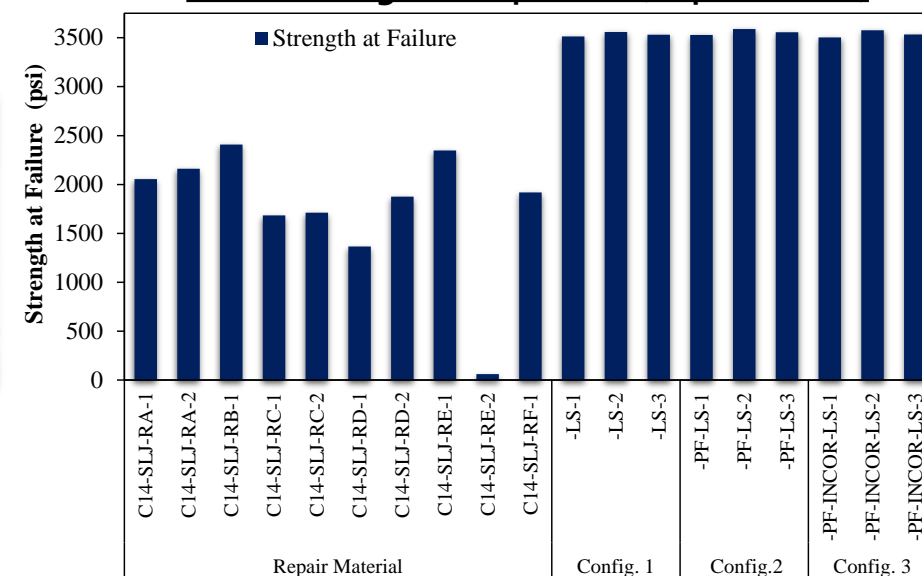
Shear Strength Comparison (Repair vs. BL)

- Lap-Shear Testing (ASTM D3165)
 - Repair Shear Strength at failure: $\approx 50\%$ of BL panels
 - BL specimen failure controlled by adherened tensile strength
 - Repair specimens: Adhesive failure (primer)

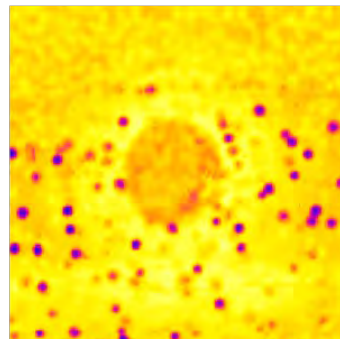
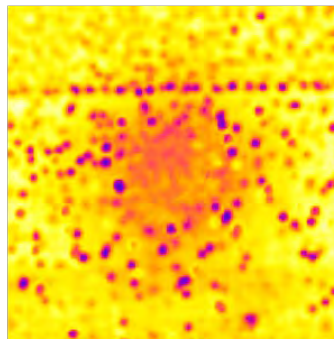
Repair 4F

- Structural Level Inspection Findings
 - Visual
 - Repair extended away from surface (not fully flush)
 - Paint Cracking
 - Speckling pattern noticed in many repairs and surrounding structure (Component 4 & 9)
 - Known that honeycomb structure can exhibit long-term degradation due to thermodynamic effects of trapped moisture in the honeycomb cells
 - Note that this can be evaluated away from the repair as it is seen in parent structure

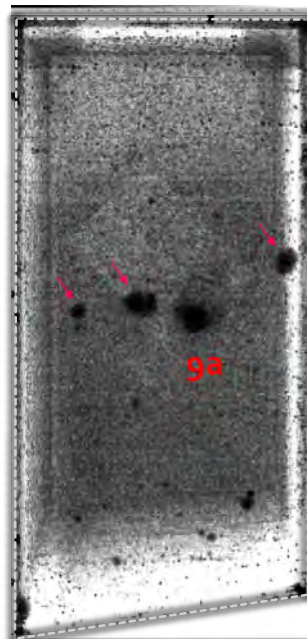
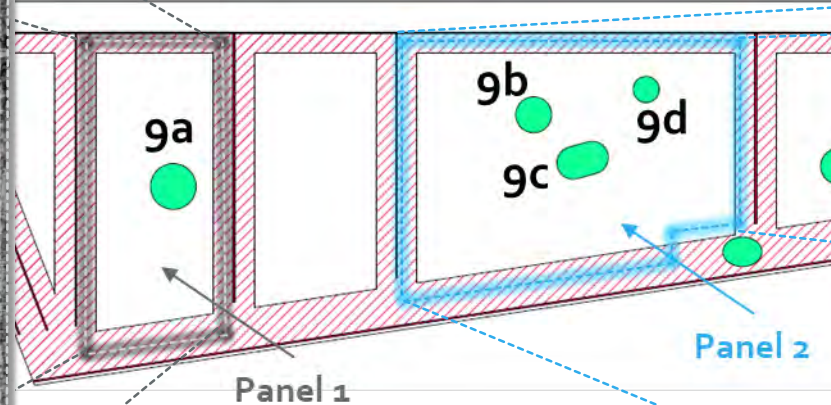
Component 9 TTU C-scans

- Inspection Findings
 - Large amount of indications outside of repair regions
 - High levels of attenuation in center of repairs
 - Not representative of a core plug (potting compound used)

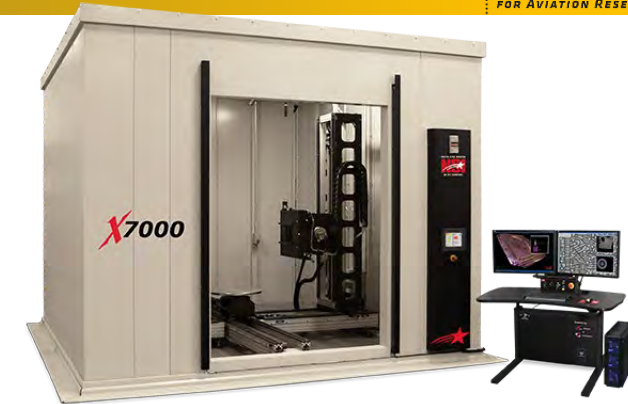
- X-ray CT Inspections
 - A clean repair and a repair with multiple indications was inspected
 - Repair 3e – No Speckling Pattern in Resonance C-Scans
 - Repair 9b – Speckling Pattern in Resonance C-Scans

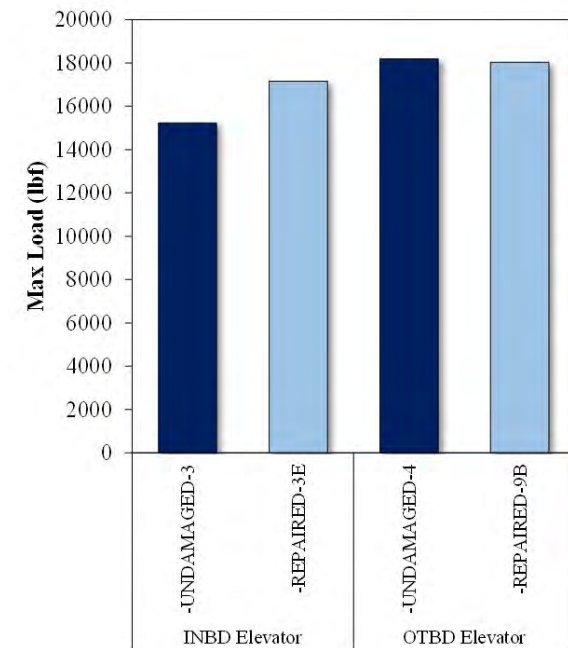
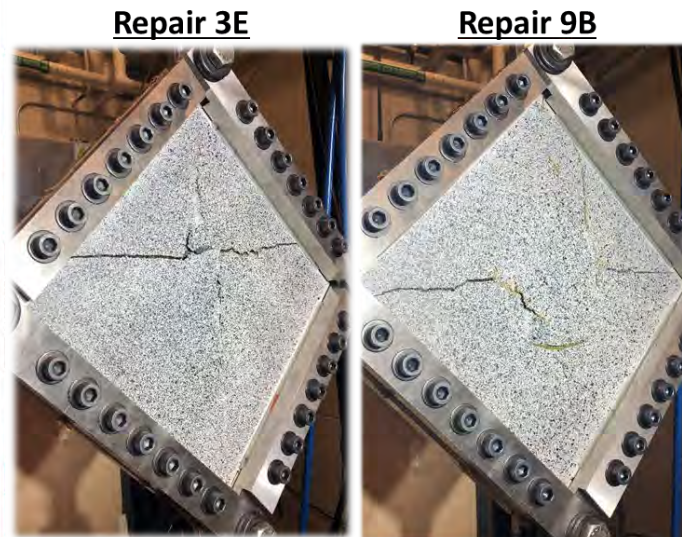
- No significant loss in strength witnessed
- Repair 9b popped away from parent material with no failure through patch material
- Repair 3e failed through repair patch material

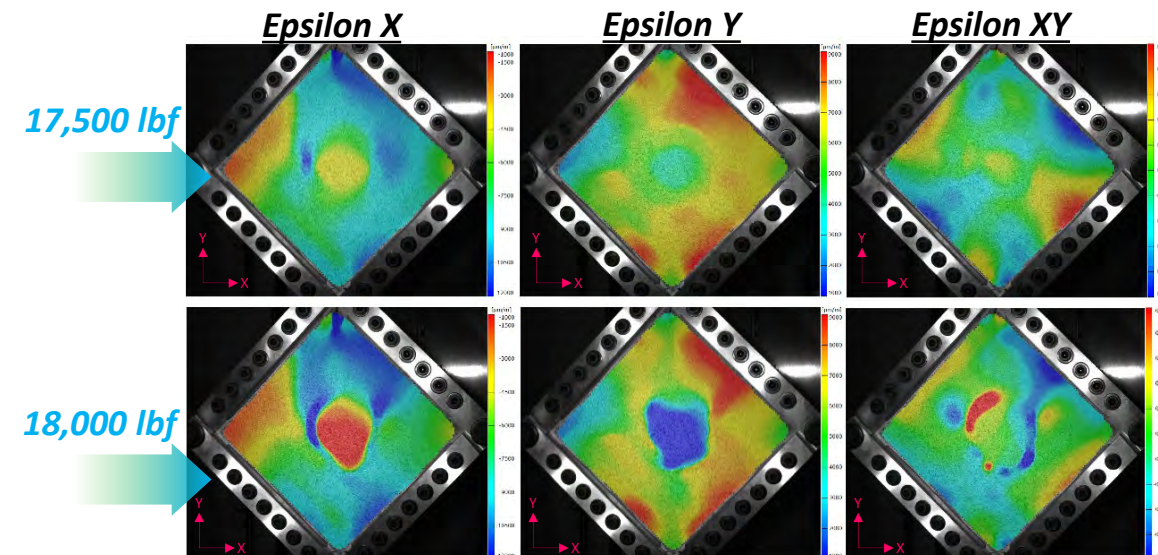
Repaired (Repair 9B) – ARAMIS

- Failure through void in potting compound allowing patch separation from core
 - Speckling further investigated following completion of testing and removal of repair patch

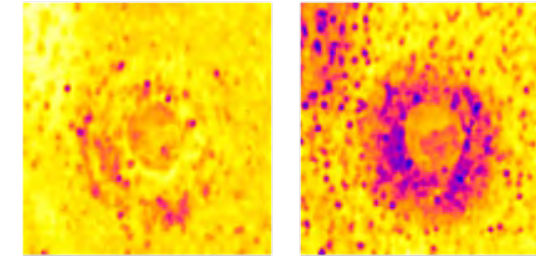
Potted Core Region of Repair

- **Post-test teardown of PFS Elements**
 - Evaluation of speckling pattern noted in NDI results on Component 4 and 9
 - Build-up of material in honeycomb cells stemming from external facesheet (top and bottom skins)
 - Green in color and small levels witnessed on internal facesheets
 - Less defined on lower skin
 - Random distribution
 - Located in specific regions on the components
