## Use of X-Ray for 717 Wing XRS 164, Lower AFT Skin Cracks

# 717 XRS 164, Lower AFT Skin Cracks

## Background

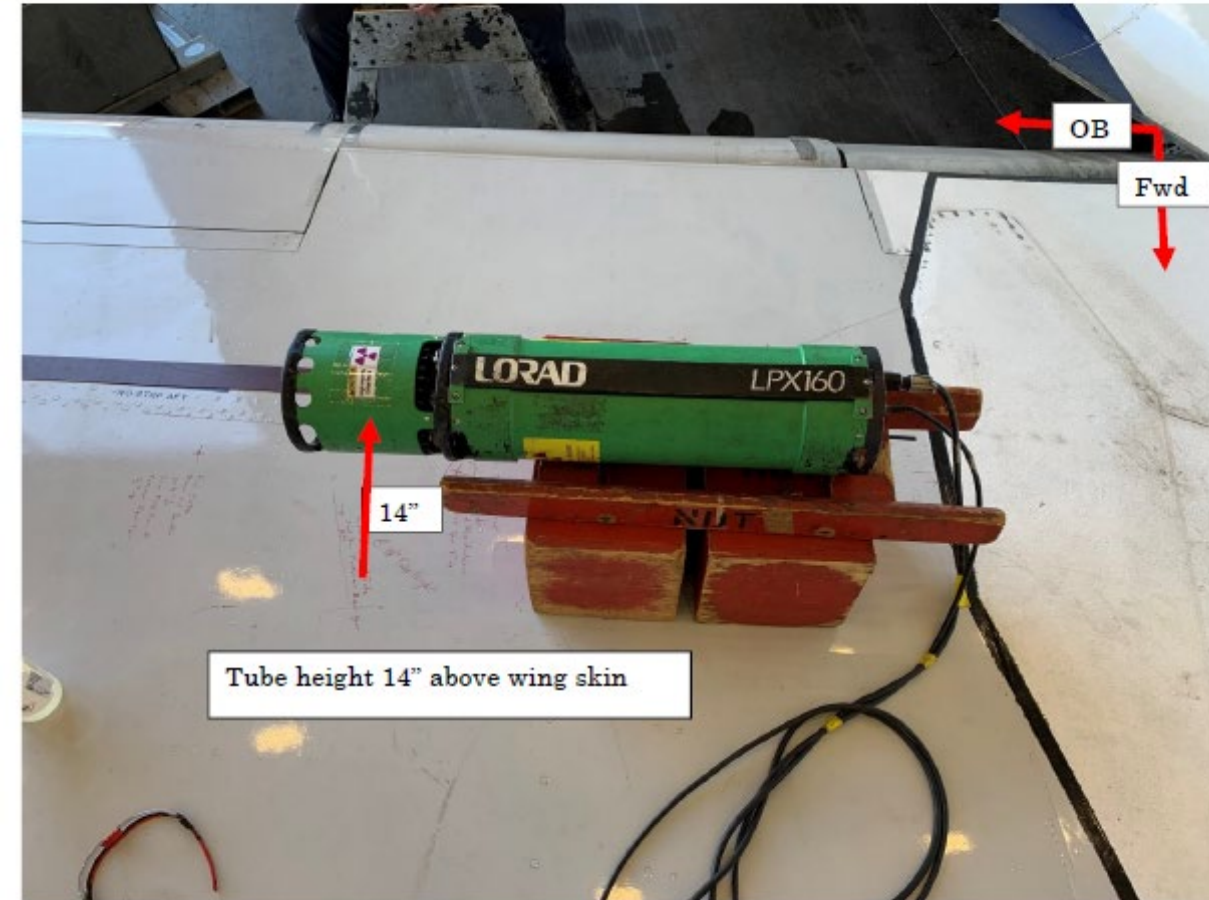
Tube Placement, Wing Upper Surface

This inspection is a set of double-wall exposures with single-wall evaluation of the lower wing skin through the upper wing structure.

This procedure is intended to find 0.25 inch and larger thru-thickness cracks in the lower wing skin that originate at the fasteners of interest.

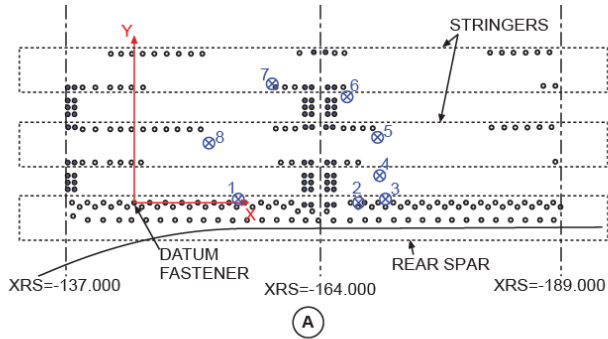
- NOTES:
- ⊗ X-RAY SOURCE APPROXIMATE POSITIONS
  - RH WING SHOWN, LH WING IS MIRRORED
  - SOURCE POSITIONS ARE APPROXIMATE; REFER TO TABLE 1 FOR EXACT POSITIONS IN X AND Y COORDINATES
  - SOME FASTENERS MAY NOT BE VISIBLE FROM THE UPPER WING SURFACE DUE TO PAINT AND OTHER CONDITIONS
- X-Ray Source Locations
