# 737NG Failsafe Strap STA 663 PZT Detection

Walt Jarecki, ATF, Aircraft Inspection - Customer Support

Zeb Tidwell, ATF/E-UM, Airframe Engineering - Customer Support

# STA 663.75 Frame Fitting and Failsafe Strap - Inspection

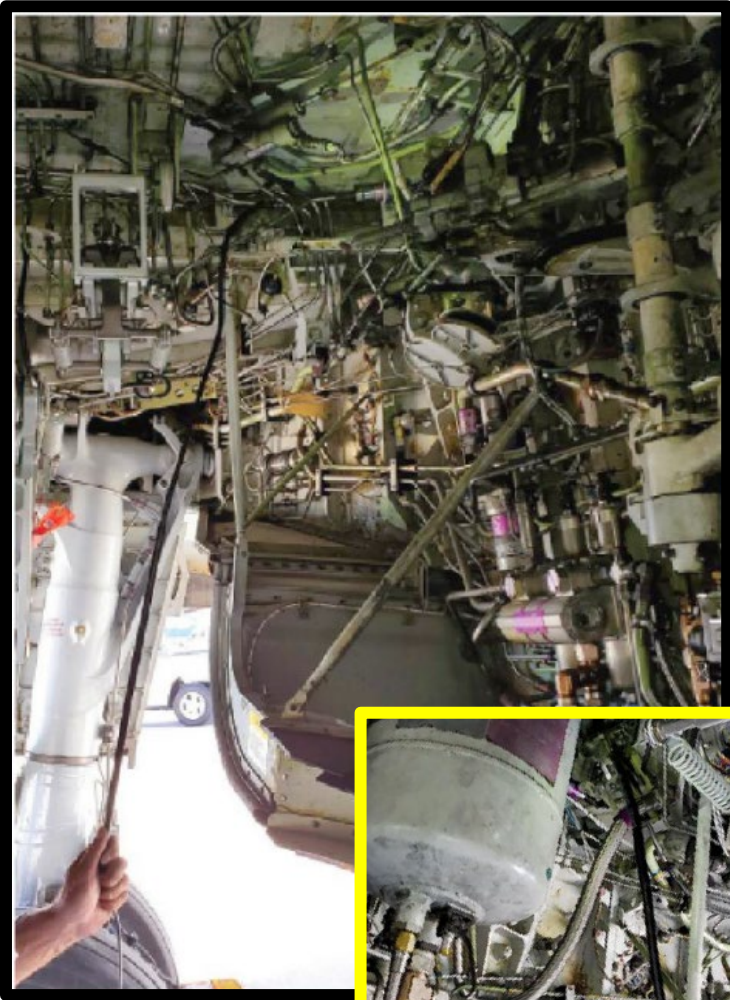
LHS

Do an internal Detailed Inspection of the frame fitting and the visible portion of the failsafe strap at STA 663.75 left and right side for any crack.  
1500 cycle repeat

This appendix is provided as an aid for the internal Detailed Inspection requirement. It shows the Olympus GX Borescope as an acceptable tool to do the Detailed Inspection in FIGURE 1 and FIGURE 2. A borescope inspection equipment that is an approved equivalent is acceptable to use to do the Detailed Inspection in FIGURE 1 and FIGURE 2.

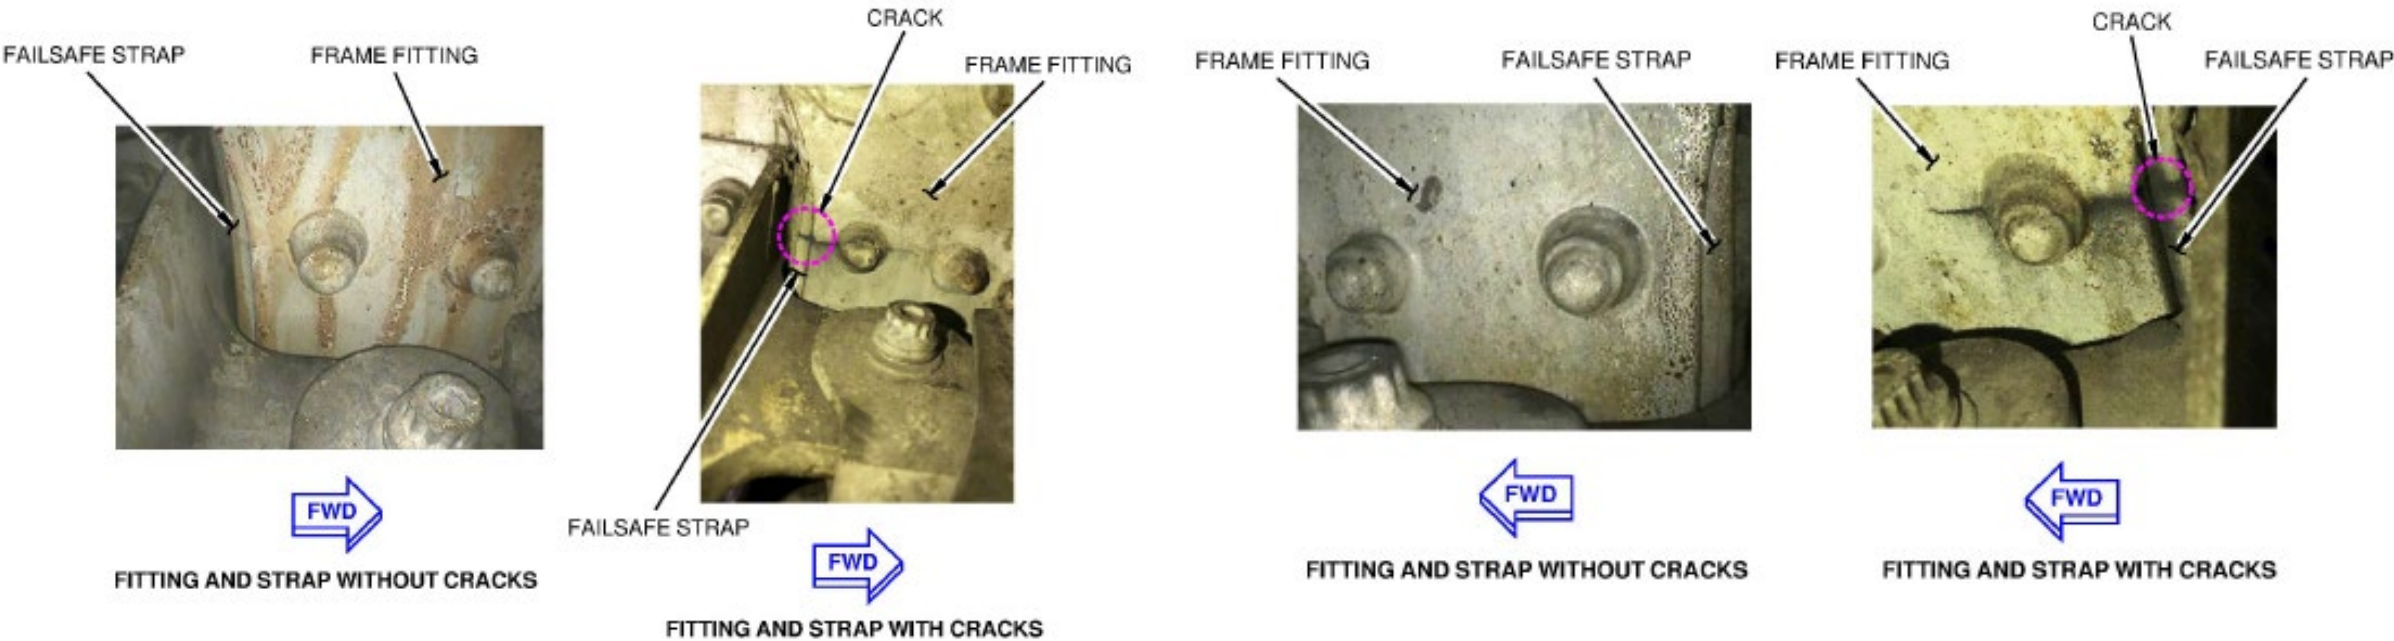
Examples of internal Detailed Inspection of the frame fitting and the visible portion of the failsafe strap at STA 663.75 left and right side for any crack.

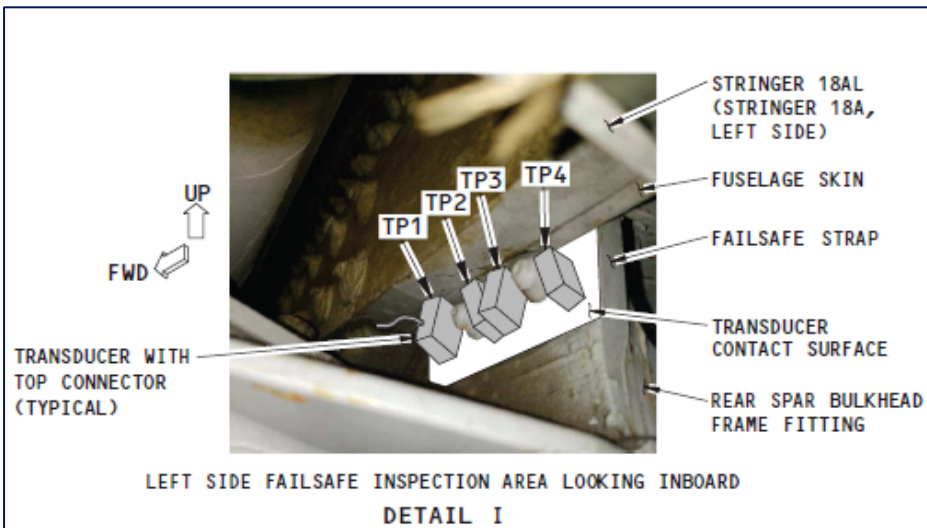
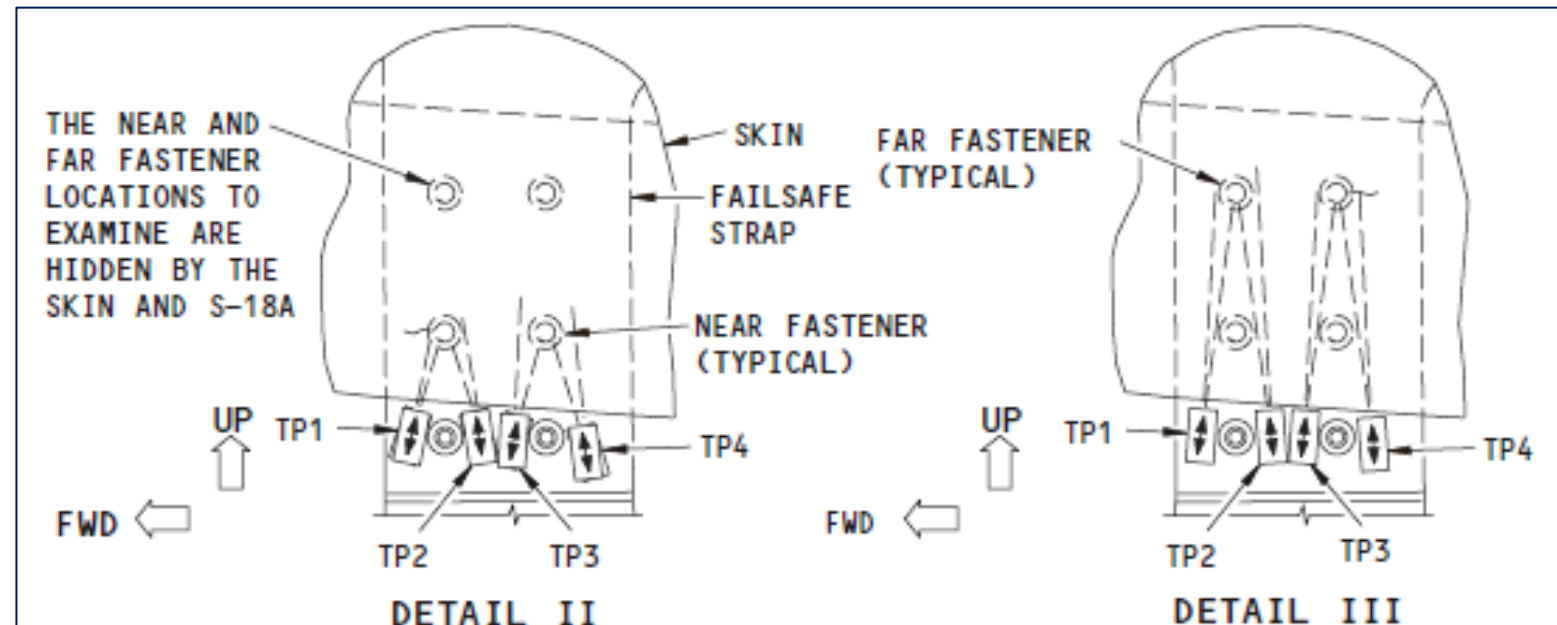
Do an Ultrasonic (UT) inspection (737 NDT Manual Part 4, 53-10-16) of the failsafe strap at STA 663.75 left and right side for any crack.

2000 cycle repeat, UT Lndi = 0.34 inches Thru Thickness at hole

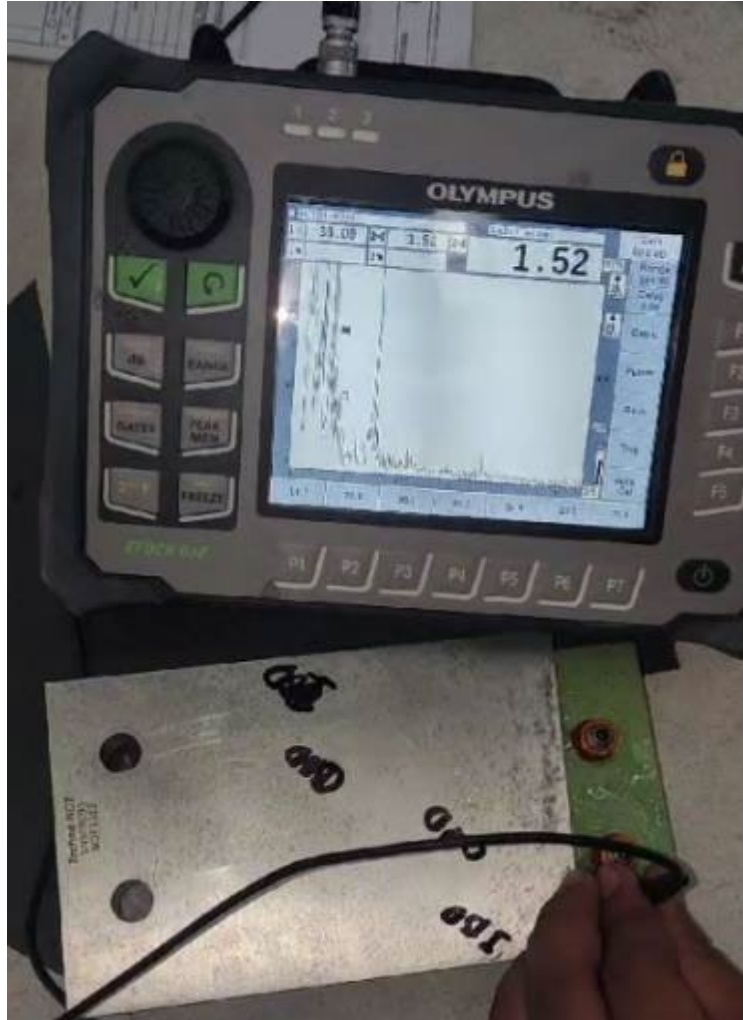
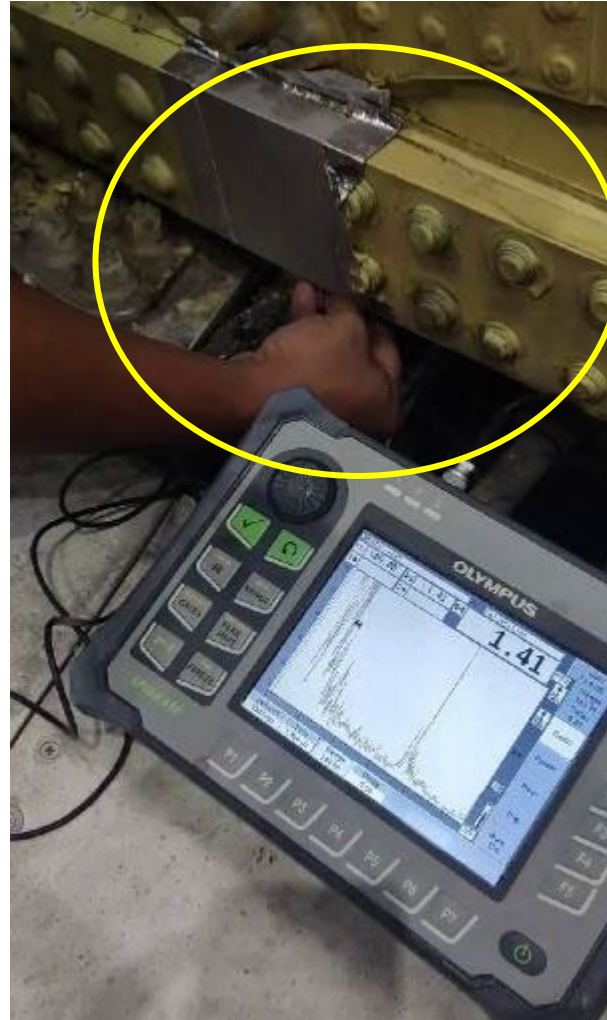
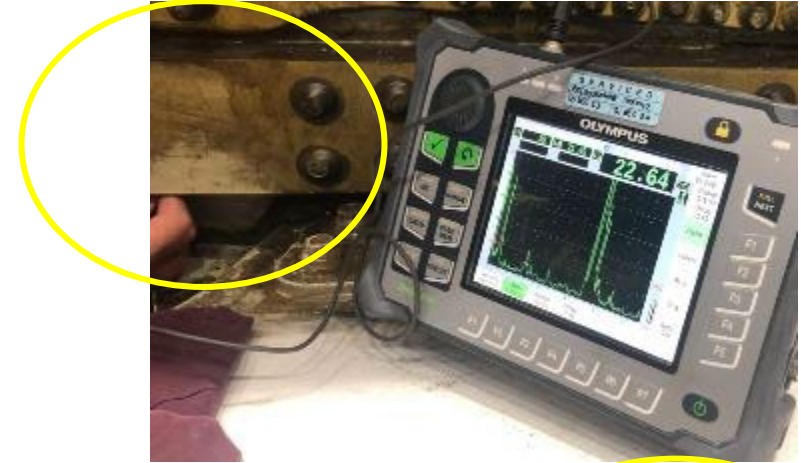
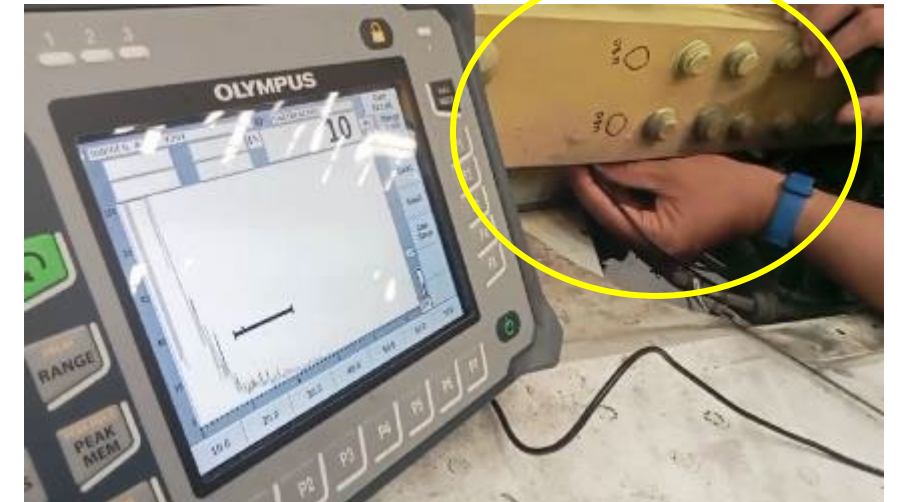
Examples of Ultrasonic (UT) inspection (737 NDT Manual Part 4, 53-10-16) of the failsafe strap inspection

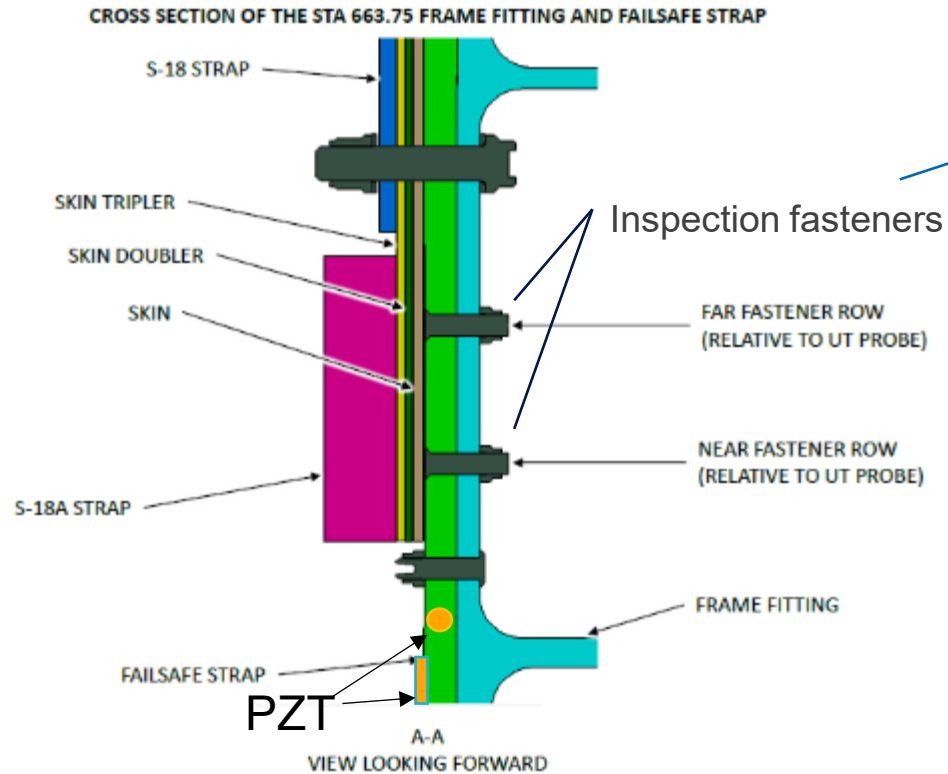
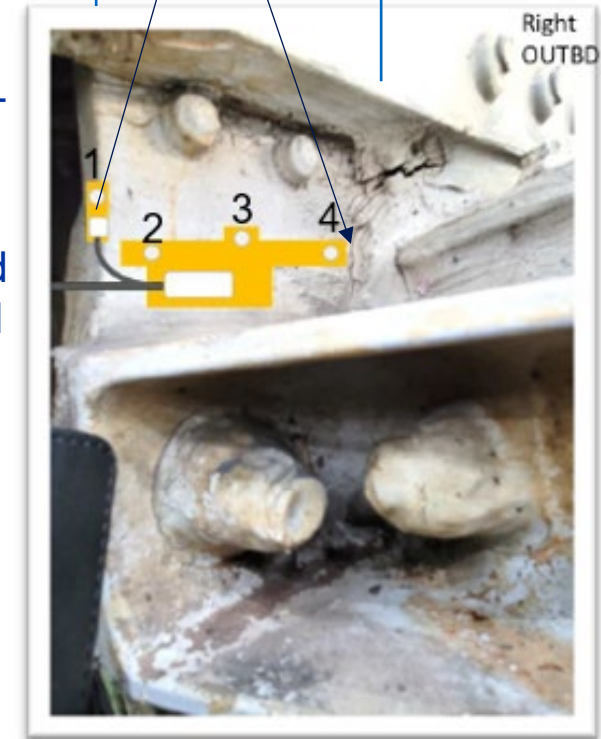
- Sensors installed outside current UT inspection zone
- Pulse-echo guided waves propagated into far side fasteners and measured by PZT

**Designed to detect any cracks from the four fasteners on Failsafe Strap**
