A4A NDT Forum 2019 Long Beach

Magnetic Particle Inspection of Low Pressure Turbine Shafts

Christian Kalbfell | Lufthansa Technik AG | Engine Services | Sept. 2019

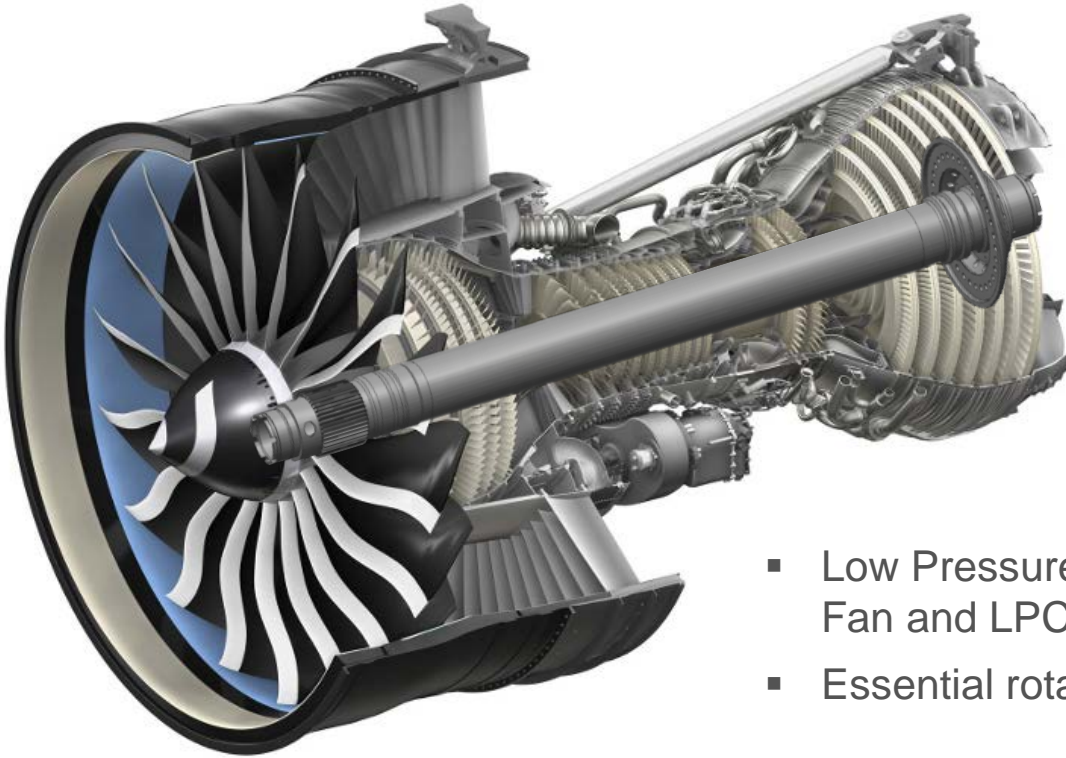
Where to find the LPT Shaft in the engine?

- Low Pressure Turbine Shaft connects Fan and LPC with LPT
- Essential rotating part in jet engine

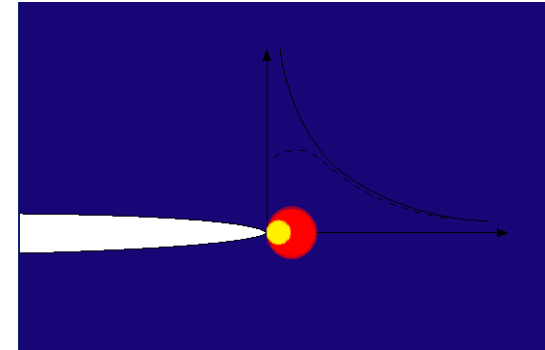
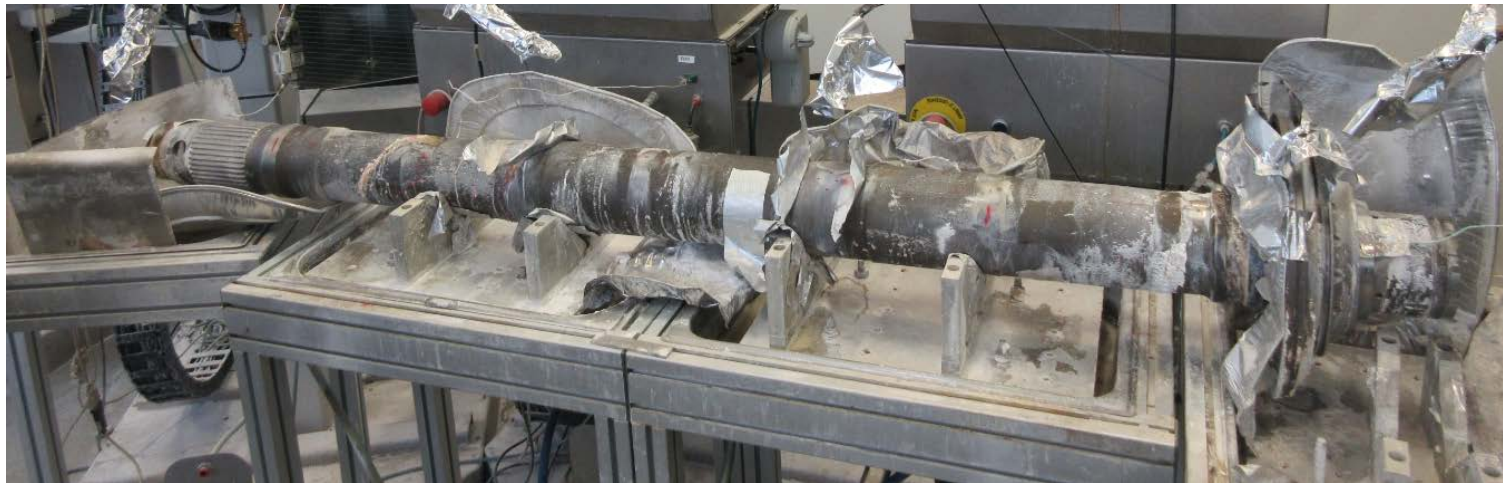
Cracks with in-situ thermal fatigue

Real fatigue cracks manufactured caused by thermal fatigue

- Repeated heating and cooling
- Thermal stresses
- Fatigue
- Cracks

Process of real fatigue cracks manufactured into the shaft

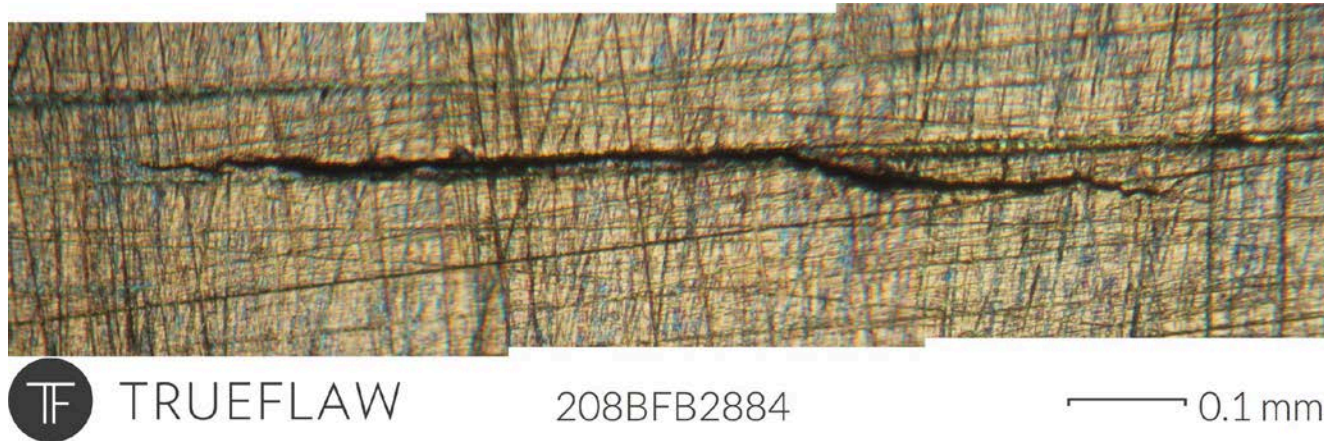
Real cracks are necessary

- In developing new methods and application solutions
 - ➔ to see what the method can really do
- In training and maintaining proficiency
 - ➔ to let inspectors know what to look for
- In reliability analysis and performance demonstration
 - ➔ to get reliable and realistic estimates

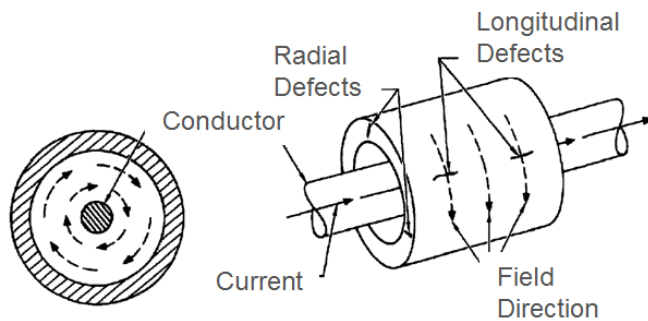
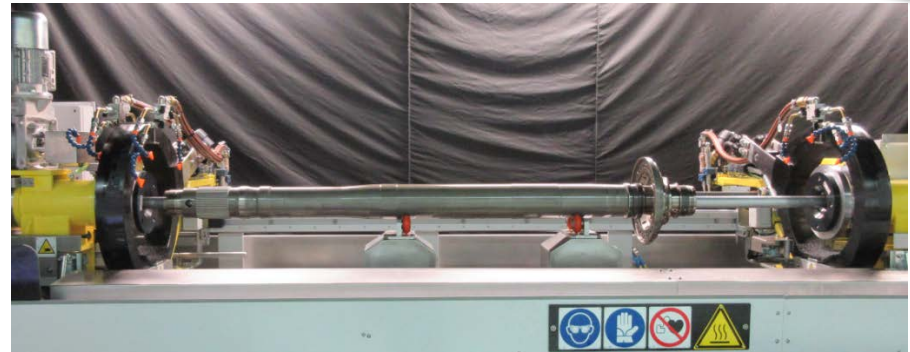
- Step 1 - Circular magnetization by concentric central conductor of inner part
- Step 2 - Circular magnetization by concentric central conductor of outer part

Using full-wave
rectified
alternating
current-FWAC
monophase

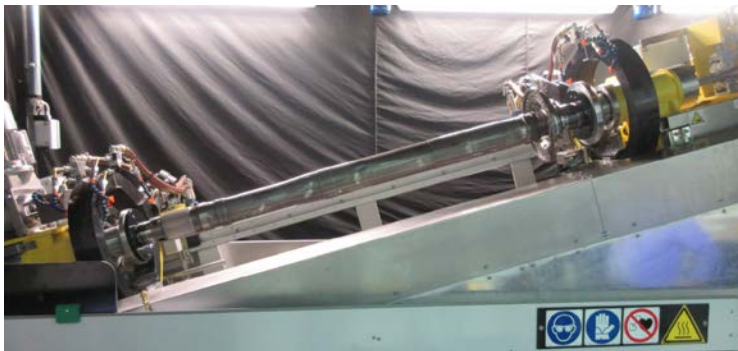
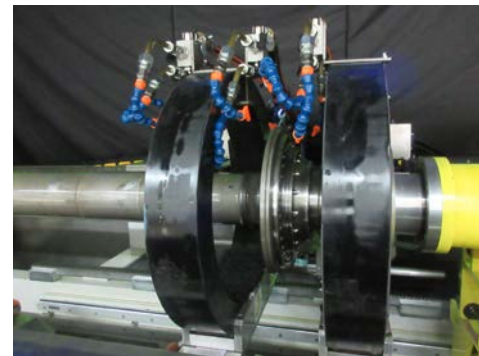
- Step 3 - Circular magnetization of flange area

- Step 4 - Demagnetization of the part

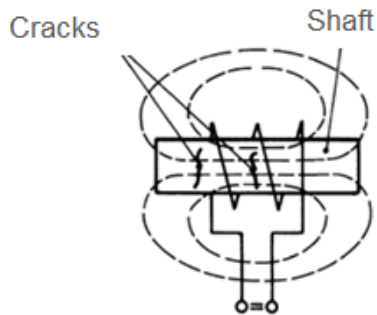
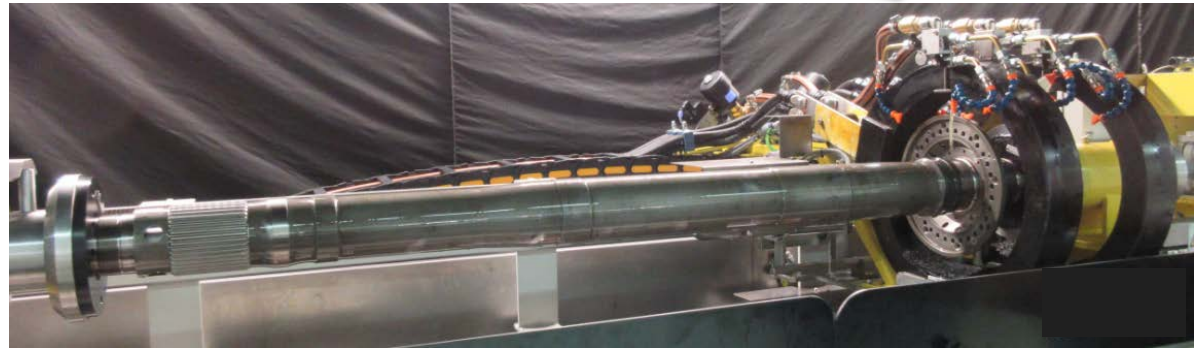
- Step 5 - Longitudinal magnetization by coil of outer part

Using full-wave
rectified
alternating
current-FWAC
monophase

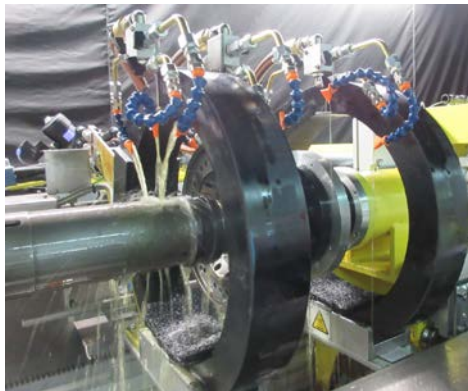
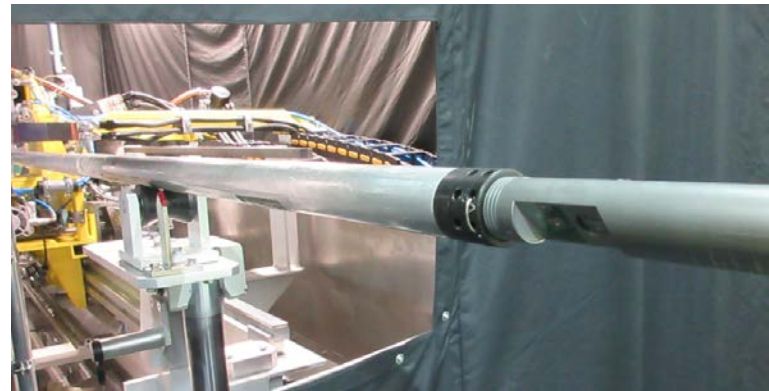
- Step 6 - Longitudinal magnetization by coil of Inner part

- Step 7 - Longitudinal magnetization by coil of flange area
- Step 8 – Demagnetization of the part

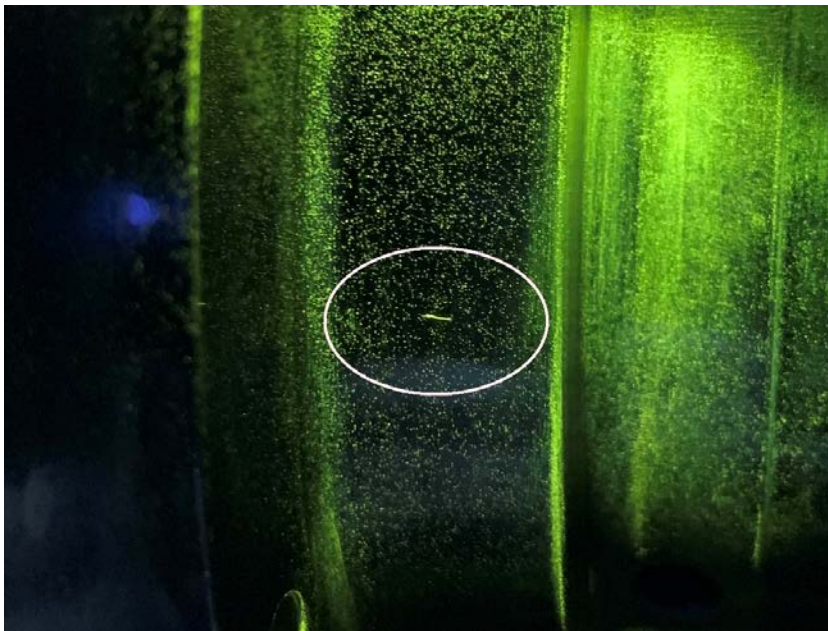
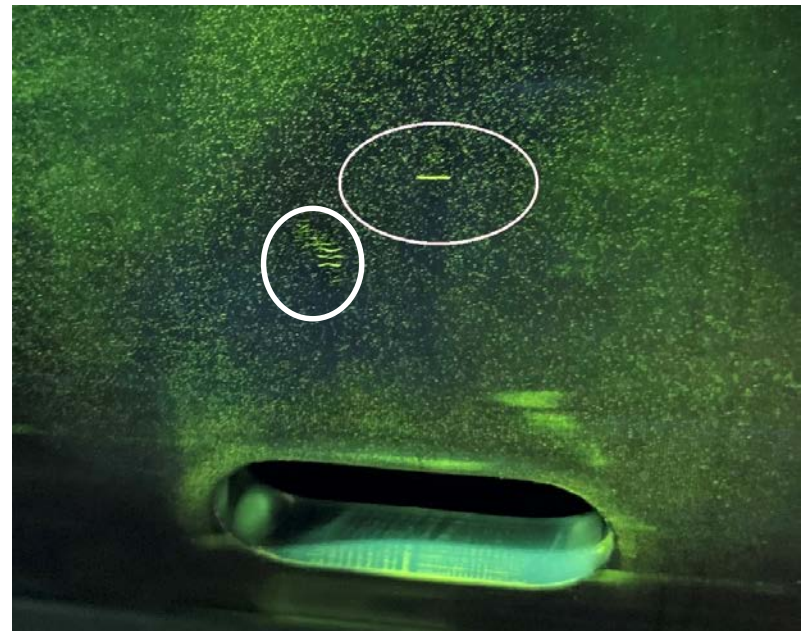
- Sample cracks and other defects on the LPT shaft

Longitudinal crack orientation after circular magnetization

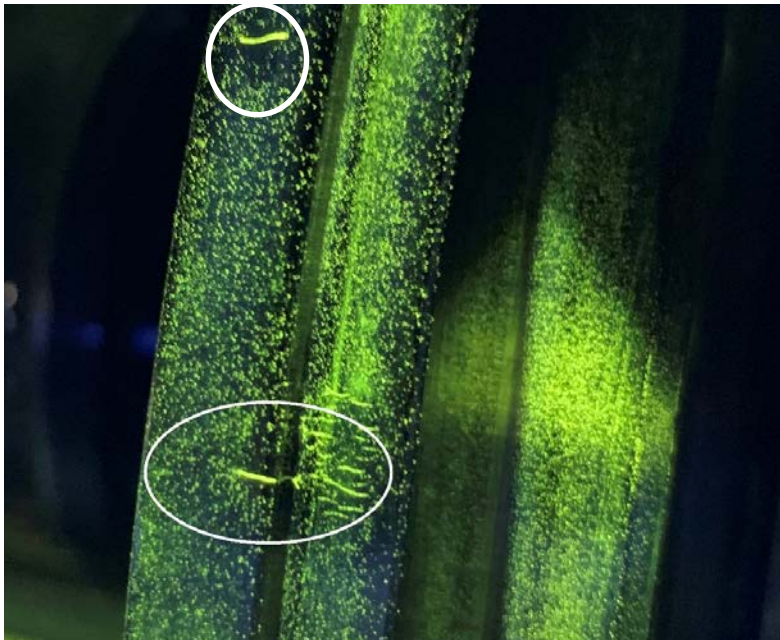
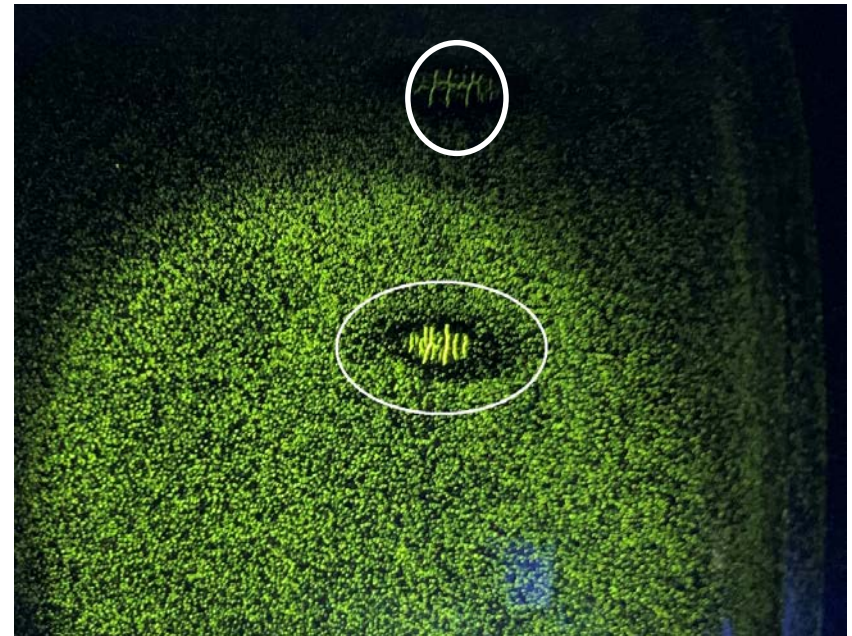
- Sample cracks and other defects on the LPT shaft

Longitudinal and circumferential crack orientation after magnetization

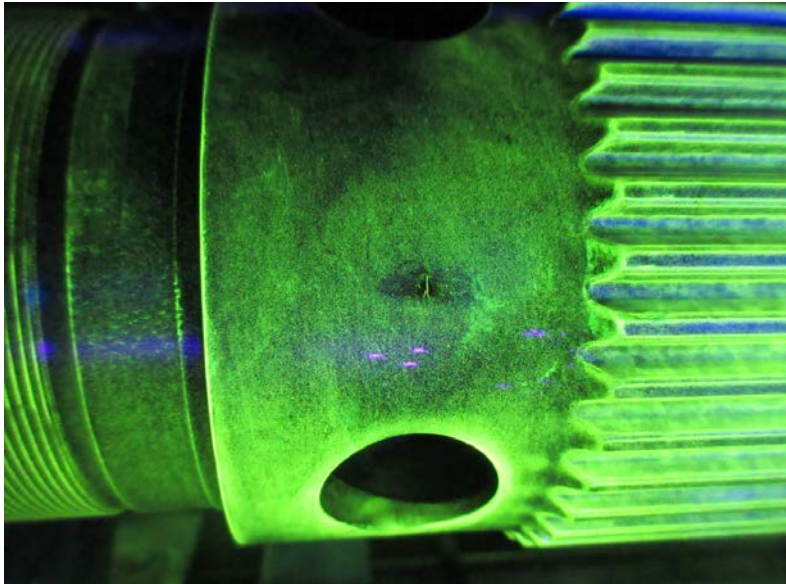
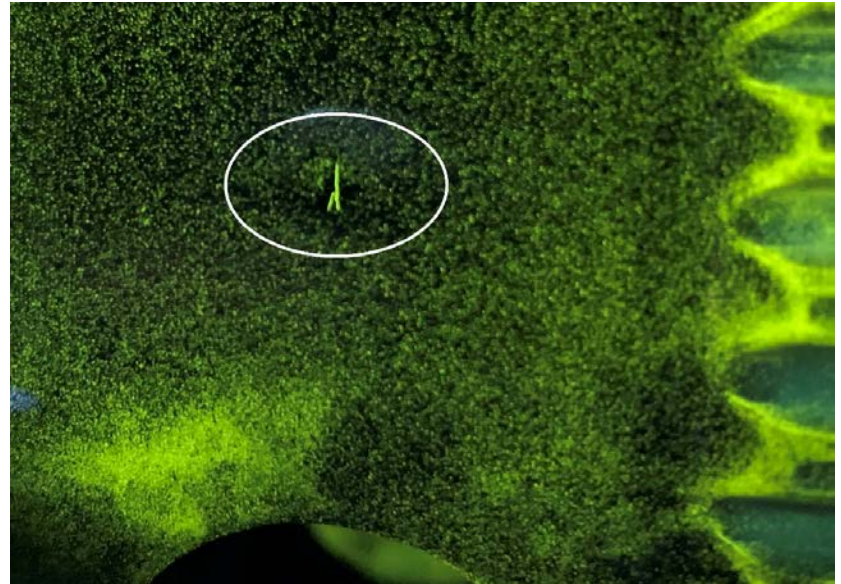
- Sample cracks and other defects on the LPT shaft
circumferential crack orientation after longitudinal magnetization
