JAMES BITTNER | SEPT. 27, 2022 | WEBSTER, TX

Eddy Current Array for Corrosion Inspection

A4A 2022 NDT Forum, San Antonio, Texas

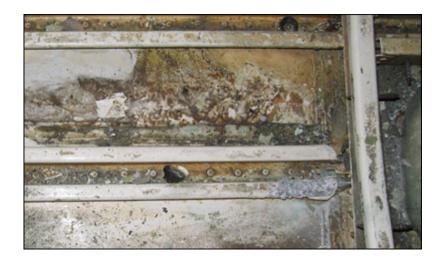
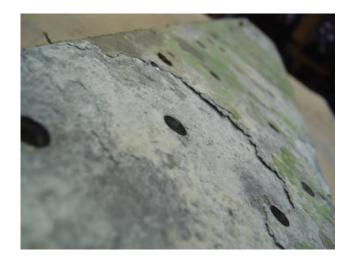
•Corrosion presents a major threat to aircraft structural integrity. Moisture that collects between aircraft layers leads to hidden corrosion and causes multisite damage if not detected. Regular inservice inspections are required. Eddy current is one of the NDT tools that is used to accomplish this task.

•Corrosion can lead to weakening of the aircraft's structure and induce stress cracking if not detected.

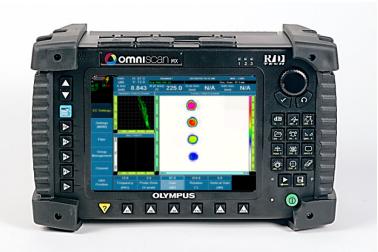
■An eddy current array (ECA) instrument such as the OmniScan[™] MX flaw detector can support eddy current array inspection with C-scan imaging.

Eddy current array probes support 32 coils (up to 64 with an external multiplexer) and work in either bridge or transmit-receive (reflection) mode. The operating frequency ranges from 20 Hz to 6 MHz, with the option of using multiple frequencies in the same acquisition.

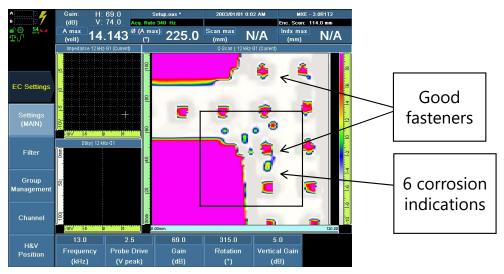
After scanning an area, the operator can make post-acquisition setting adjustments of the raw data. This will enable fine-tuning of the instrument for calibration and acquisition, enabling improved analysis of the data.

In acquisition mode, the C-scan shows real-time mapping of the part under inspection.

In analysis mode, using the cursors shows the data in the impedance plane and a strip chart display to aid in the measurement.
