## Incorporating Autonomous Drones with Assisted Defect Recognition into Airline Maintenance Programs

Emma Galarza – Senior Technology Development Engineer, Delta Air Lines

Floris Straver – Robotics Software Engineer, Mainblades Inspection

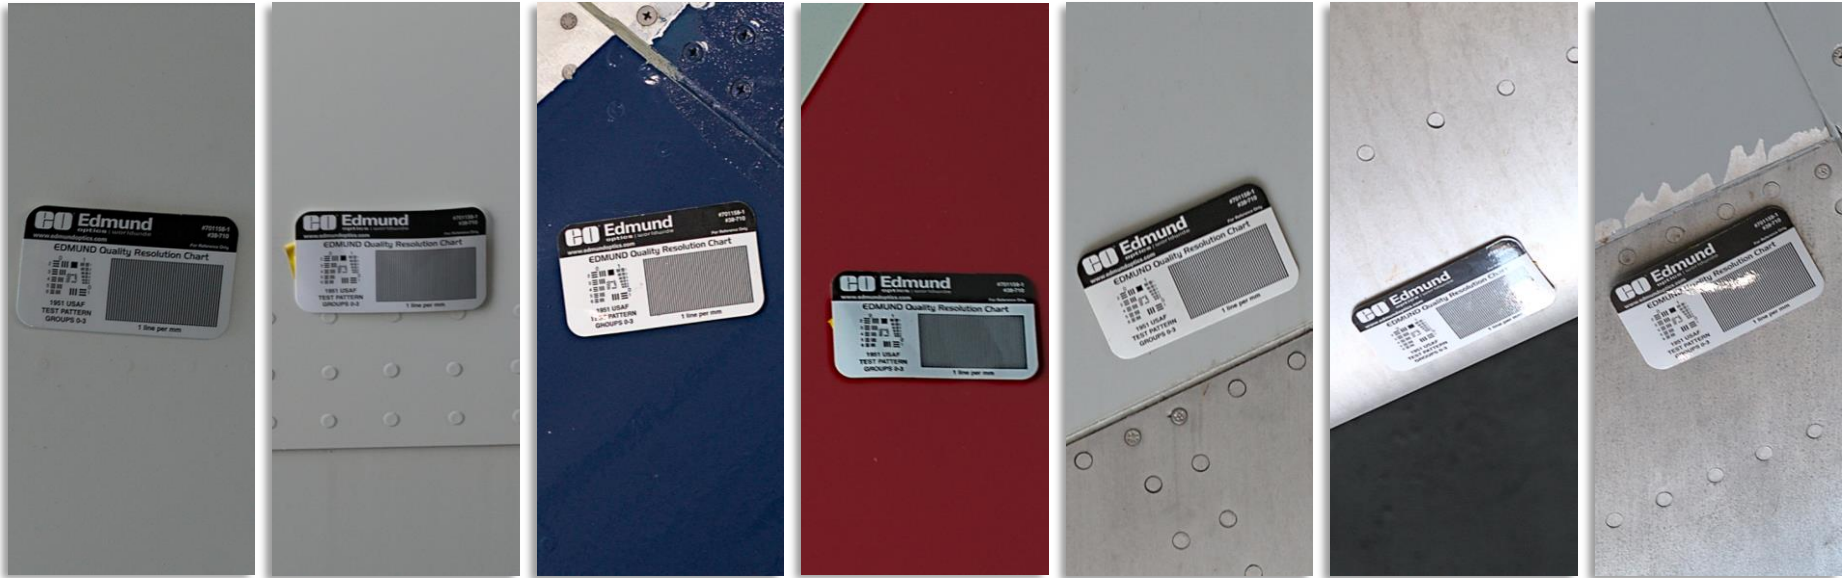
## USAF-1951 Resolution Target Examples

Photo Comparison of 7 Targets placed at varying locations of the aircraft

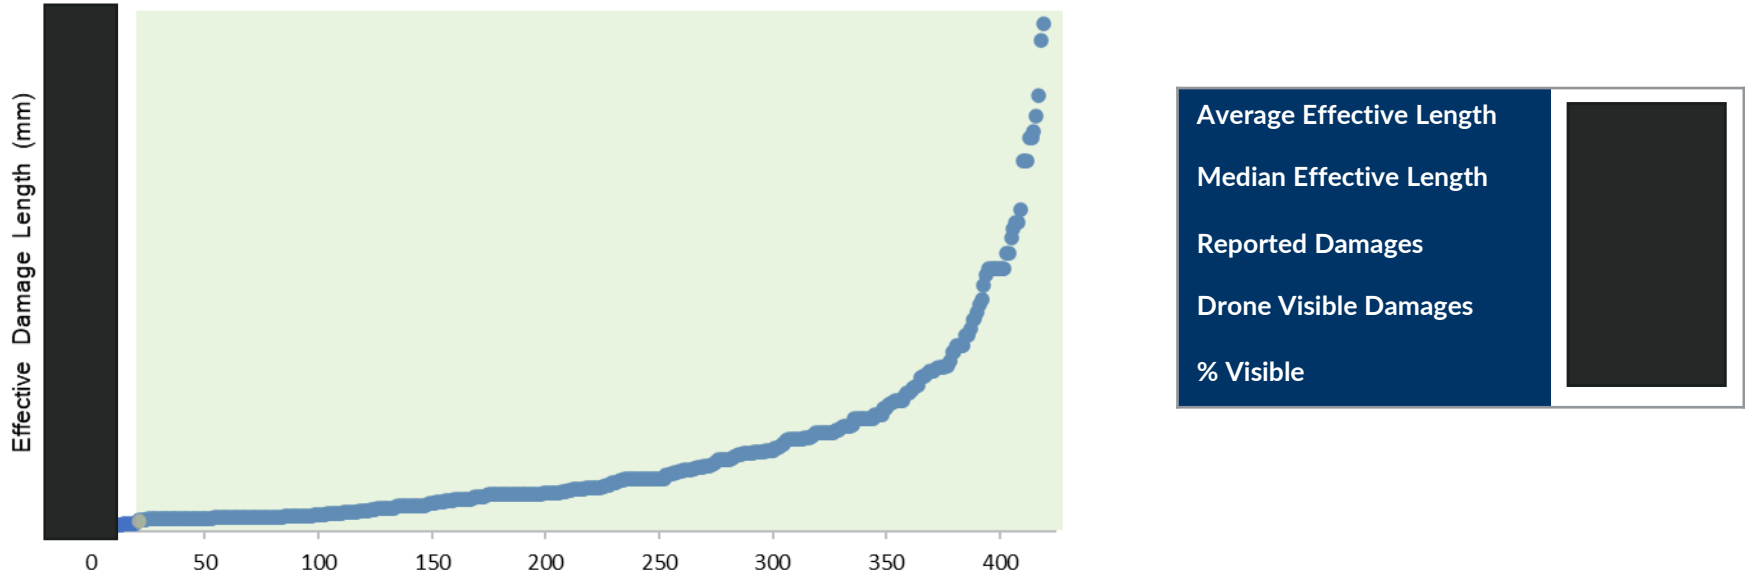
## Reported Lightning Strike Damage Size

Results indicate drone assisted GVI technology has a [redacted] of lightning strike damage

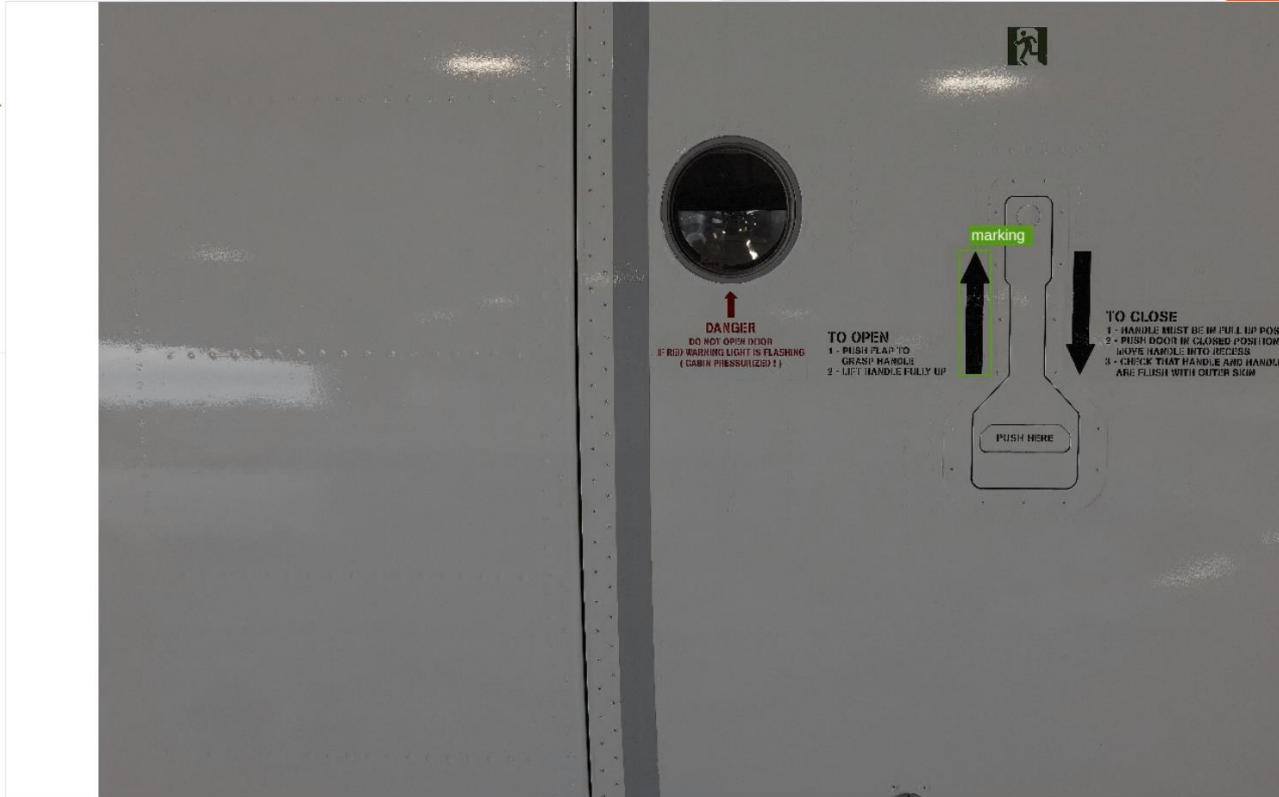
# Photo Review

Image center location  
RIB 64-65, STGR 21-22

- 22. Marking
- 23. Light source
- 24. Water drop
- 25. Rivet/screw rash
- 26. Text
- 27. Marking

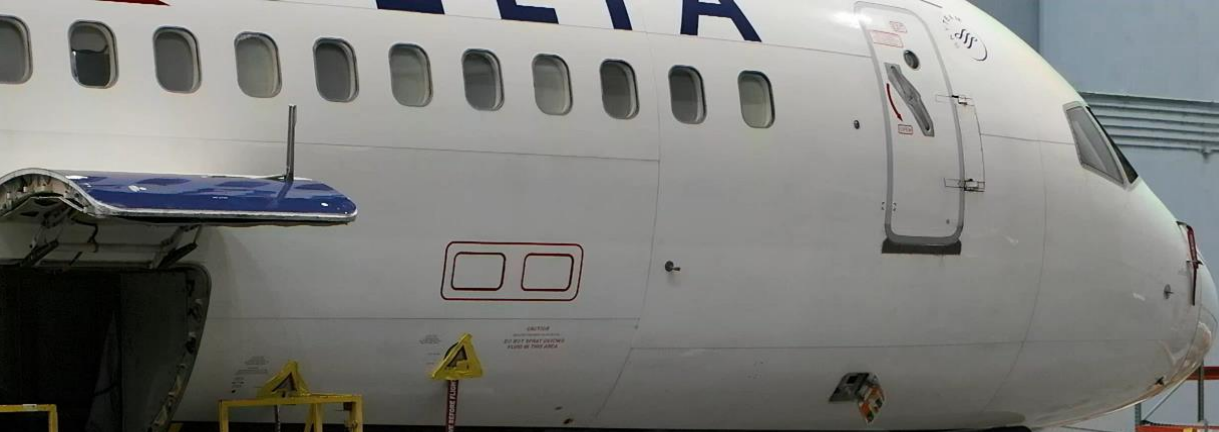
# Assisted Damage Detection

Annotations: light source, rivet/screw rash, water drop, marking, light source, light source, text, marking, rivet/screw rash, marking, text, sticker, text, text, text, text, TO OPEN, TO CLOSE, PUSH HERE, dirt, dirt, light source, light source.

- 1. Rivet/screw rash
- 2. Light source
- 3. Text
  - Type: Text
  - Depth: N/A
  - Width: 5mm Length: 25.1mm
  - Area: 125.8mm<sup>2</sup>
  - Location: RIB 64-66, STGR 20-21
- 4. Rivet/screw rash
- 5. Marking
- 6. Light source
