Small Indication Analysis in Airframes and Powerplants

Benefits of NDT Using Highest Definition Remote Visual Inspection (RVI)

Paul Thompson Inspection Technologies Remote Visual Sales Leader

September 23, 2019

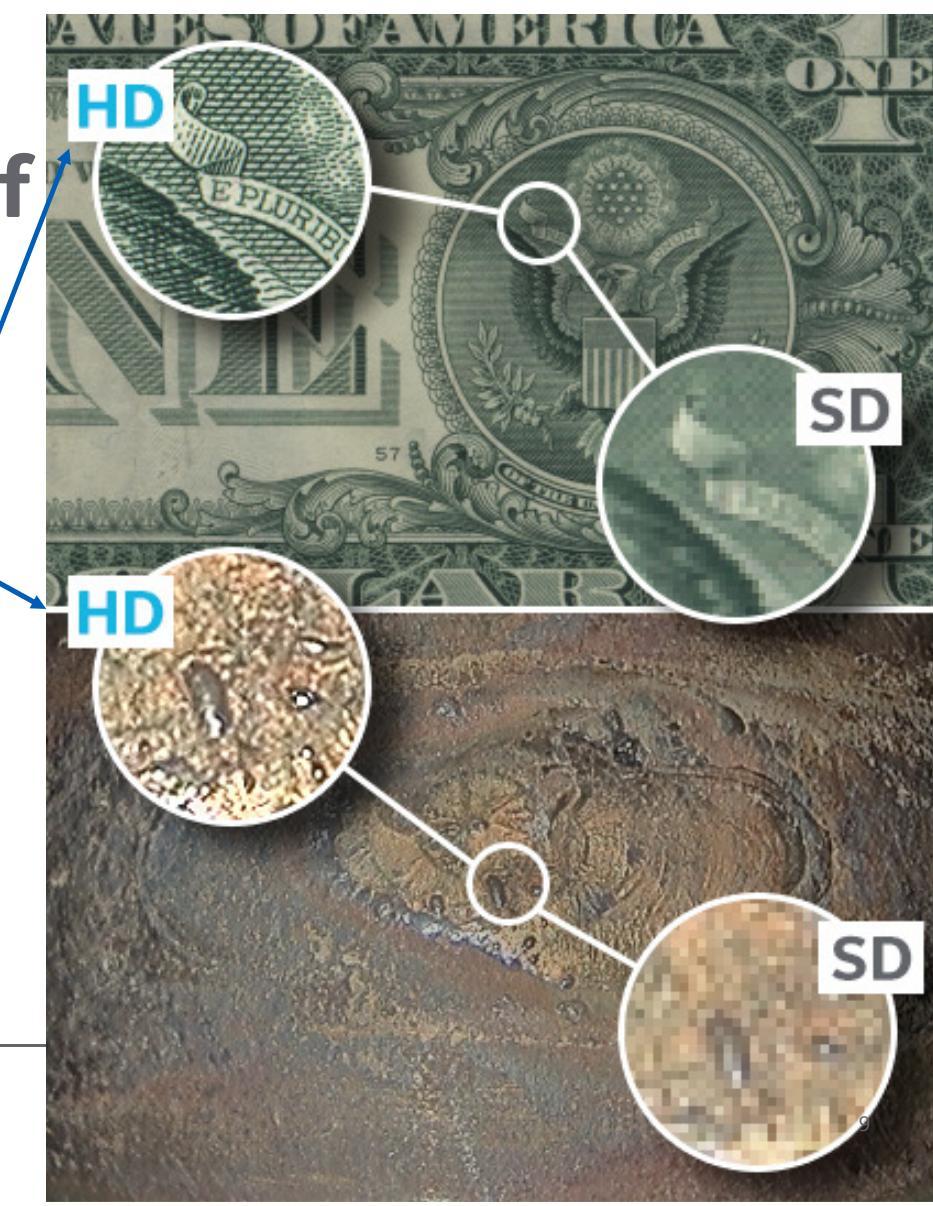
Revolutionizing Remote visual inspections with Hi-Def

• New advancements in higher definition RVI technology provides unprecedented image quality with 1.2-megapixels

> 1.2-mp Highest Def .79-mp

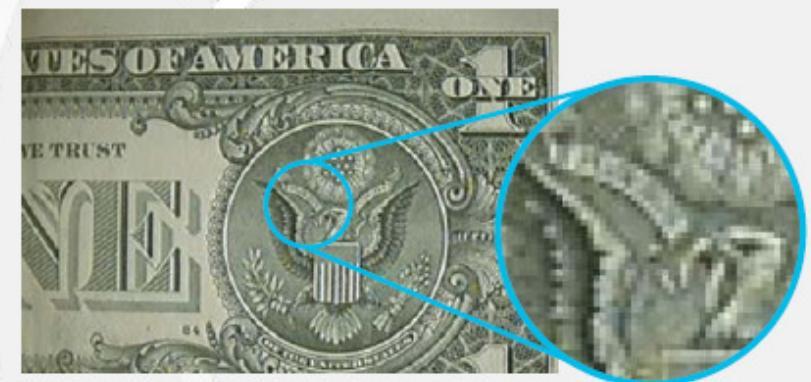
HD Probe Basics

- 1.2-megapixel camera imager
- Video resolution is 1024 x 768 (XGA)
- Saved HD Image size (1280 x 960) vs. Saved SD Image size (752 x 576)
- HD Digital Zoomed to 1.8X = SD pixelation at 1.0 X (no zoom)
- **BENEFIT**: Measurement cursor placement in some scenes, and especially with Stereo measurement where pixel matching is hyper-critical, allows for improved precision of cursor placement due to increased spatial resolution

Standard Definition

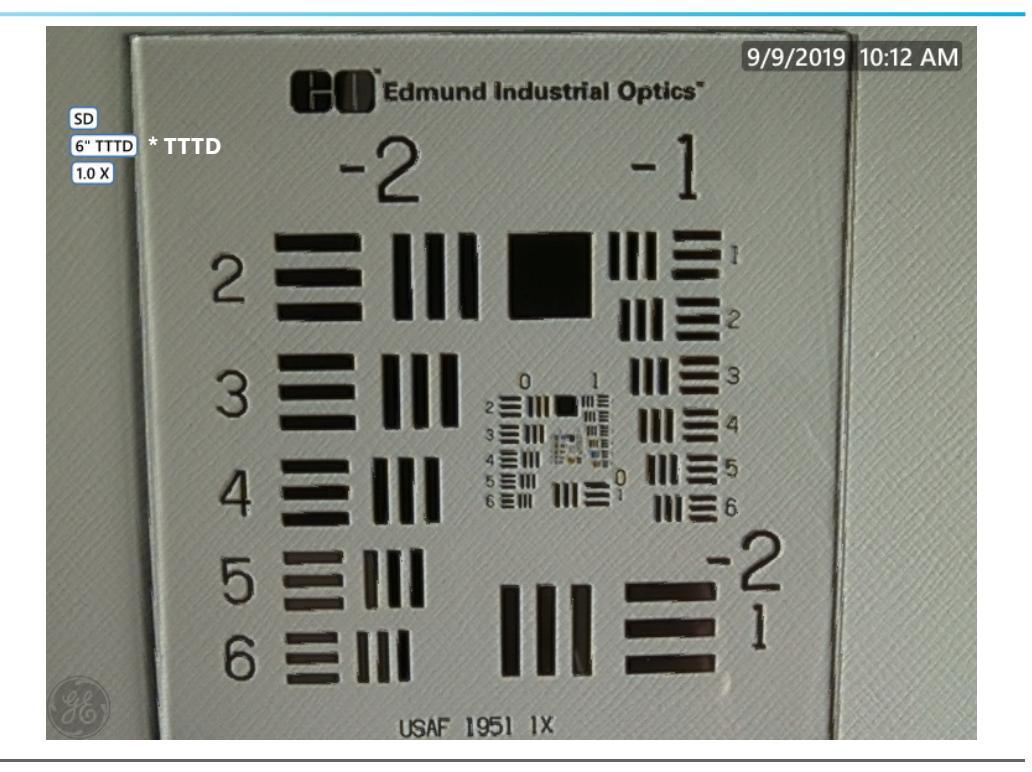
Resolution Standard - USAF 1951 1X Target

- In use since 1951, MIL-STD-150A
- Resolution test chart for validating spatial resolution
- Groups / Elements are presented as line pairs (one black line + one white line)
- All following images taken from Edmonds Optics USAF 3"X3" POS Res Target ; NIST Cal Due 04/2020

* TTTD – (camera) Tip-To-Target Distance

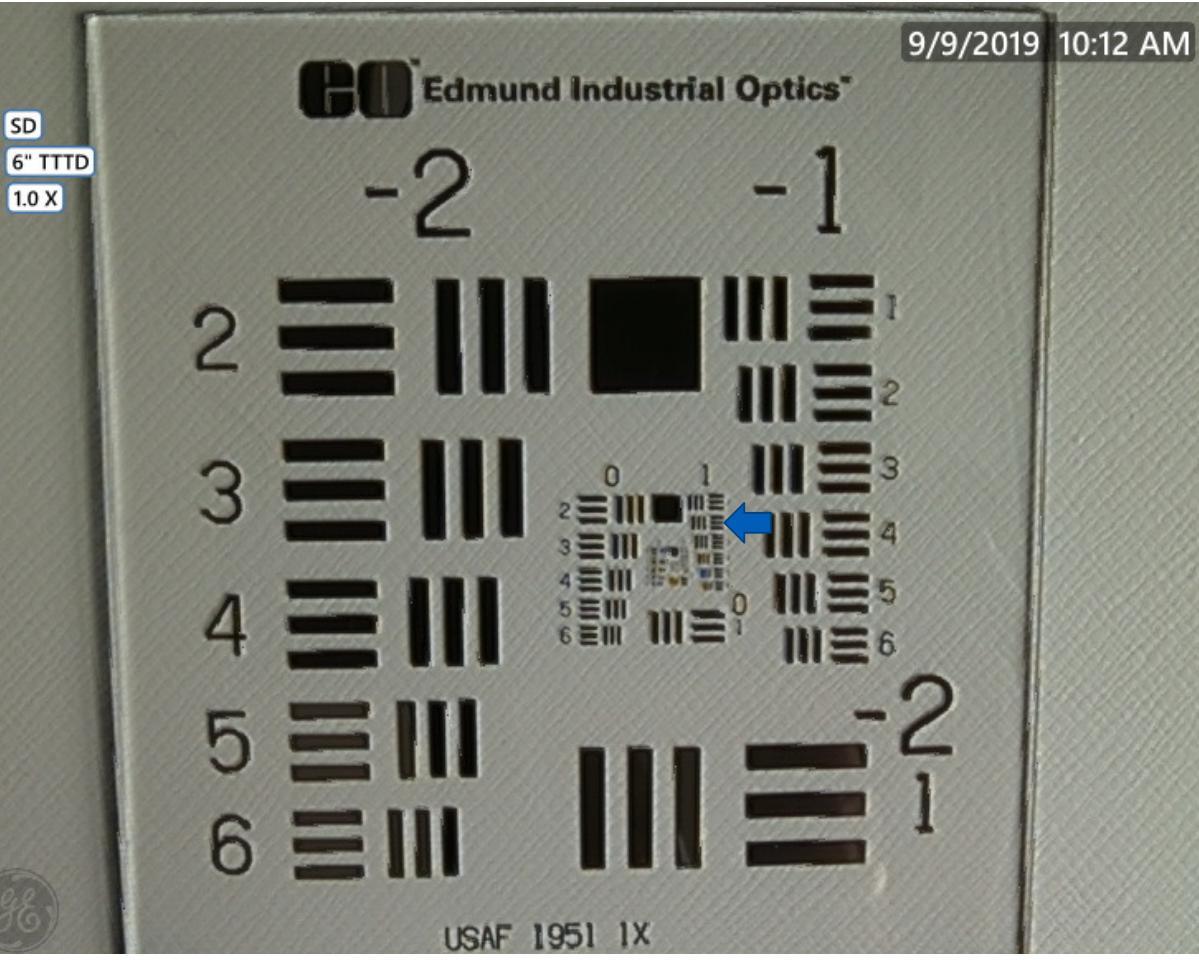
SD Camera

SD camera with 6" (152 mm) tip-totarget distance with 1.0X zoom

Spatial resolution can be observed in Group 1 Element 2

Group 1 Element 2 LP are 0.018" (0.45mm) wide

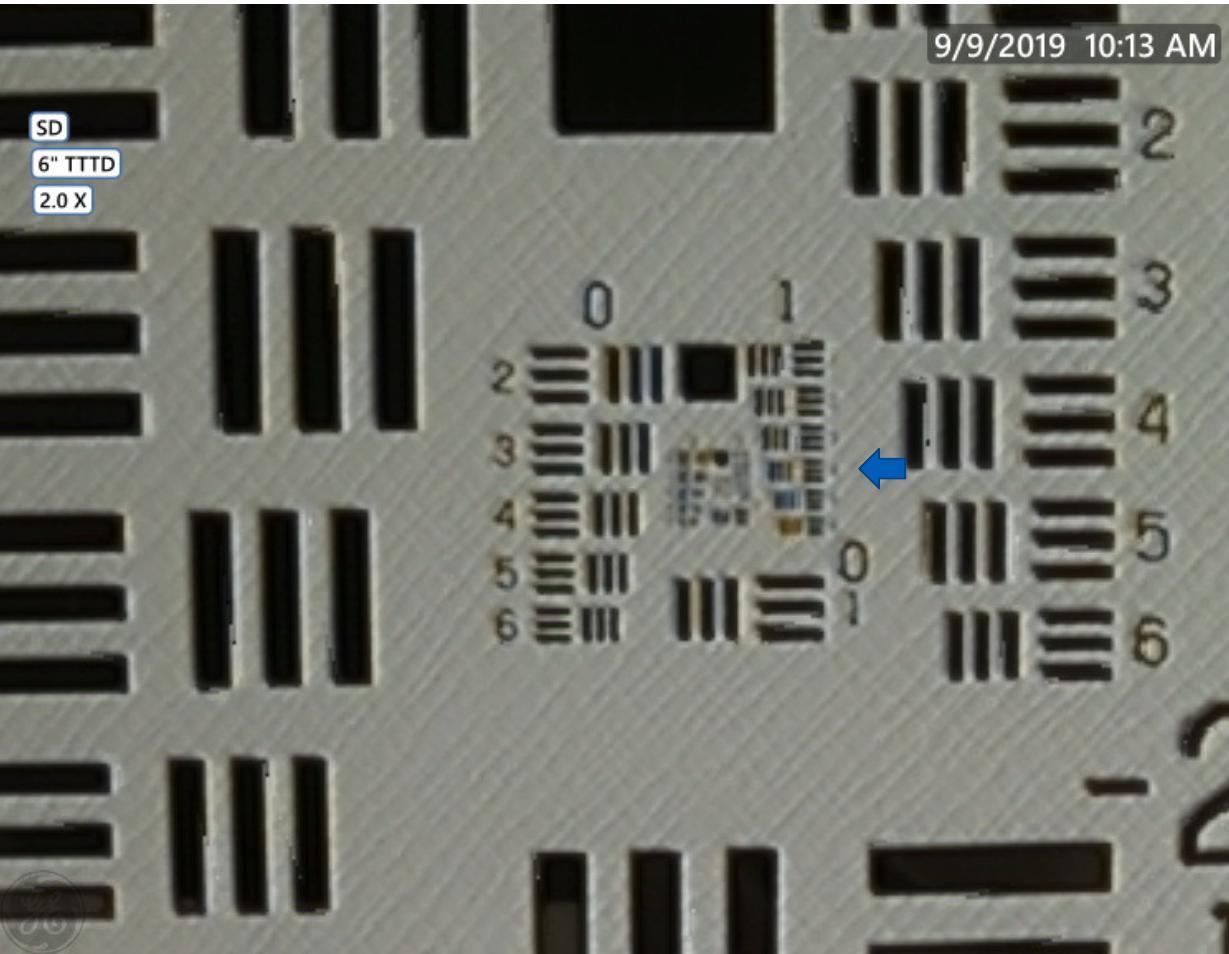
SD Camera

SD camera with 6" (152 mm) tip-totarget distance with 2.0X zoom

Spatial resolution can be observed in Group 1 Element 4

Group 1 Element 4 LP are 0.014" (0.35 mm) wide

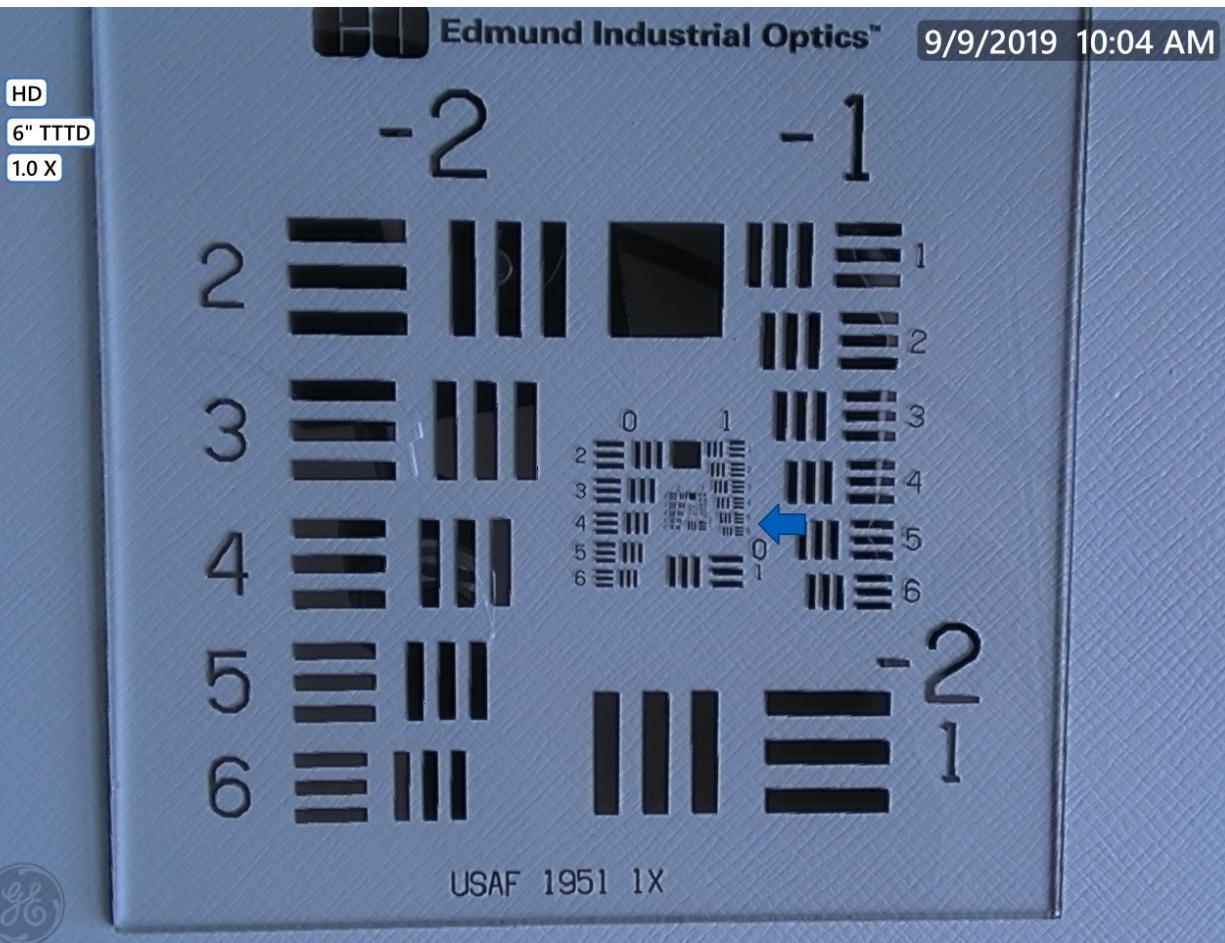
HD Camera

HD camera with 6" (152 mm) tip-totarget distance with 1.0X zoom

Spatial resolution can be observed in Group 1 Element 5

Group 1 Element 5 Resolved LP are 0.012" (0.32 mm) wide

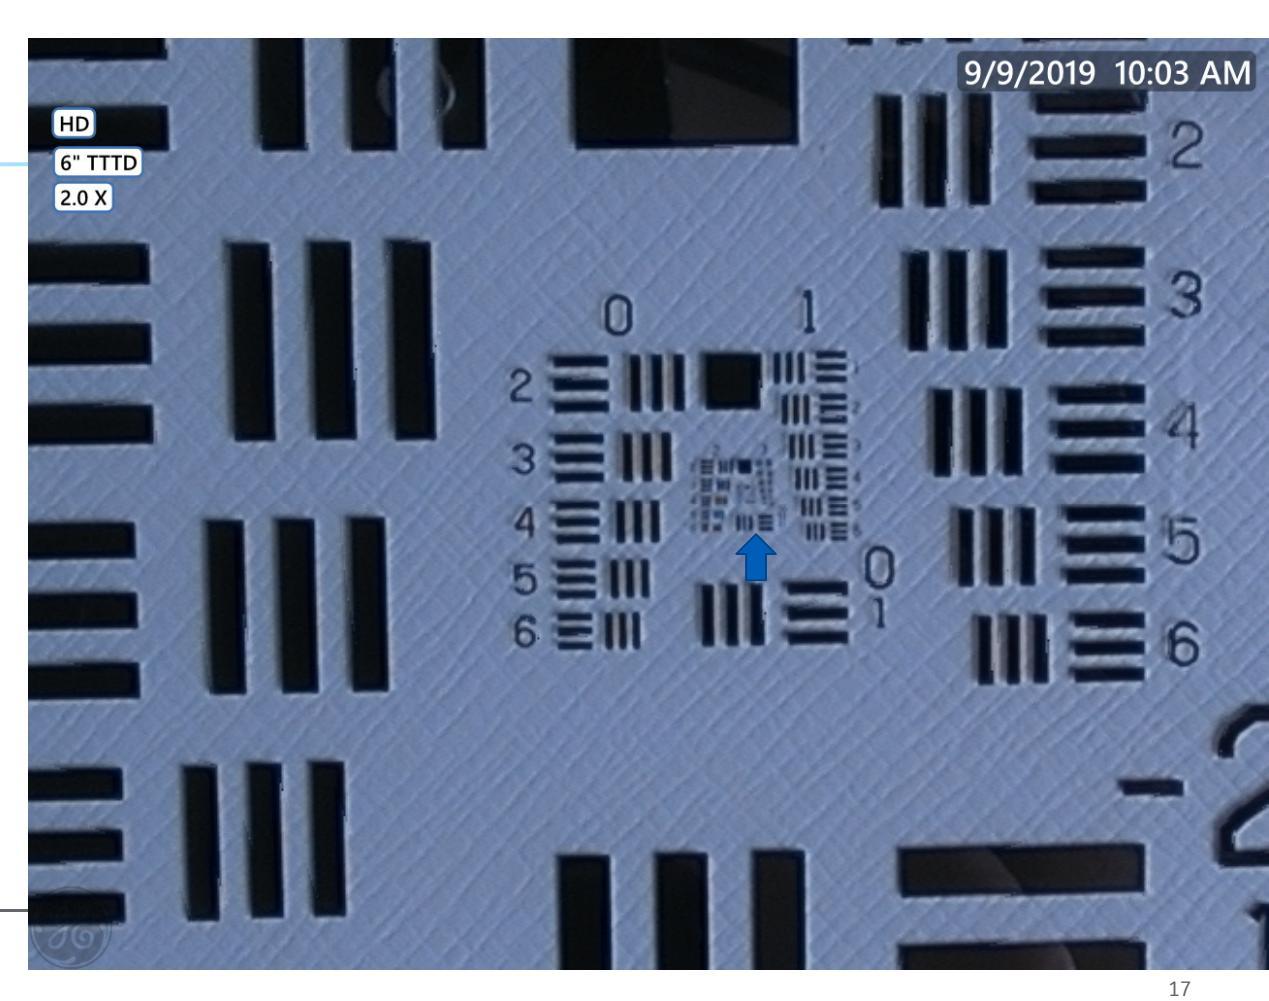
HD Camera

HD camera with 6" (152 mm) tip-totarget distance with 2.0X zoom

Spatial resolution can be resolved in Group 2 Element 1

Group 2 Element 1 Resolved LP are 0.010" (0.25 mm) wide

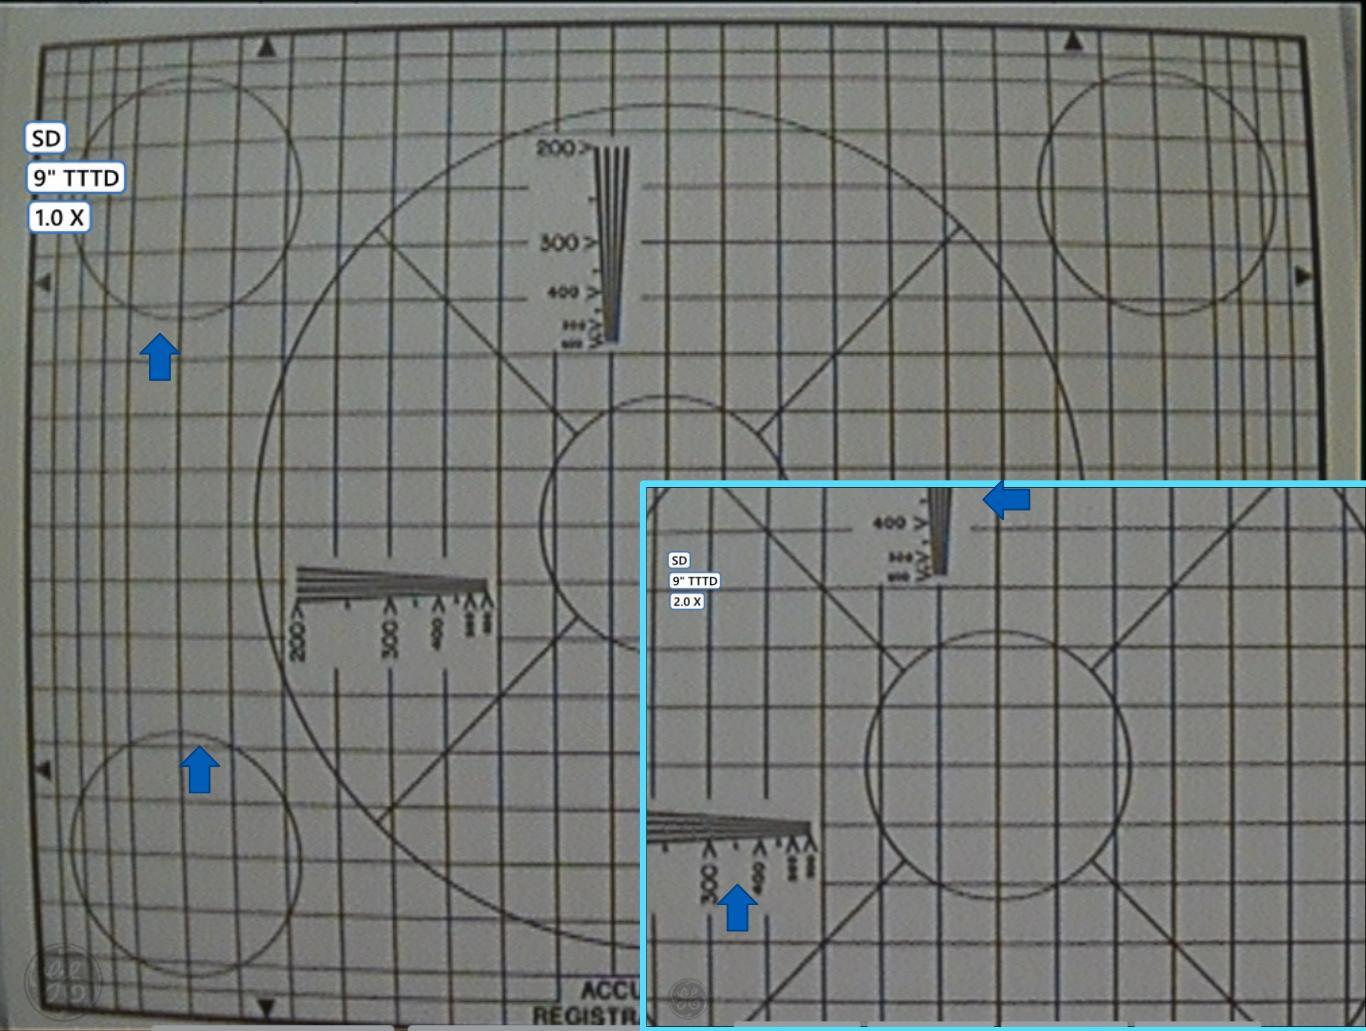
SD Camera on ACCU-CHART

SD camera with 9" (229 mm) tip-to-target distance

Both vertical and horizontal resolution at this TTTD is ~350 lines pairs per inch (350 / 25.4 mm)

Pixilation noted in outer circles

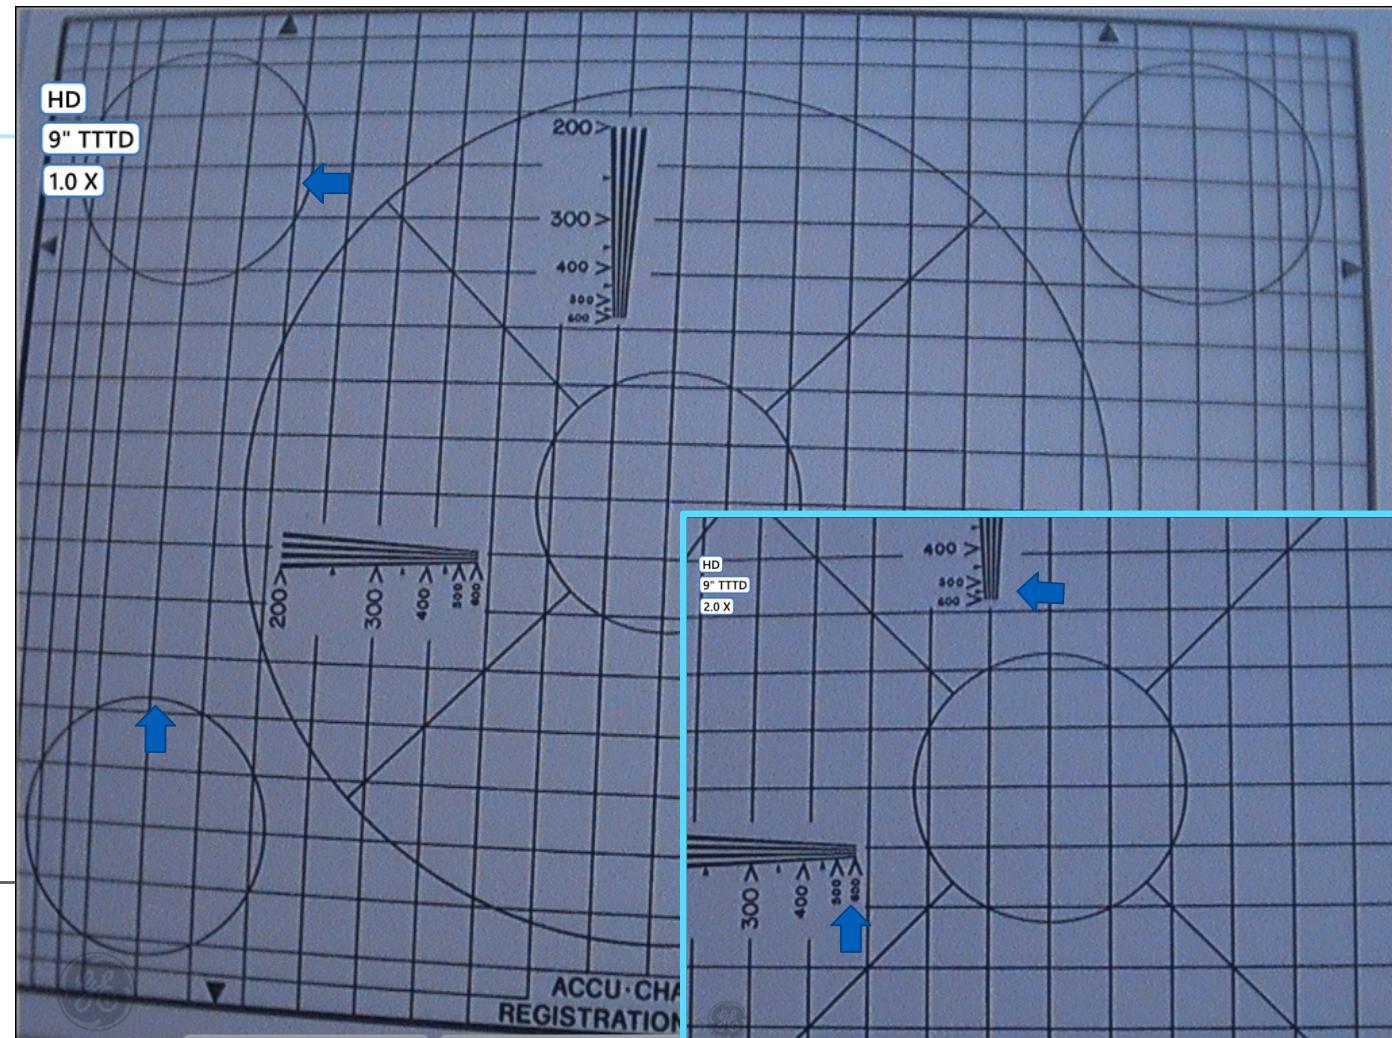
HD Camera on ACCU-Chart

HD camera with 9" (229 mm) tip-to-target distance

Both vertical and horizontal resolution at this TTTD is ~600 lines pairs per inch (600 / 25.4 mm)

Notice outer circles are not pixelated

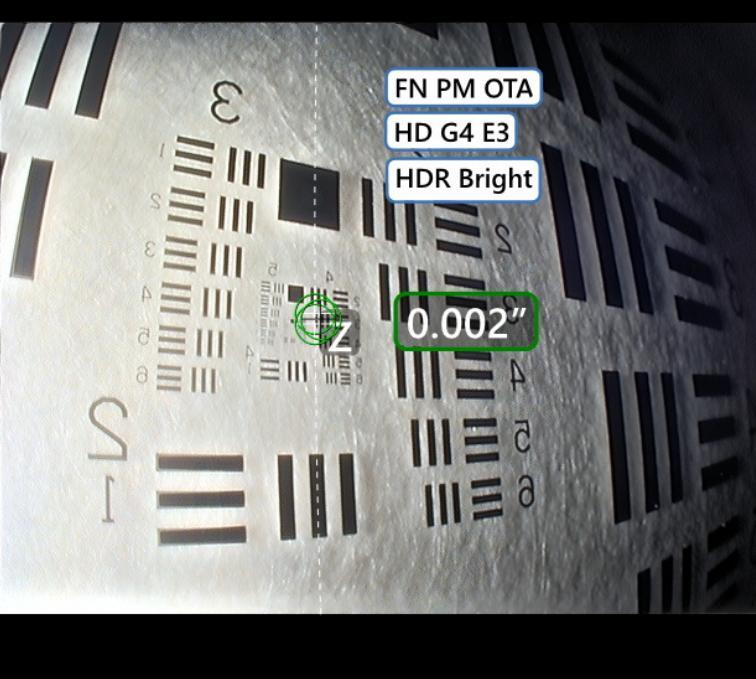
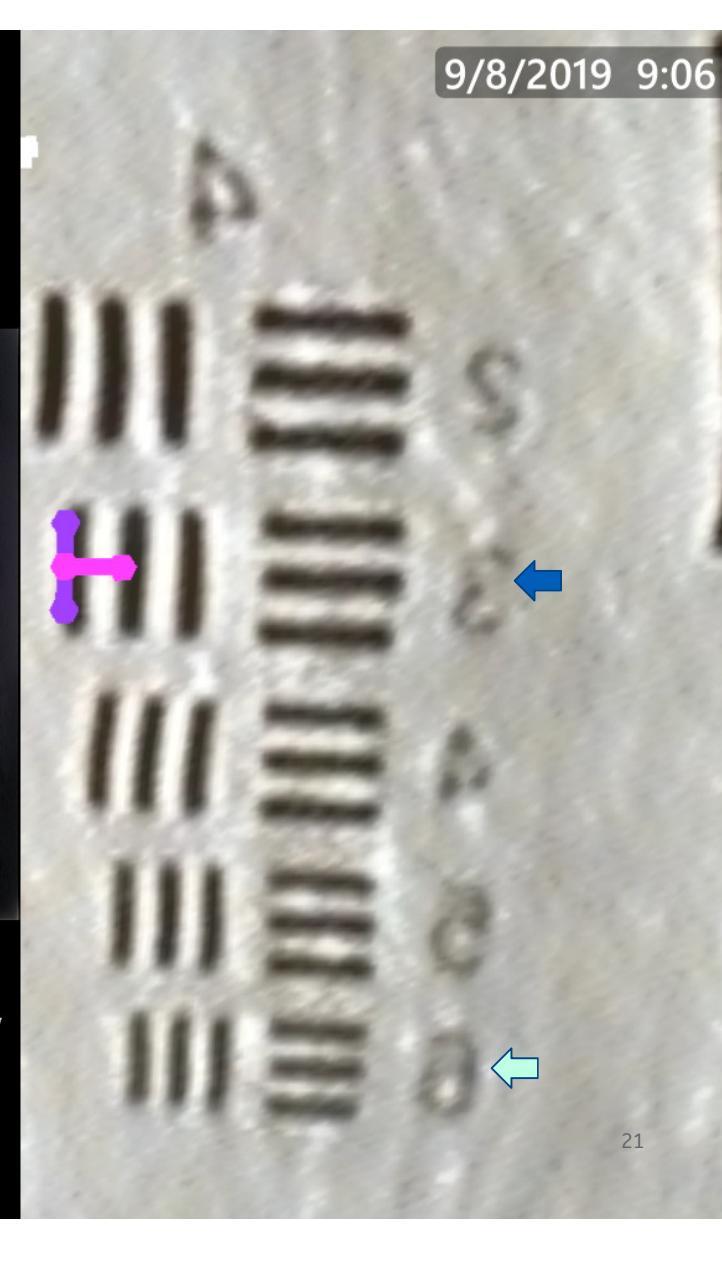
HD Camera

Group 4, Element 3 Line pairs are 0.0020" (0.050 mm) wide

G4E6 LP are 0.0014" (0.035 mm) wide and are resolved in the Point Cloud

Image quality and cursor placement were assisted with TrueSight[™] HDR processing

HDR – High Dynamic Range imaging provides a greater dynamic range of luminosity in a given scene

Z=0.003"

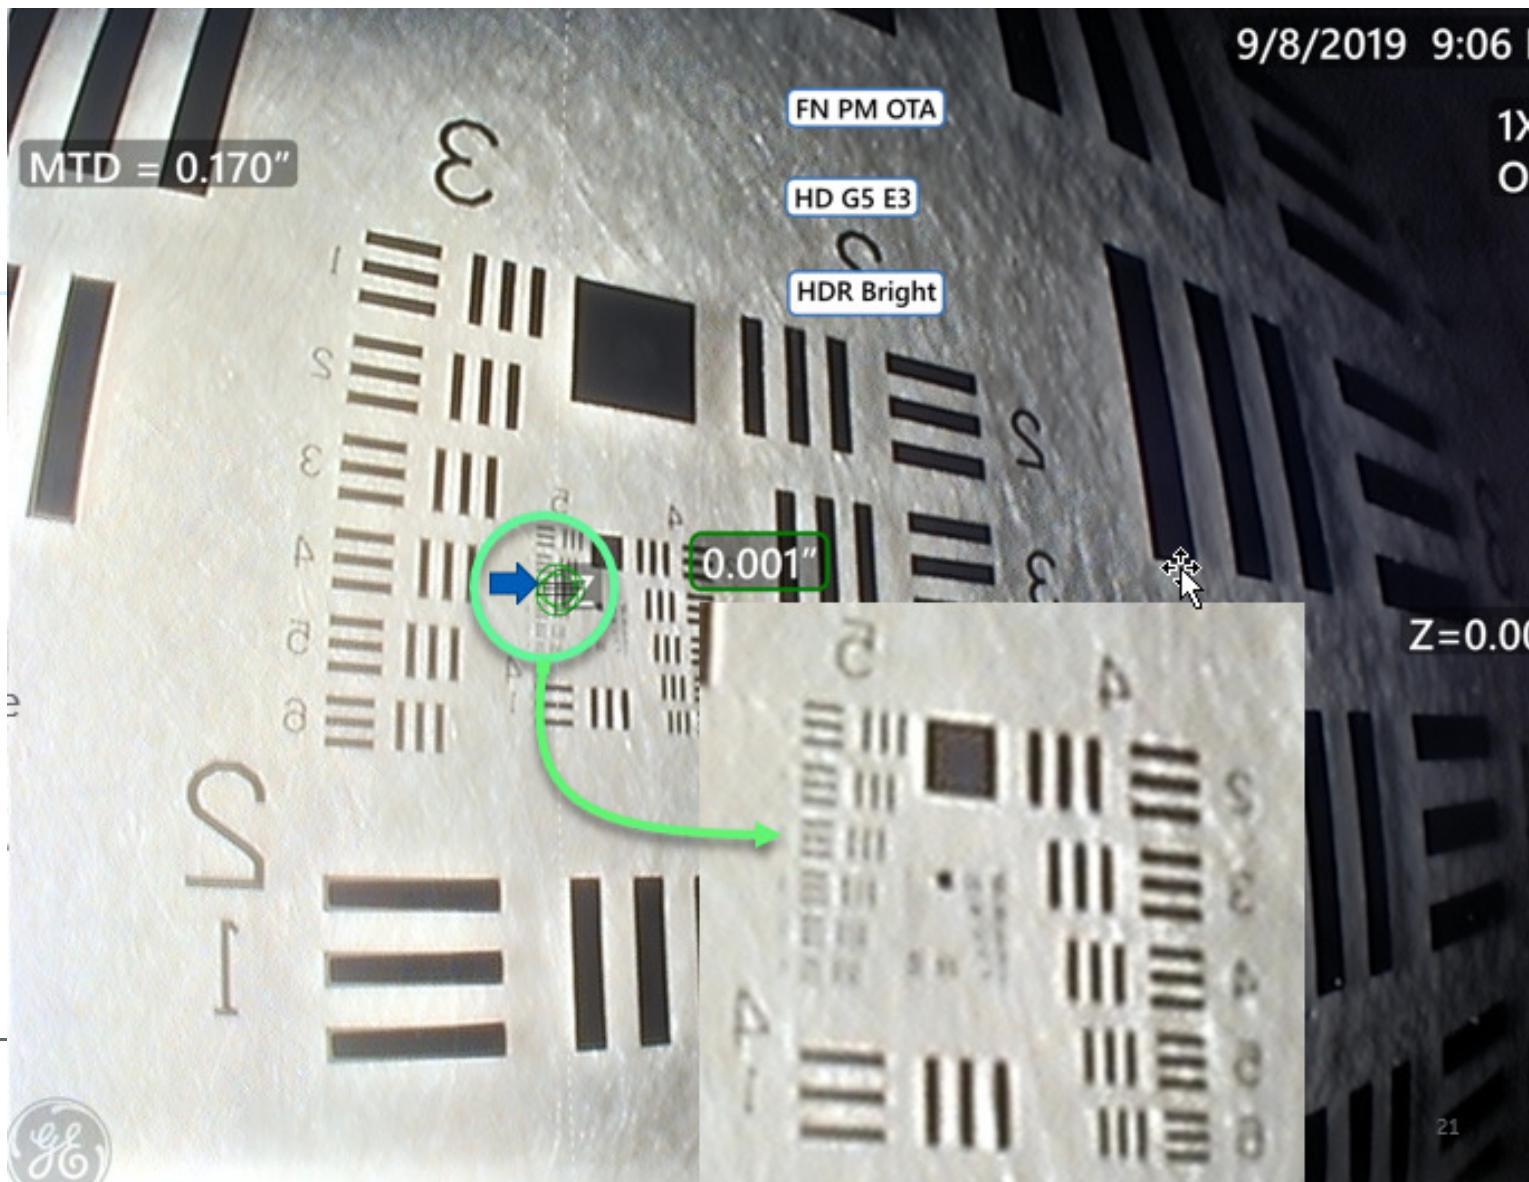
HD Camera

Group 5, Element 3 Line pairs are 0.0010" (0.025 mm) wide

Image quality and cursor placement were assisted with TrueSight HDR processing

HDR – High Dynamic Range imaging which provides a greater dynamic range of luminosity in a given scene

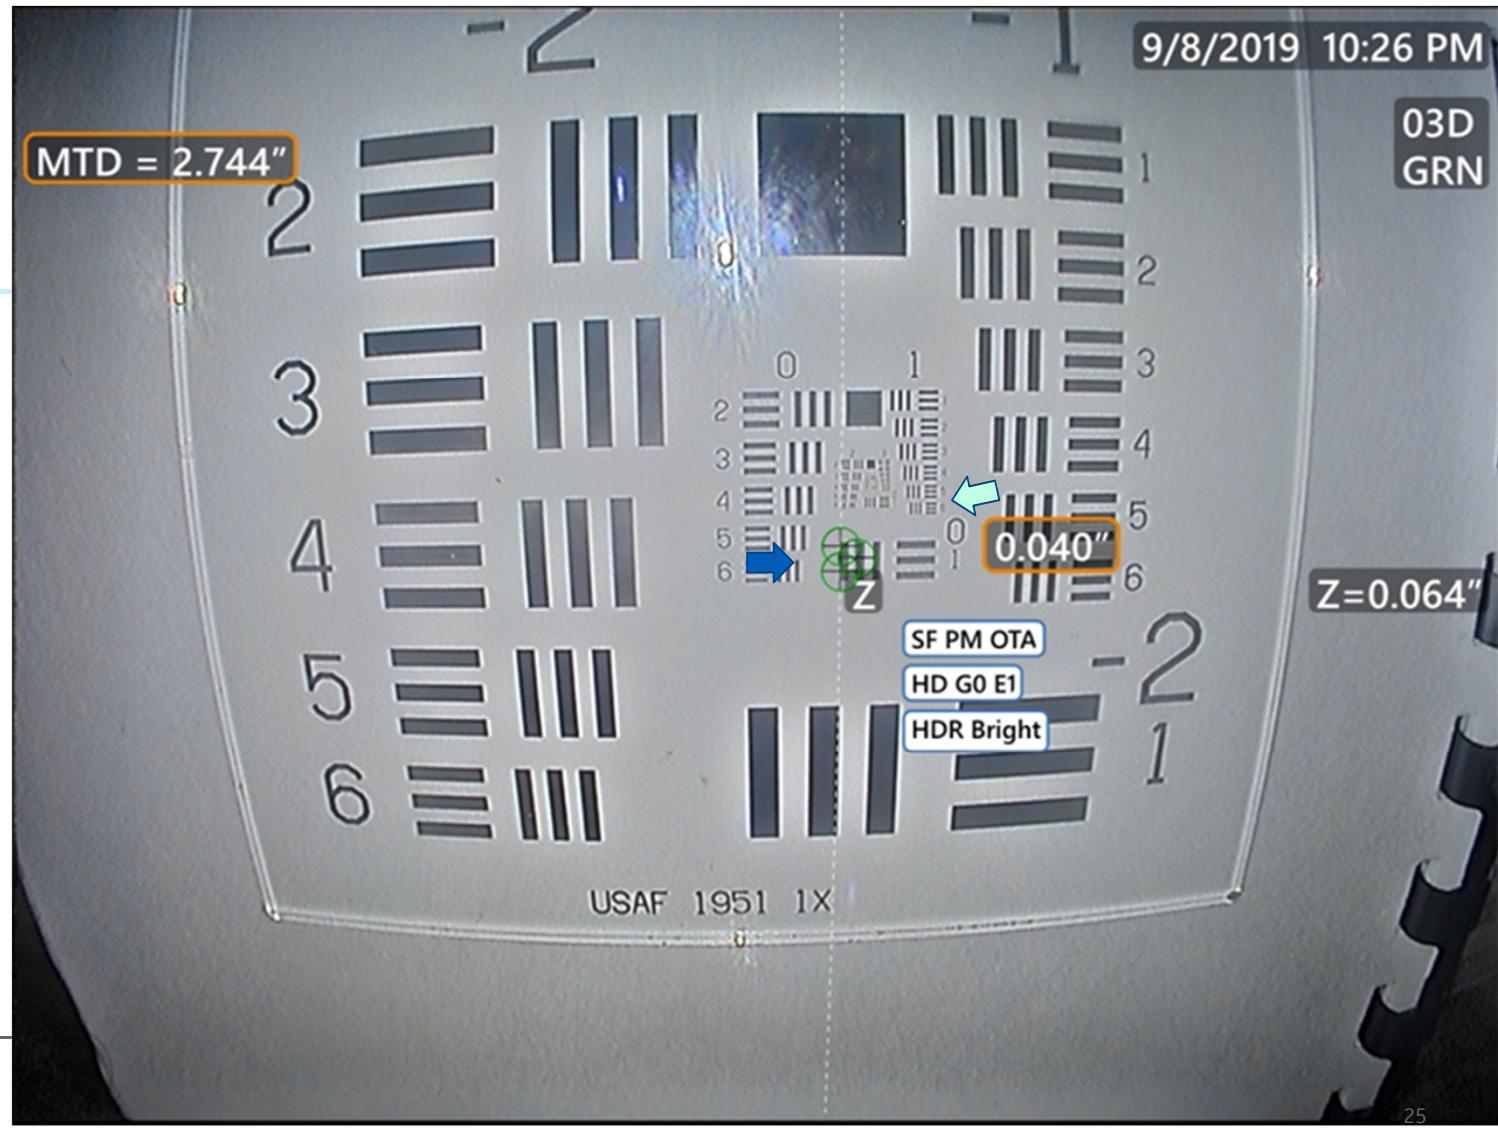
HD Far Focus

Group 0, Element 1 Line pairs are 0.0394" (1.00 mm) wide

G1E6 LP are 0.011" (0.28 mm)

Image quality and cursor placement was assisted with TrueSight HDR processing

HDR – High Dynamic Range imaging which provides a greater dynamic range of luminosity in a given scene

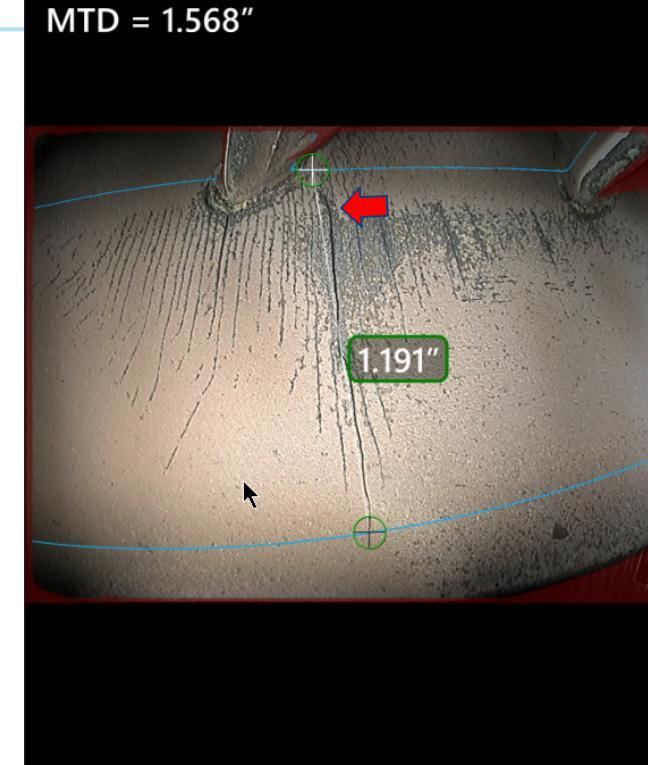
HD Far Focus Powerplant Inspections

Measuring with long Tip-to-Target Distances is now possible

Large-area indication analysis now possible

Areas previously accessible only with significant disassembly now accessible easier/faster

A "bad" call on a CF6-80C2 on a 747 is in excess of a \$1.2M decision

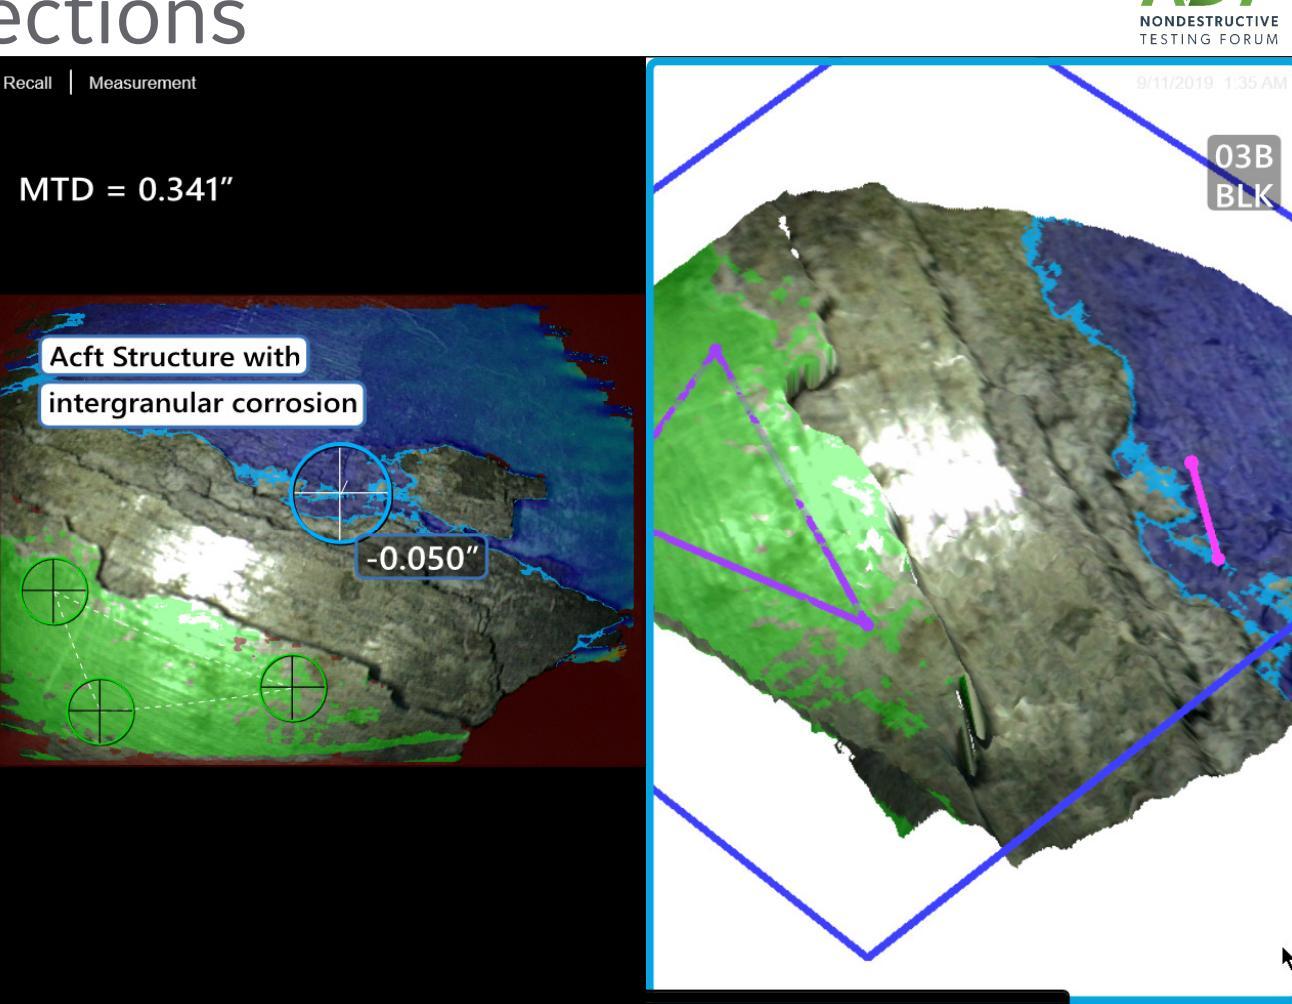
HD Airframe Inspections

Measuring intergranular corrosion under floorboards or in other airframe structure via >0.250" access

Allows for pre-inspection planning allowing parts to be on-hand for C or D checks

Reduces time to complete repairs once aircraft is grounded with needed parts ordered and onhand
