# A4A NDT FORUM

## Use of Small Unmanned Air Vehicles (Drones) to Enhance Aircraft Structural Integrity Programs

Walt Jarecki (ATF)

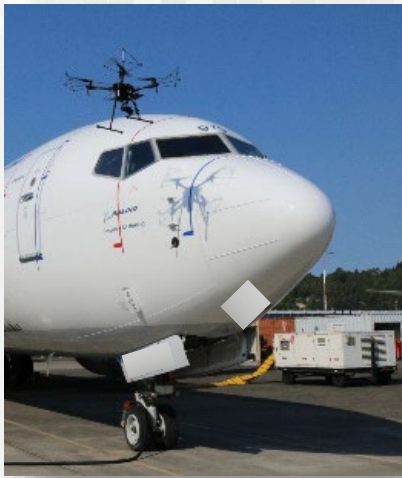
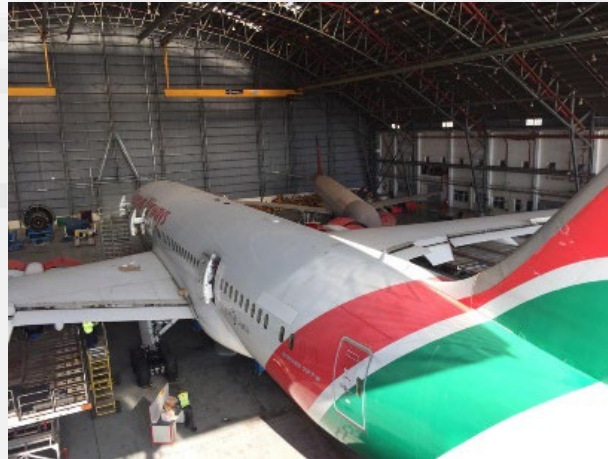
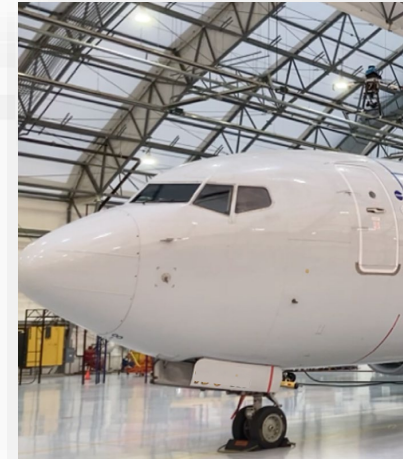
# Testing - Boeing Activities

- Boeing supports the use of Auto flight sUAS in maintenance task inspection
- Since 2019 Boeing has been conducting sUAS assisted aircraft inspection Equivalency tests
  - Goal is to prove sUAS assisted inspections are equivalent to mechanics manual inspections
    - Zonal General Visual Inspection (GVI)
    - A data set of standardized images that provide an opportunity to perform fault identification.
  - Aircraft condition images were captured in accordance with:
    - Flight plans
    - Locations
    - Camera specifications
- 2023
  - Auto flight image capture
    - Boeing Flight Plan/Supplier Flight Plan
    - Overlap/Coverage
    - Inspector image review traditional and supplier applications

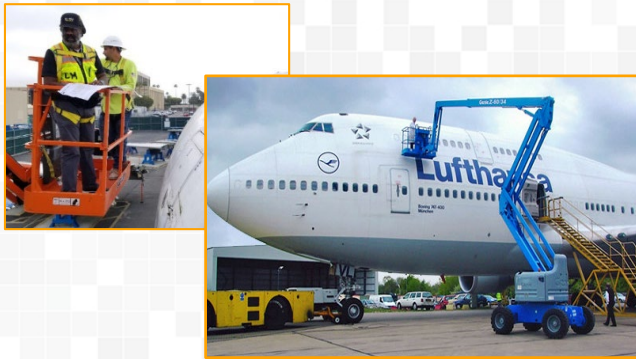
## Data Collection

- Manual
- Labor Intensive
- Time consuming
- Unsafe to personnel or aircraft

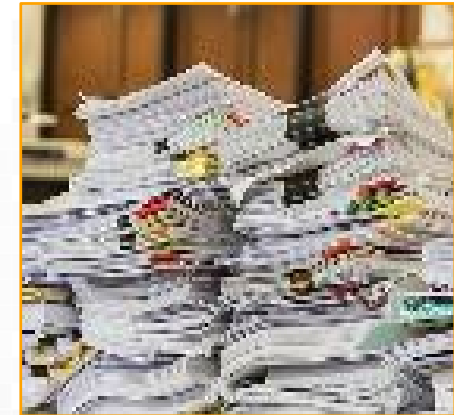
## Maintenance History

- Manual cataloging of damage in maintenance databases
- Must do manual research to find new vs old damages

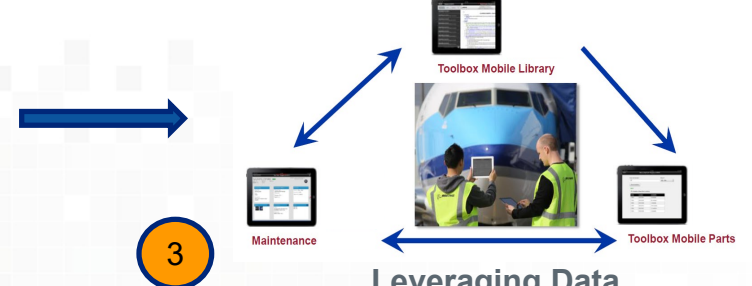
- ## 3 Leveraging Data
- Provide UI with damage detection software
  - Tie to Boeing or host databases
  - Validate/document damage

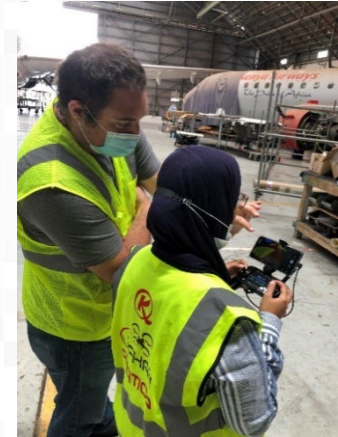
# Analysis – Human Factor Assessment

The following 11 Human Factors issues are based on the list of questions presented to the AMTs performing the Auto flight sUAS assisted Zonal GVI image review.

- Resolution Requirements for the imaging process
- Interpretation of 2-D vs 3-D images
- Basic image quality:
  - Blur, focus, overlap.
- Lighting quality and quantity
- Other available image enhancements
- Inability to use tools or touch
- Training for image review.
- Maintaining location awareness on aircraft in image set
- List of defect types
- Image interpreter fatigue and vigilance decrement
- The environment beyond visual:
  - Thermal
  - Auditory
  - Workspace design

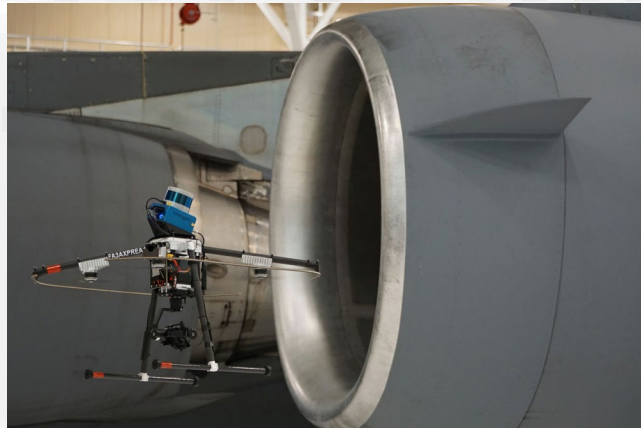
*Data Collection*

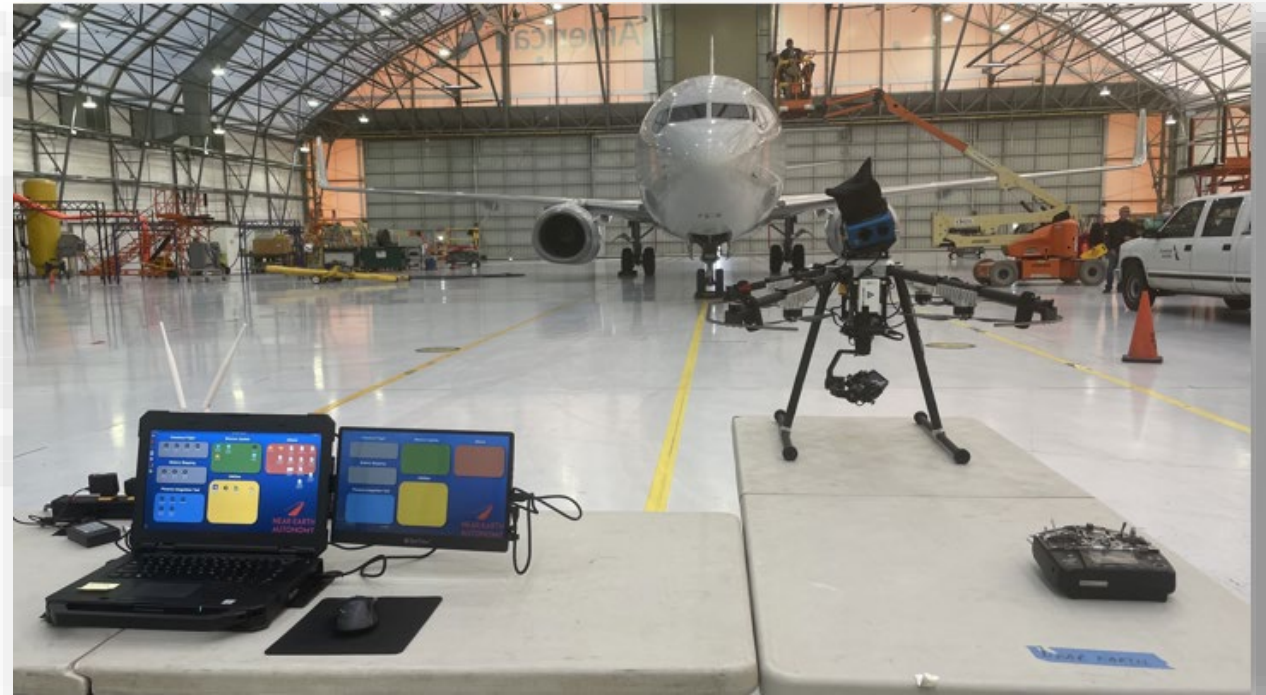
- **Auto flight:** sUAS takes off, locates and maps the aircraft using preplanned trajectories - “flight plan”

- Technician monitors inspection trajectories around aircraft
- Collects HD images tagged with 3-D location on aircraft

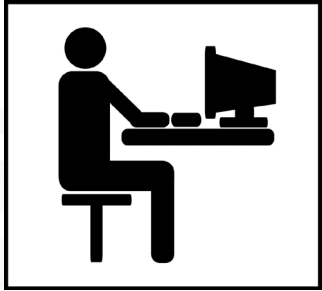
The better the screen size and resolution, affect the time spent by the Aviation Maintenance Technician (AMT) Inspector in zooming and panning.

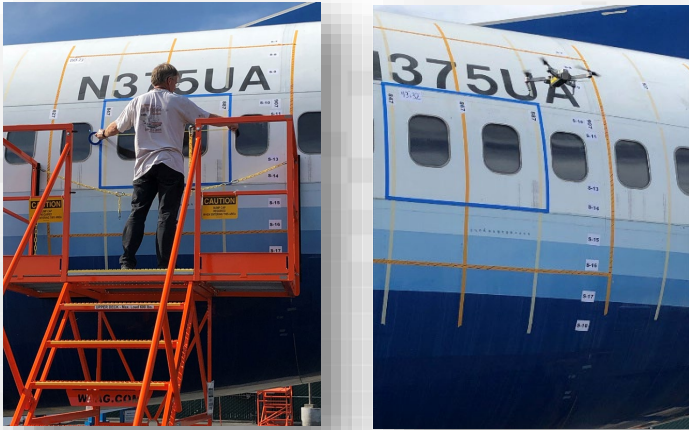
Standard GVI Outline Dimension

- The image should simulate as if the AMT captured from touching distance
- Any zooming images may become blurry and pixelated
- Image inspection procedure criteria will be provided to AMT or UI

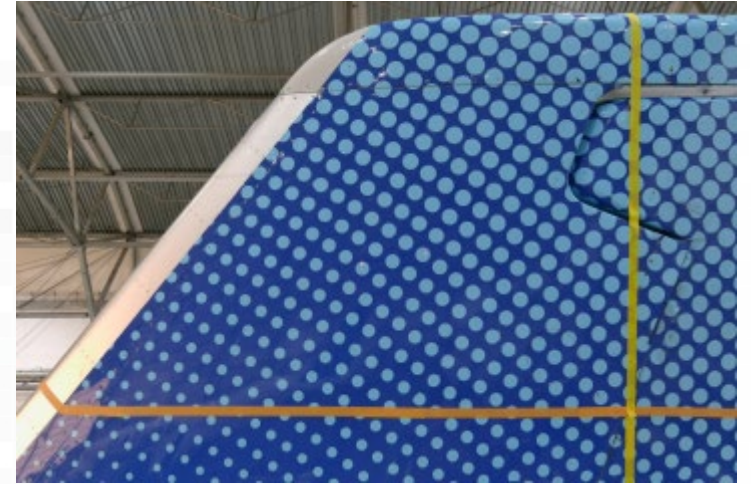
The Maintenance Steering Group-3 (MSG-3) GVI definition:

“Visual examination of an interior or exterior area, installation or assembly to detect obvious damage, failure or irregularity, made from within touching distance and under normally available lighting condition such as daylight, hangar lighting, flashlight or drop-light”.
