JAL Experience - 787 1st D-Check and NDI use cases

Junya Matsuda
Airframe Engineering
JAL Engineering Co., Ltd.

30OCT2022

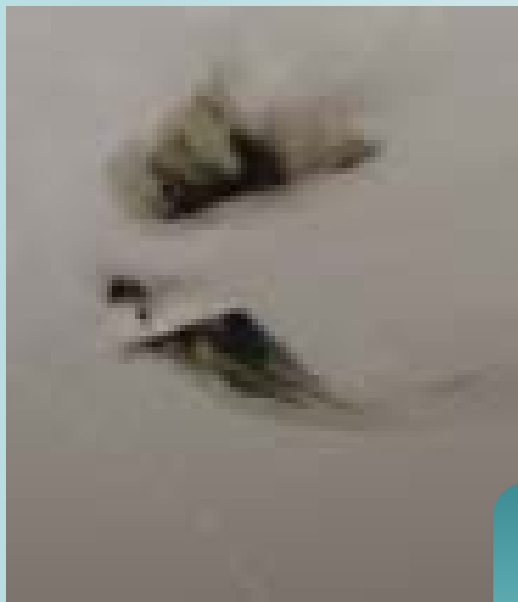
Which is serious ? Which is not ?
⇒ NDI is the key for determination...

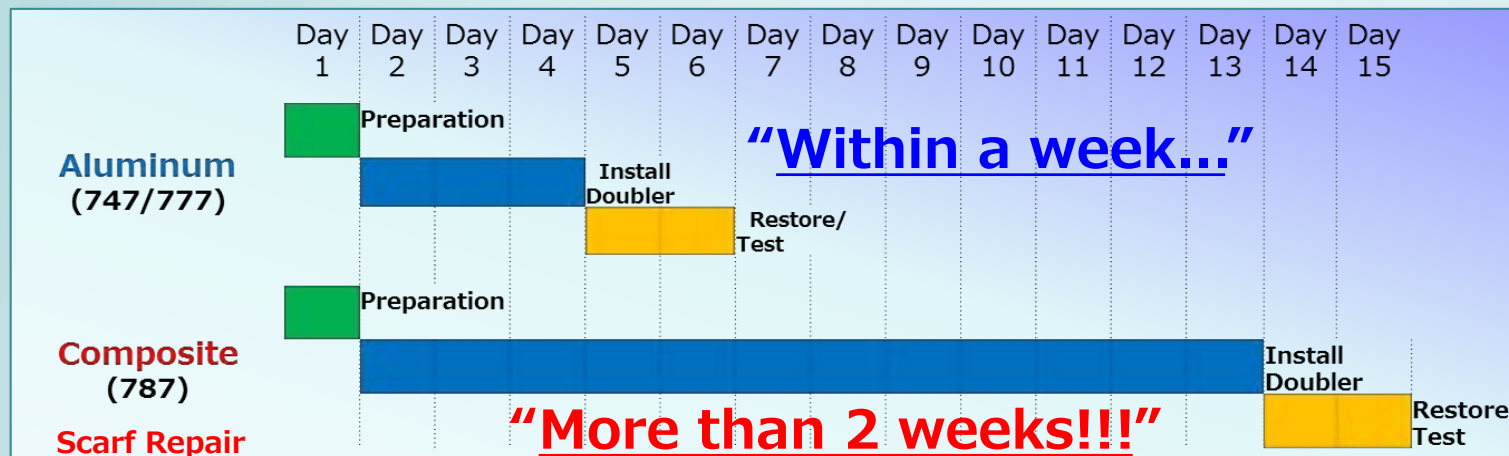
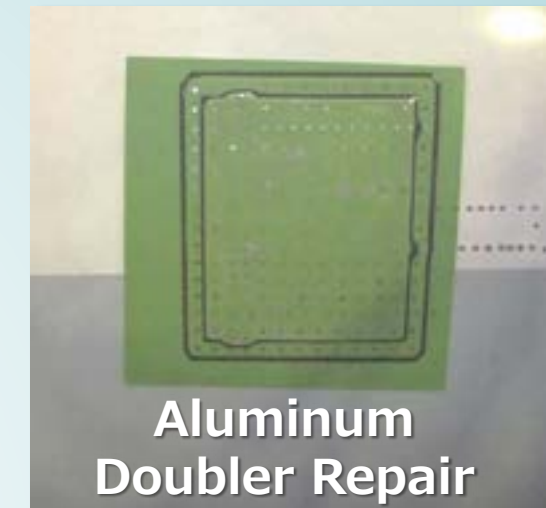
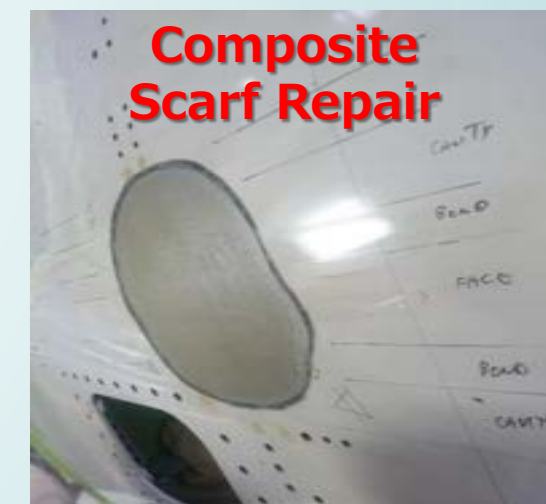
Scarf repair is always the impact for AOG period and resource constraint...
